Oyster Creek Nuclear Generating Station

Unresolved Problems With Drywell Corrosion

January 18, 2007

Richard Webster, Rutgers Environmental Law Clinic
on behalf of the Coalition to Stop the Relicensing of
Oyster Creek

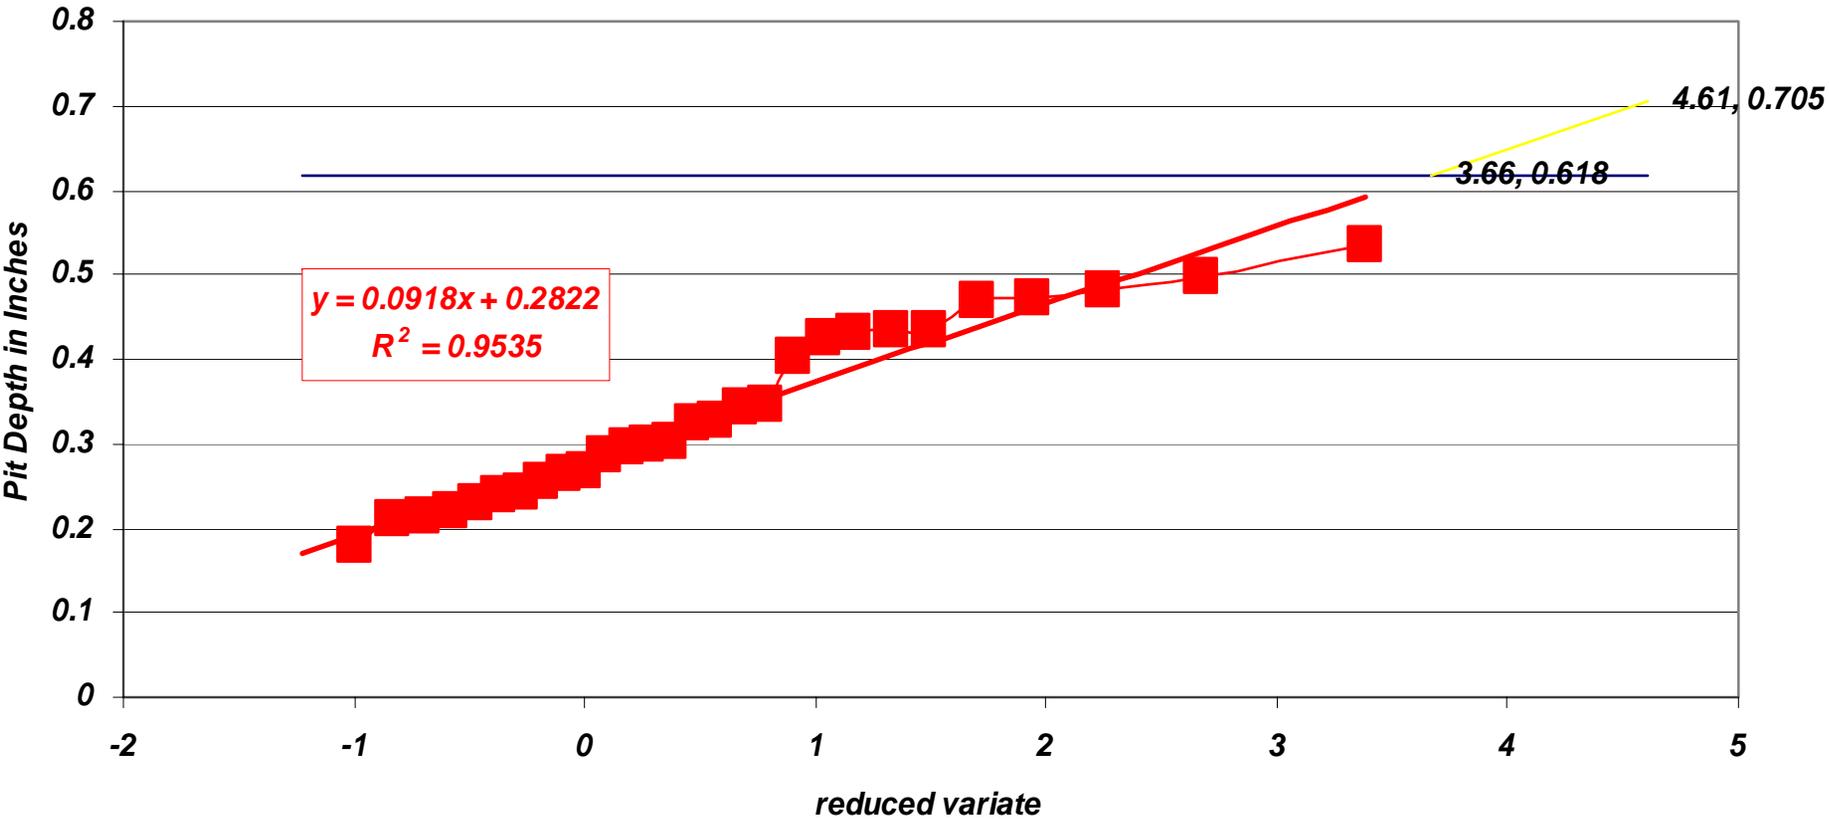
Extreme Value Statistics for 1992 Exterior UT Results in Bay 13

2.5% chance a single point measurement would give thickness less than 0.536"
 At 99% certainty shell thickness at each point is > 0.449 inches

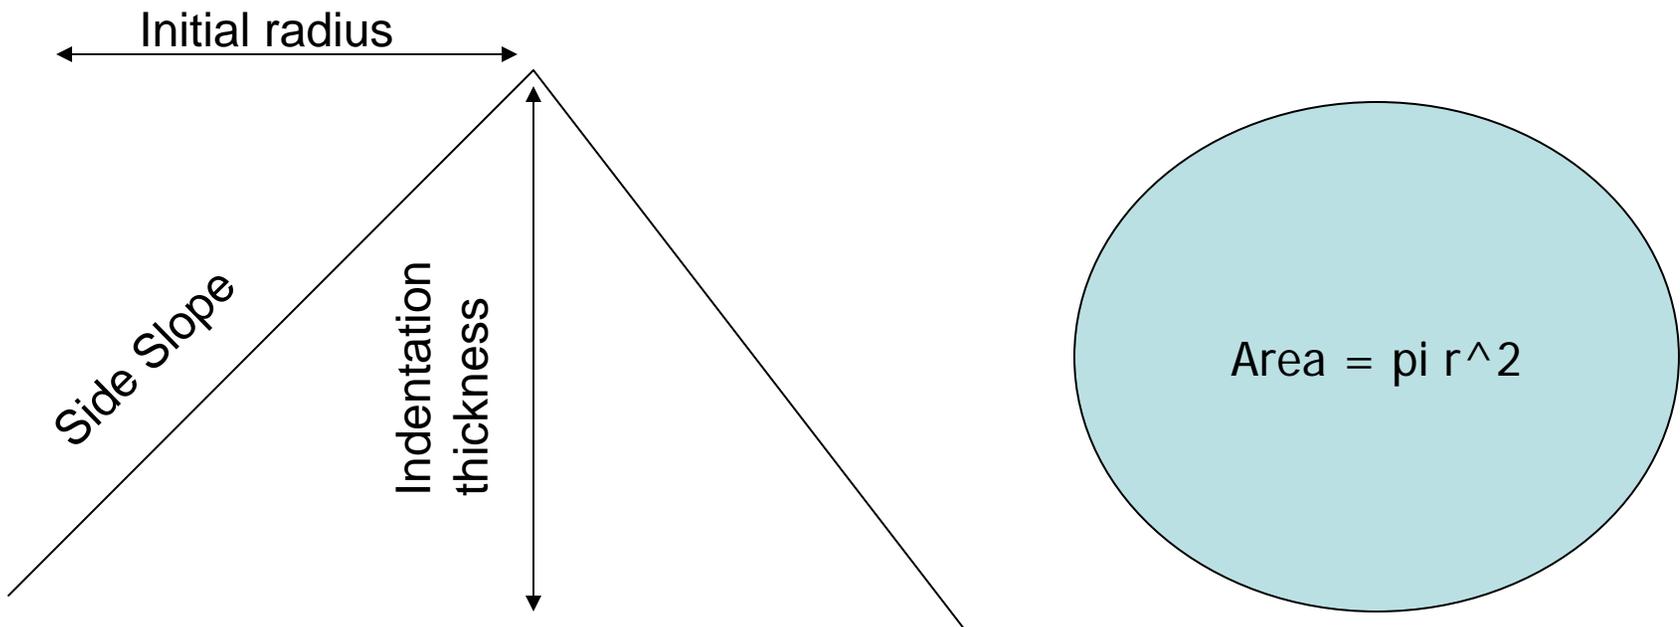
Sensitivity of Area Below 0.736 Inches to Thinning

For illustration assume constant side slope and conical shape
Use known result that Point 7 in Bay 13 has min thickness of 0.618 inches and area below 0.736 inches of 0.25 sq. ft

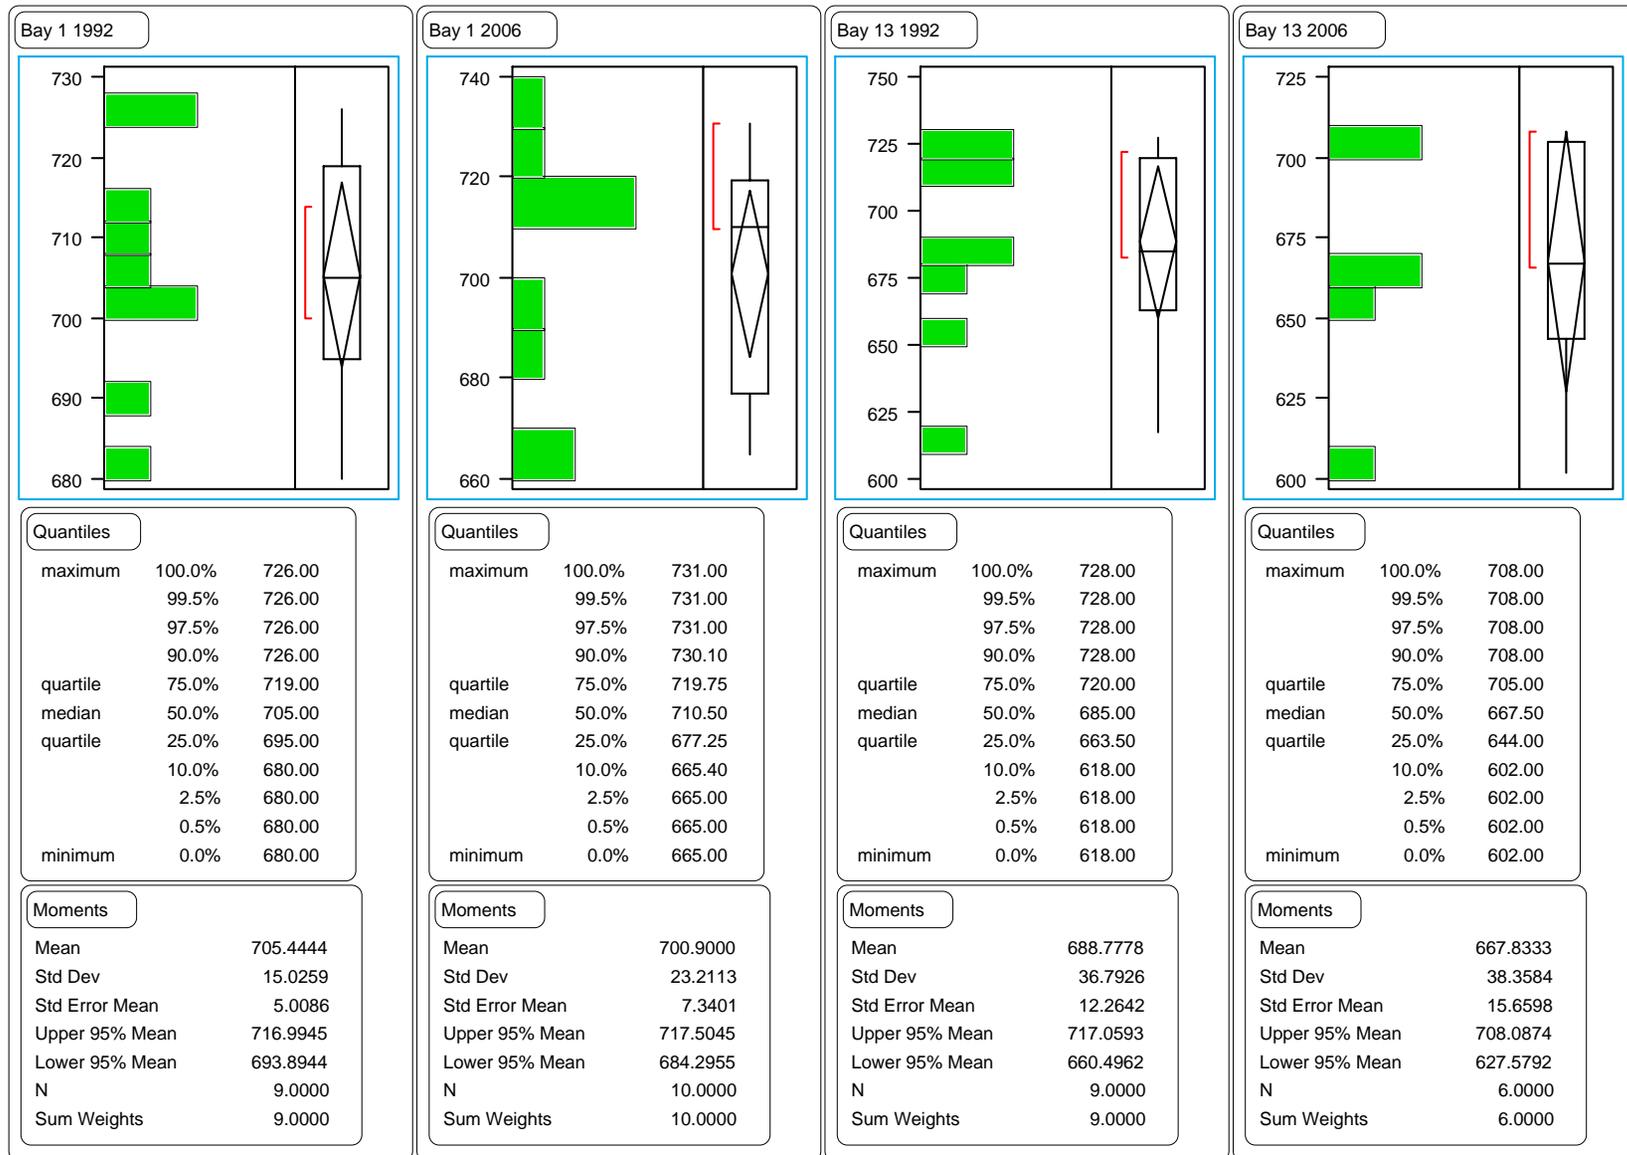
2006 External UT Results: Details

- Incomplete results presented in an opaque way in ACRS information package
- Thinnest point measured decreased from 0.618 inches to 0.602 inches
- Results indicated general thinning of the drywell shell by up to 0.039 inches
- Likely that shell is thinner than it was in 1992
- Even 0.02 inches of corrosion would be significant because claimed margin was 0.064 inches and thin areas expand quickly with additional thinning
