**CORRO-CONSULTA**

**MEMORANDUM**

**Subject: Update of Current Knowledge Regarding the State of Integrity of OCNGS Drywell Liner and Comments Pertaining to Aging Management Thereof**

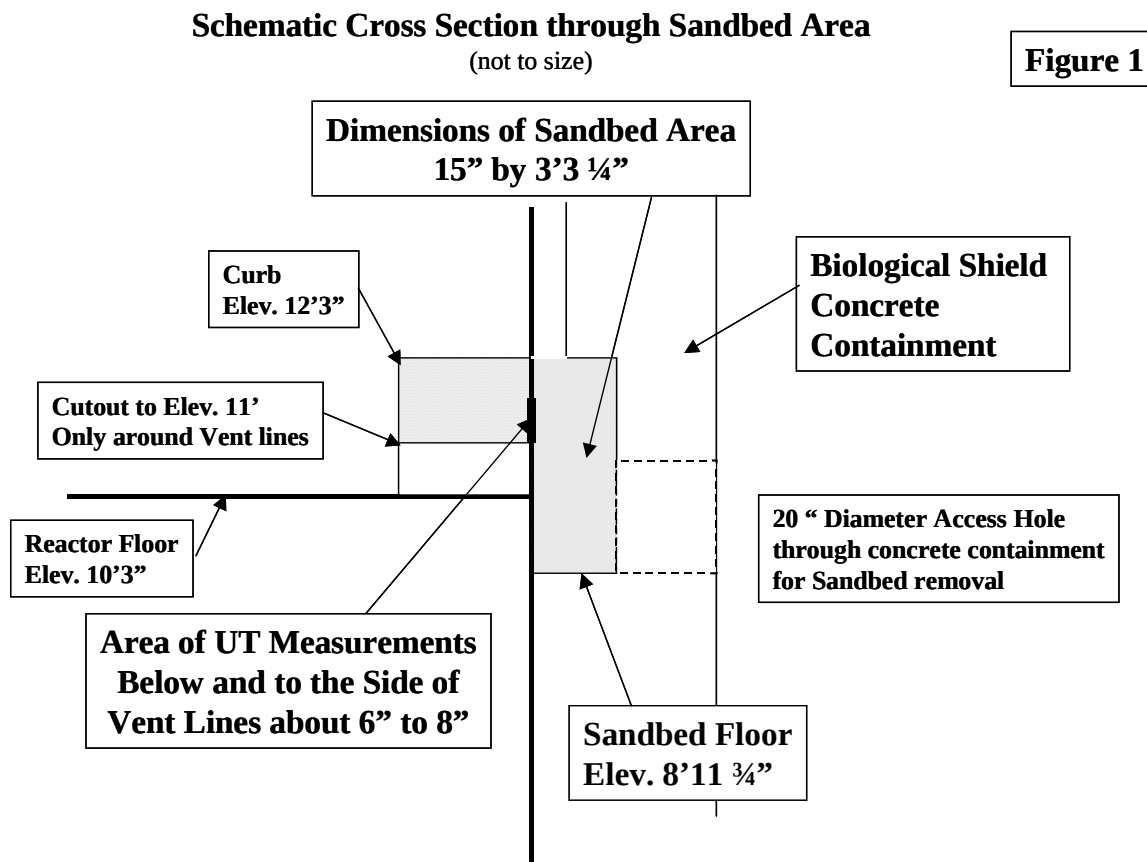
We take issue with this statement. In support of this contention, an effort was made to show graphically the remaining wall thickness observed in all of these various locations. Thus Figure 2 shows, by way of example, the remaining wall thickness from the 2006 UT measurements made with the help of 6 by 6 inch grids as a function of elevation in the **trench of Bay 17**. It is understood, as is described in Ref. 3 that 6 such grids were placed one on top of the other in the trench in order to capture the corrosion from the bottom to the top of the sandbed. Hence, if the bottom of the trench had the elevation about 9 feet, then the top of the 6 grids would have had an elevation of about 12 feet, which according to Figure 1 corresponds to the top of

The most striking observation is that the corrosion is most severe at the top, almost uniform in severity over most of the depth of the sandbed and again somewhat more severe at the very bottom. **In other words, one sees already in this presentation that it would be difficult to single out one small area by means of a 6 by 6 inch grid and claim it to be representative of the corrosion having occurred in the sandbed area.**

increasing depth and very likely uneven water content as well. This inhomogeneity is illustrated in Figure 2, where one can see greater corrosion attack toward the top of the sandbed. Similarly, the data show that in Bay 1 the corrosion below the ventpipe occurred more or less in a band of increased corrosion. This band appears to be about 6 to 7 feet long and perhaps a foot wide, although the lowest residual wall thickness (0.669) is found much deeper in the sandbed (Ref. 3). These data shown numerous in various discussions and appendices clearly demonstrate how difficult it is to assess the extent of the damaged areas as is necessary for comparison with the integrity criteria. For instance, the data gathered in Bay 1 in 2006 (and previous years) represent but a small fraction of the overall drywell liner surface exposed to the sandbed environment, and no amount of statistics can predict the pit distribution seen in Bay 1 (Fig. 5). Furthermore, again, the measurements which assess the corrosion in Bay 1 are all point measurements, and one has no way of assessing whether the pits are as local as the representation suggests or whether in fact the thin areas extend from one measurement to the next. I believe that when assessing the extent of severe corrosion, reviewers should assume that the measured points connect unless other measurements show this not to be the case.

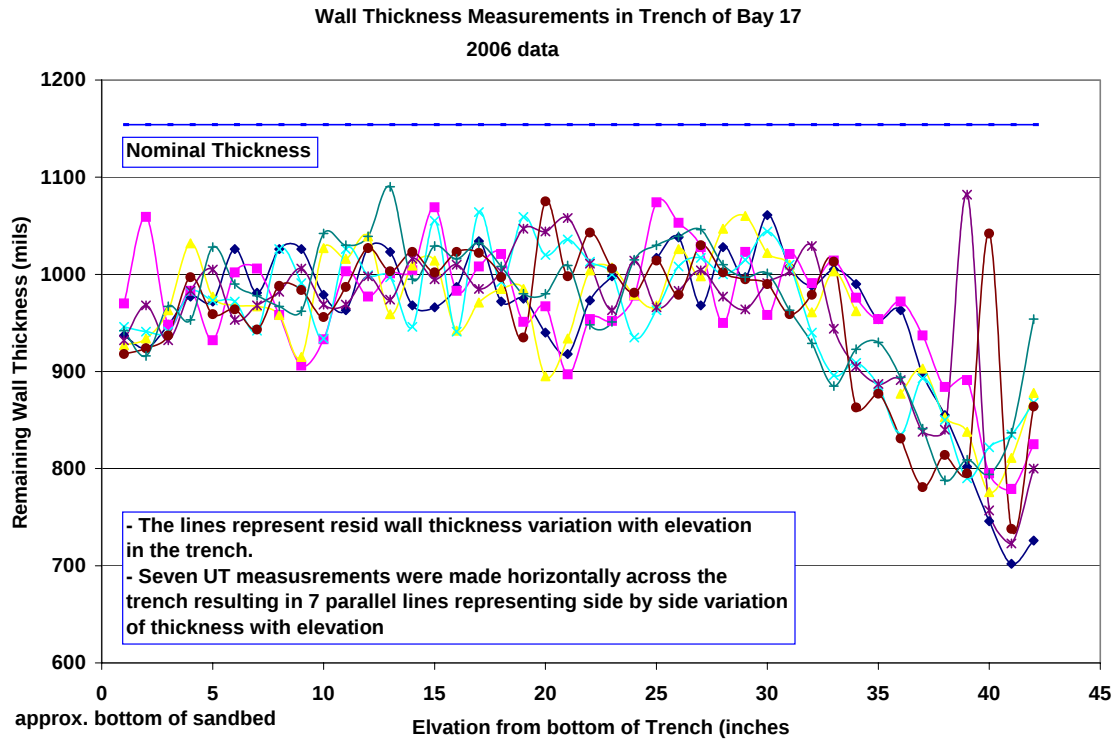
In Figure 3 an effort is being made to compare the average remaining wall thickness from trench measurements (averaged over the horizontal direction) with the average of the 6 by 6 grid measurement from the inside and the direct UT measurements from the outside. Also graphed in this figure are the averages of the outside measurements for the three zones for which data are reported (Ref. 5). What one can see is that the averages for the grid and the trench data overlap quite well at the same elevation. However, the average outside measurements are significantly lower at comparable elevations. <sup>4)</sup> This is probably because the choice of location for the external measurements was deliberately biased towards thin spots.

**Conclusion: What the superposition of the UT measurements in Bay 17 demonstrates is that wall loss ranges from zero to 33 percent, however, only the trench and outside measurements come close to represent the most severe corrosion at the highest elevations. The inside grid measurements give a distorted picture. It should also be remembered that the grid measurements at the inside curb cutout as well as those in the trench are only 6 inches wide. One**

Comparison of Various Thickness Measurements in Bay 17  
2006 data

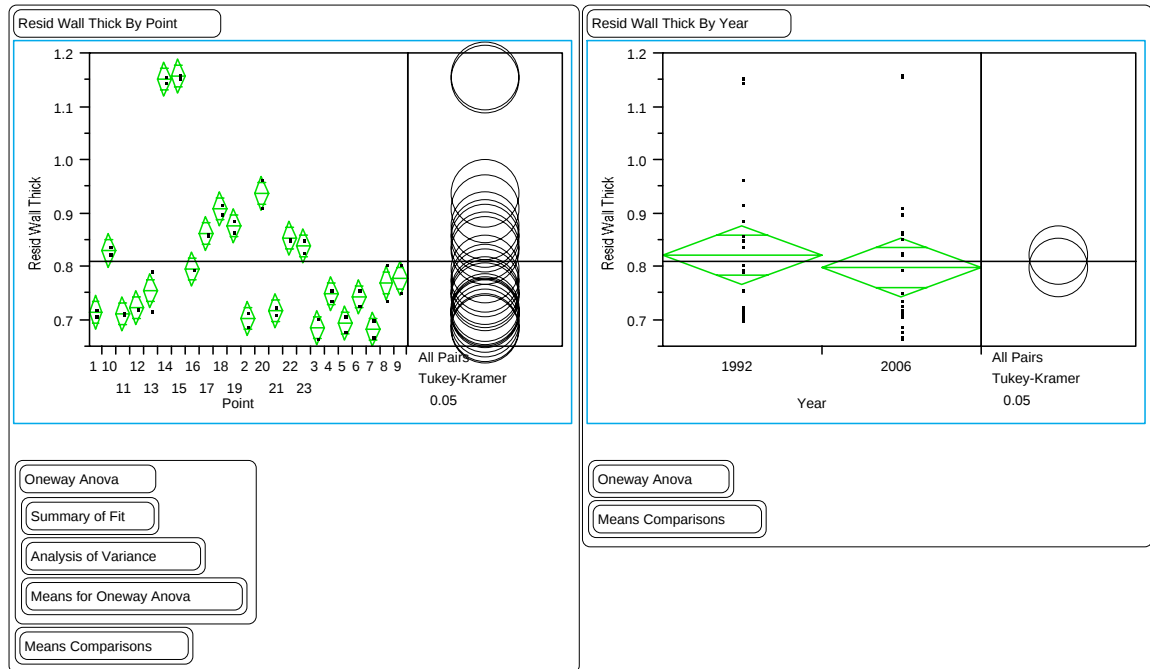
**Figure 10: External UT measurements in Bay 19**

Again one finds that the “up” measurements are significantly lower from the 1992 measurements.
