CORRO-CONSULTA

MEMORANDUM

Subject: Update of Current Knowledge Regarding the State of Integrity of OCNGS Drywell Liner and Comments Pertaining to Aging Management Thereof

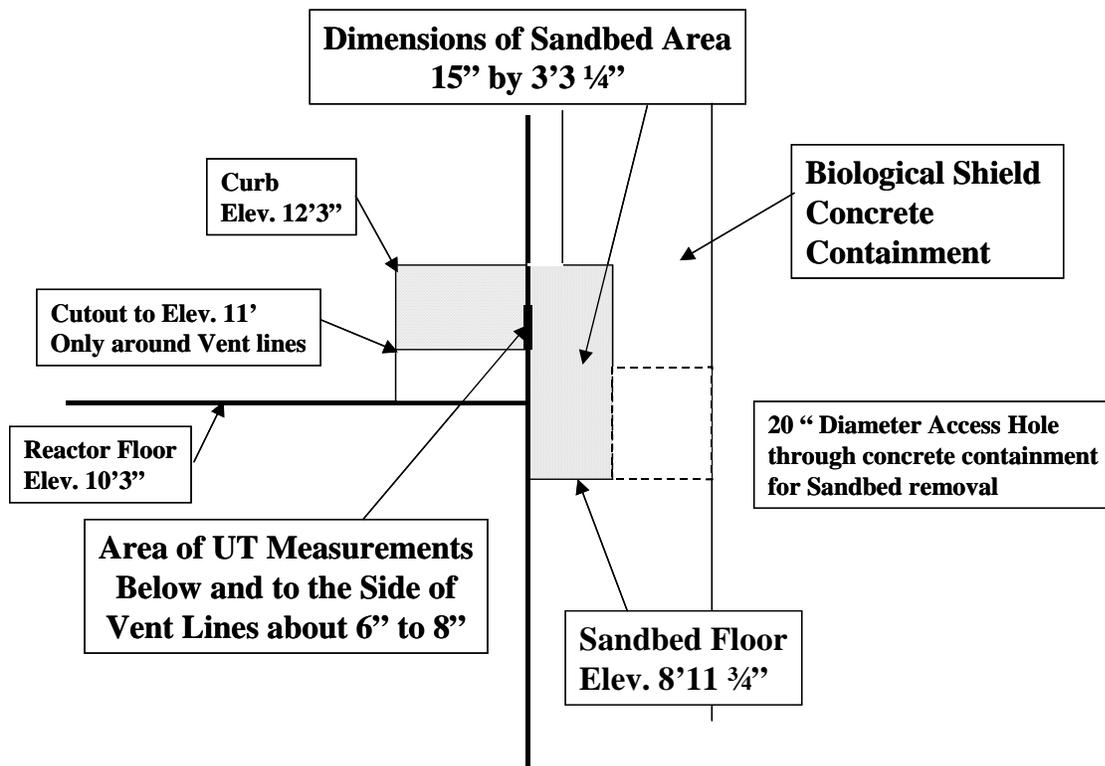
We take issue with this statement. In support of this contention, an effort was made to show graphically the remaining wall thickness observed in all of these various locations. Thus Figure 2 shows, by way of example, the remaining wall thickness from the 2006 UT measurements made with the help of 6 by 6 inch grids as a function of elevation in the **trench of Bay 17**. It is understood, as is described in Ref. 3 that 6 such grids were placed one on top of the other in the trench in order to capture the corrosion from the bottom to the top of the sandbed. Hence, if the bottom of the trench had the elevation about 9 feet, then the top of the 6 grids would have had an elevation of about 12 feet, which according to Figure 1 corresponds to the top of

Schematic Cross Section through Sandbed Area
(not to size)

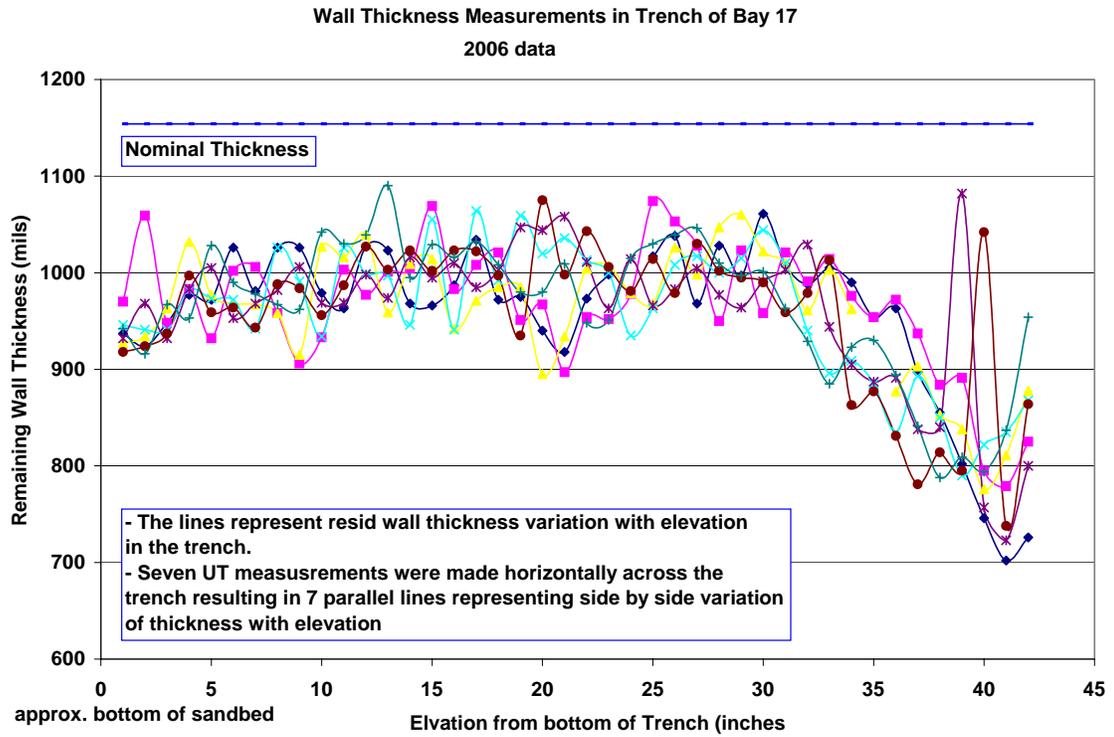
Figure 2

The most striking observation is that the corrosion is most severe at the top, almost uniform in severity over most of the depth of the sandbed and again somewhat more severe at the very bottom. **In other words, one sees already in this presentation that it would be difficult to single out one small area by means of a 6 by 6 inch grid and claim it to be representative of the corrosion having occurred in the sandbed area.**

increasing depth and very likely uneven water content as well. This inhomogeneity is illustrated in Figure 2, where one can see greater corrosion attack toward the top of the sandbed. Similarly, the data show that in Bay 1 the corrosion below the ventpipe occurred more or less in a band of increased corrosion. This band appears to be about 6 to 7 feet long and perhaps a foot wide, although the lowest residual wall thickness (0.669) is found much deeper in the sandbed (Ref. 3). These data shown numerous in various discussions and appendices clearly demonstrate how difficult it is to assess the extent of the damaged areas as is necessary for comparison with the integrity criteria. For instance, the data gathered in Bay 1 in 2006 (and previous years) represent but a small fraction of the overall drywell liner surface exposed to the sandbed environment, and no amount of statistics can predict the pit distribution seen in Bay 1 (Fig. 5). Furthermore, again, the measurements which assess the corrosion in Bay 1 are all point measurements, and one has no way of assessing whether the pits are as local as the representation suggests or whether in fact the thin areas extend from one measurement to the next. I believe that when assessing the extent of severe corrosion, reviewers should assume that the measured points connect unless other measurements show this not to be the case.

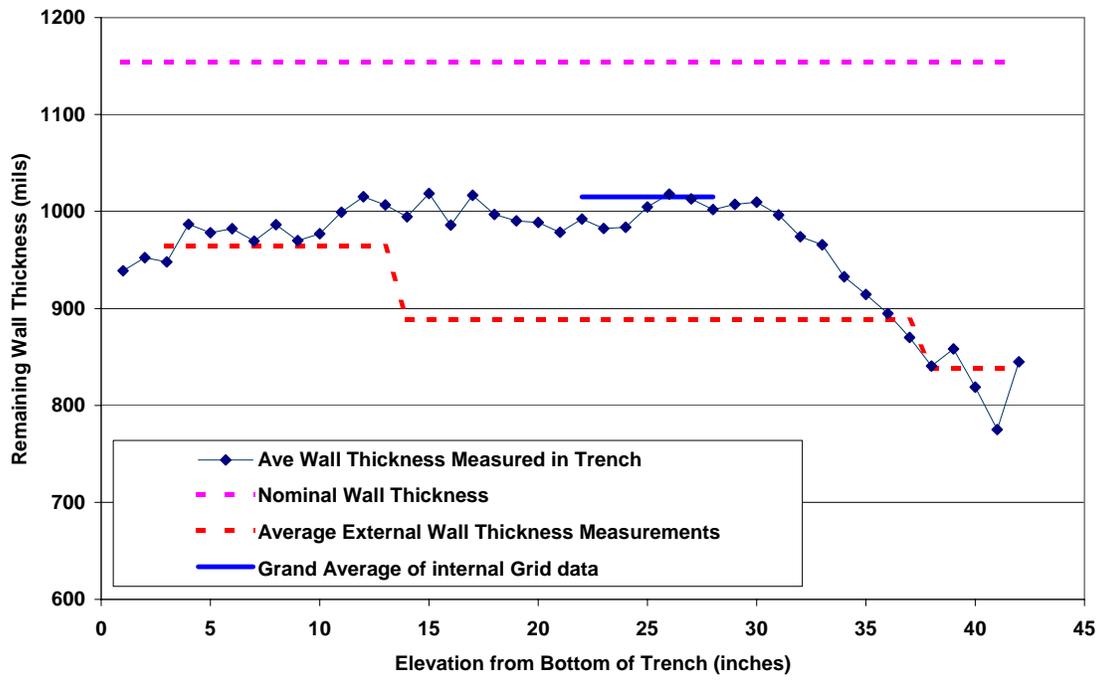
In Figure 3 an effort is being made to compare the average remaining wall thickness from trench measurements (averaged over the horizontal direction) with the average of the 6 by 6 grid measurement from the inside and the direct UT measurements from the outside. Also graphed in this figure are the averages of the outside measurements for the three zones for which data are reported (Ref. 5). What one can see is that the averages for the grid and the trench data overlap quite well at the same elevation. However, the average outside measurements are significantly lower at comparable elevations.⁴⁾ This is probably because the choice of location for the external measurements was deliberately biased towards thin spots.

Conclusion: What the superposition of the UT measurements in Bay 17 demonstrates is that wall loss ranges from zero to 33 percent, however, only the trench and outside measurements come close to represent the most severe corrosion at the highest elevations. The inside grid measurements give a distorted picture. It should also be remembered that the grid measurements at the inside curb cutout as well as those in the trench are only 6 inches wide. One

Comparison of Various Thickness Measurements in Bay 17
2006 data

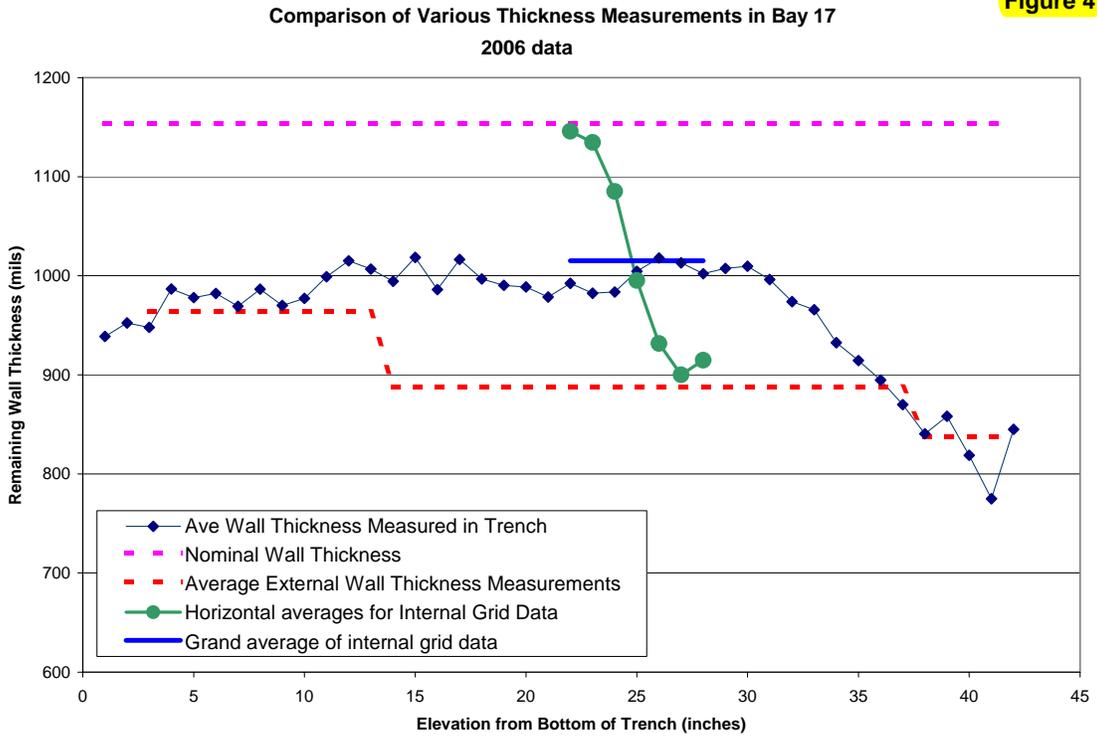
Finally in Figure 4 we see the spread of the 6 by 6 inch inside grid measurements superimposed on the averages of the other measurements.

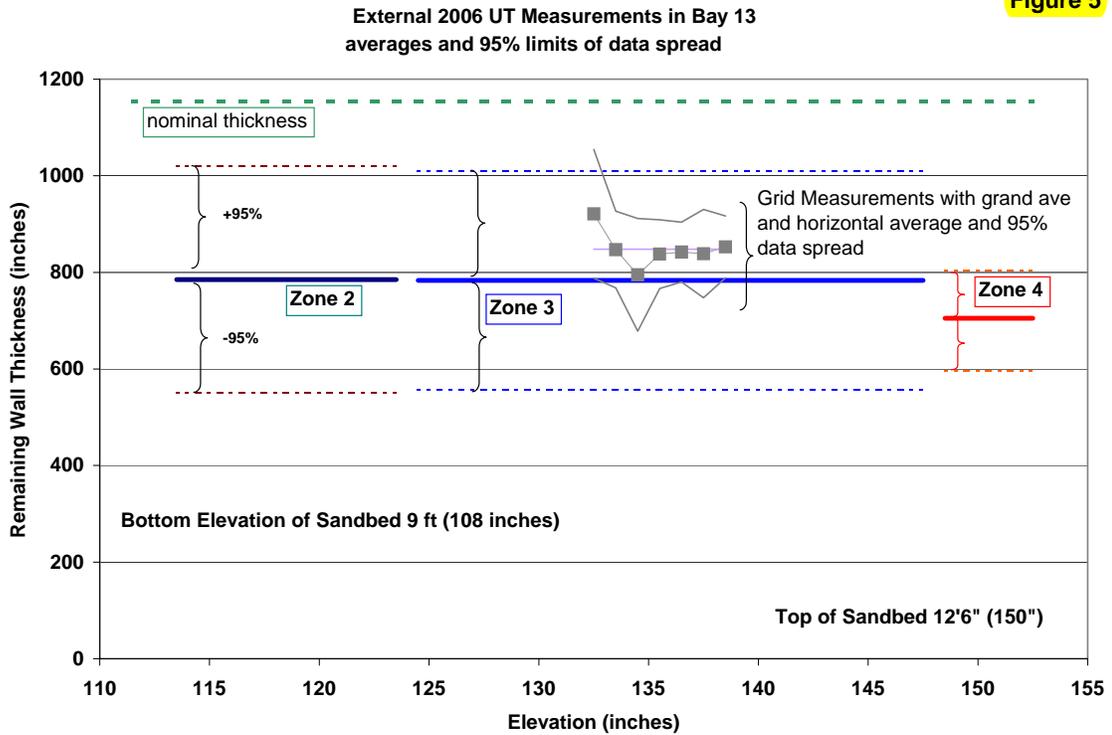
Figure 5 shows an analysis of the available 2006 data for Bay 13. Bay 13 is probably the second worst corroded bay apart from Bay 1. The averages for the external measurements for each zone are fairly similar, as are the 95% limits for the data spread. There is a 95% percent probability for the deepest penetration to be of the order of 48% of the original wall thickness. The superposition of the internal grid data shows a higher average and a narrower distribution of the data spread. Again one recognizes that the internal 6 by 6 inch grid measurements do not represent the worst corrosion degradation.

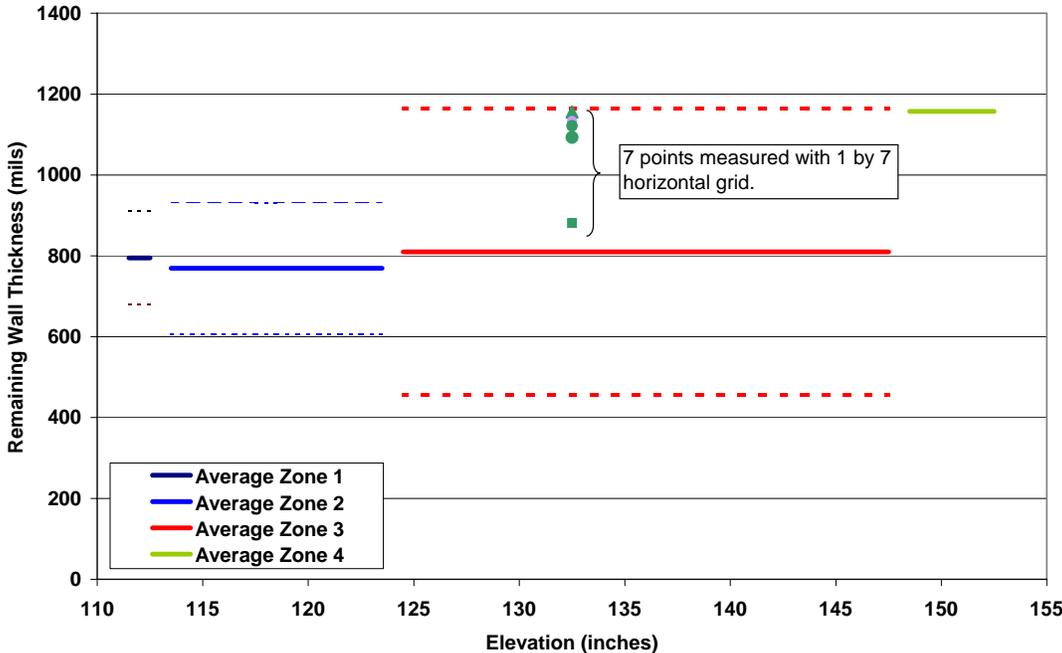
Finally in Figure 6 we show the distribution of the external measurements for Bay 1. One observes that the 95% lower limit of the data spread is around 40% of the original wall thickness, or indeed at a remaining wall thickness of 450 mils, which is 0.04 inches below the required sandbed thickness for the Design Pressure and Temperature. Because the external sampling in Bay 1 was designed to capture the thinnest points, this is a conservative estimate of the minimum wall thickness. However, given the need for a very high degree of confidence that the drywell shell is ready to withstand accident pressures and the uncertainty created by the sparse data set, I believe that a conservative approach is required in this case.

External UT Measurements 2006 in Bay 1
Averages and 95% limits of data spread

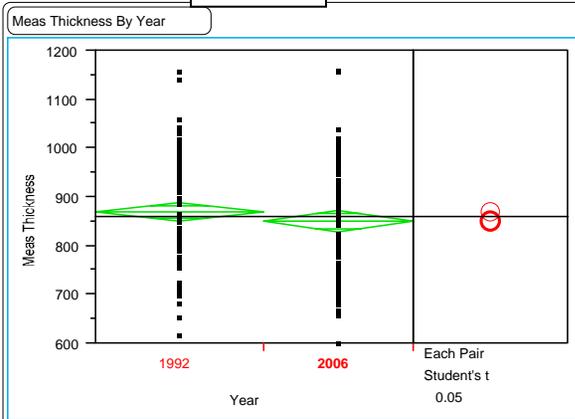
Fig 7 a

It was found that there is no significant effect of the time (Fig.7a). While there is a decrease of 19 mils between 1992 and 2006, this difference is not statistically

Figure 7a: Comparison between measurements in 1992 and 2006 show no significant difference. The means from 1992 and 2006 show a bias of 0.018 inches, but the bias is statistically not significant despite of the many data points. Fig. 7b: The comparison between the “zones” (elevations) is significant. Zones 1 is significantly different from zones 2 and 3. For zone 4 there are not enough data for statistical significance. Fig. 7c: Some bays, red ones, are significantly different from the black ones.

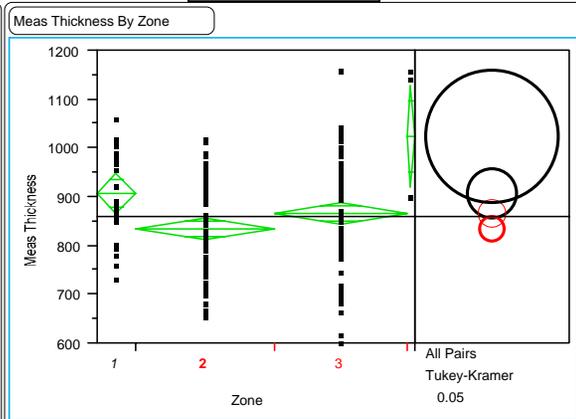
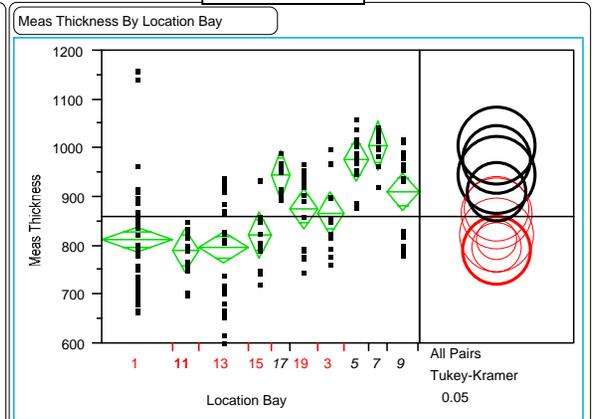
significant within the variability of the data. The differences between the zones, however are significant. Zone 2 is by far the most corrosive zone. When the bays are compared, one finds as expected that some bays have experienced little corrosion in contrast to others. The importance of these observations is obvious: they point again to the fact that the intensity of corrosion is a clear function of elevation and bay. Hence, averaging data and generalization may lead to doubtful conclusions.

Statistical Analysis of all External UT Measurements

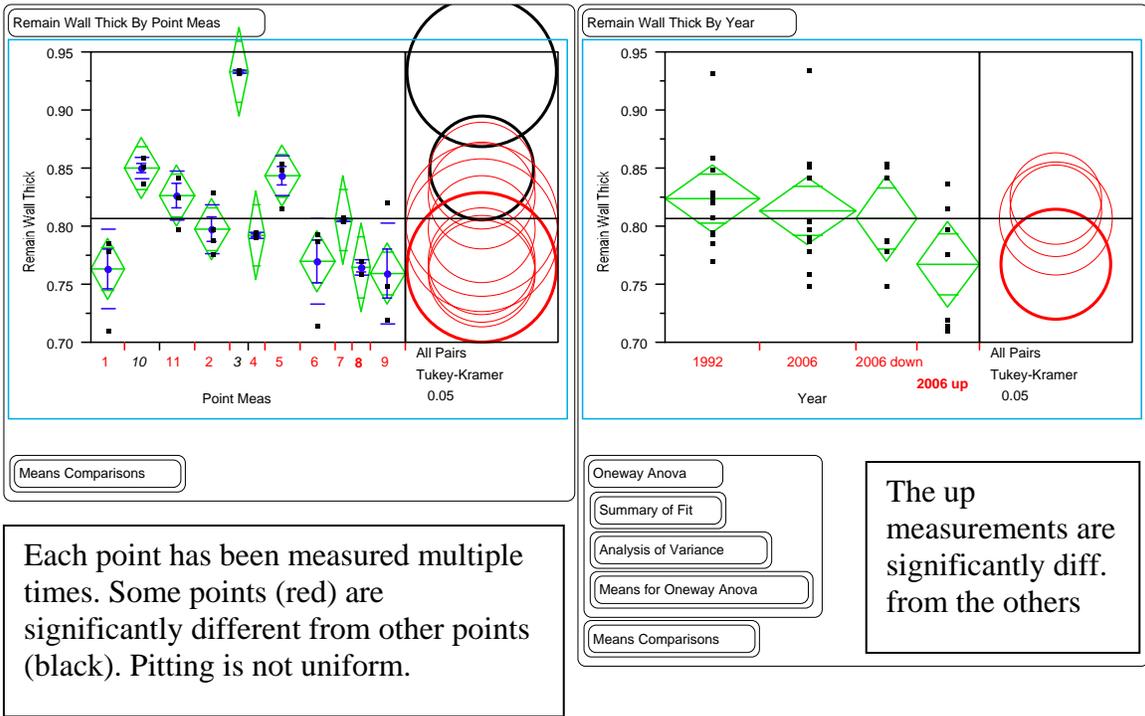
Figure 8: External UT Measurements in Bay 15

In 2006 the validity of some of the external UT measurements was explored by measuring around the nominal original locations. These data were statistically evaluated in Figures 8, 9, 10 for Bays 15, 1 and Bay 19. The additional data collected in Bays 19 and 15 had been identified as “up” or “down”, hence additional data sets identified as 2006 up and 2006 down were compared with the original 2006 data. It turns out for Bay 19 for instance that the UT penetrations identified as 2006 up were significantly lower than the measurements of 1992 with a probability of better than 95%. The difference between the 1992 and 2006 up data is 0.1 inch. Similarly for Bay 15 one finds that the 2006 up data are significantly lower than the original 1992 data by about 0.06 inches, although this difference is not significant at the 5% level. For Bay 1 there is practically no difference between the 2006 and the 1992 data sets, because of the two or three measurements in the non-corroded areas. Summarizing these results in Table 1, one finds that the lower 95% confidence limits for Bays 1, 15 are marginally within the 0.736-inch limit. Since one does not know exactly how extensive the “cancer of corrosion” in the sand bed area really is, it is very difficult to put this interpretation in perspective with the assessments made by AmerGen relative to areal criteria for thinned areas (see discussion below).

Each point has been measured multiple times. Some points (red) are significantly different from other points (black). Pitting is not uniform.

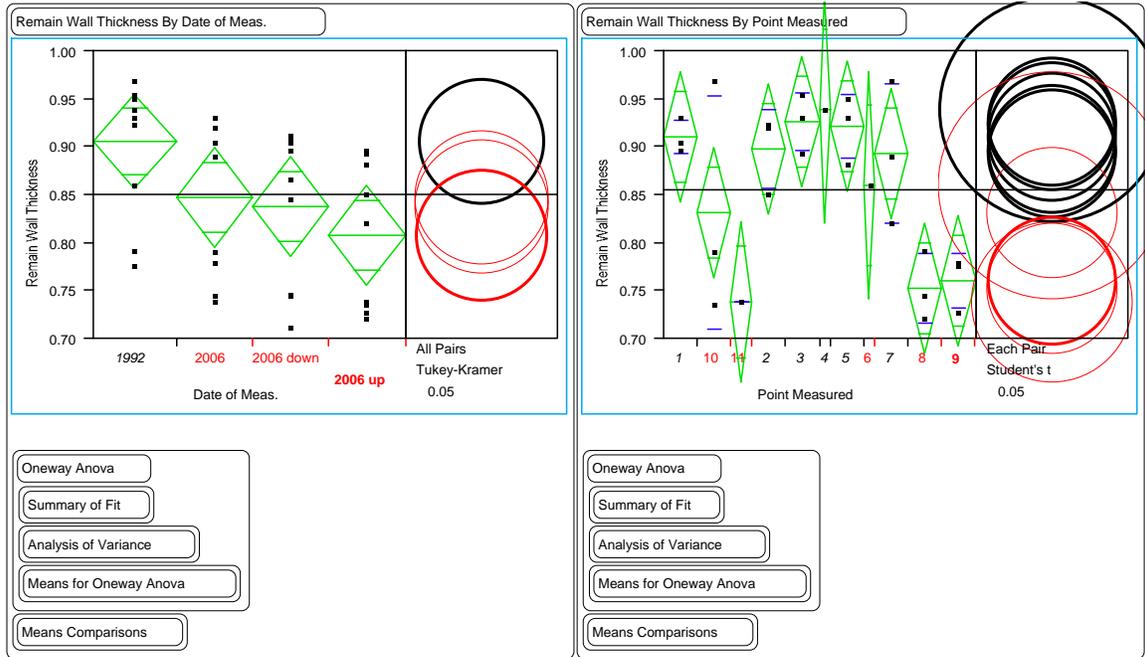
Figure 10: External UT measurements in Bay 19

Again one finds that the “up” measurements are significantly lower from the 1992 measurements.
