**MEMORANDUM – REDACTED VERSION – JULY 19, 2007**

**Subject: Update of Current Knowledge Regarding the State of Integrity of OCNGS Drywell Liner and Comments Pertaining to Aging Management Thereof**

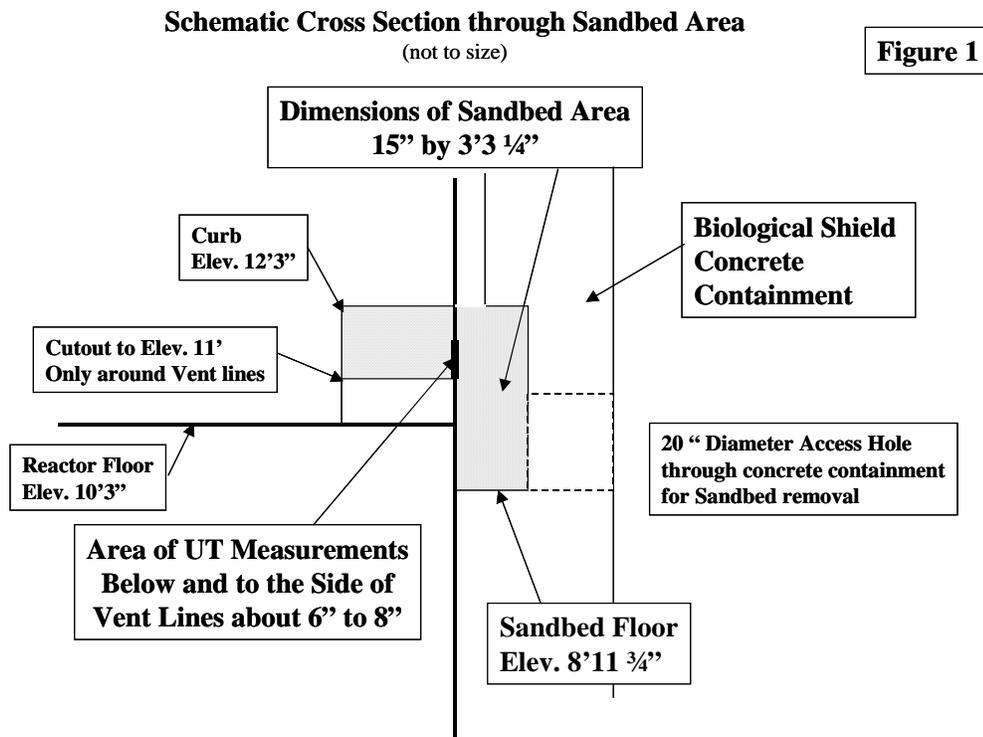
We take issue with this statement. In support of this contention, an effort was made to show graphically the remaining wall thickness observed in all of these various locations. Thus Figure 2 shows, by way of example, the remaining wall thickness from the 2006 UT measurements made with the help of 6 by 6 inch grids as a function of elevation in the **trench of Bay 17**. It is understood, as is described in Ref. 3 that 6 such grids were placed one on top of the other in the trench in order to capture the corrosion from the bottom to the top of the sandbed. Hence, if the bottom of the trench had the elevation about 9 feet, then the top of the 6 grids would have had an elevation of about 12 feet, which according to Figure 1 corresponds to the top of the sandbed and is at least 9 inches higher than the top of the grid used for UT measurements from the inside. (Note, none of these elevations is terribly accurate, however, the top of the trench measurements were definitely lower (deeper pits) by a good margin than the inside grid measurements). Figure 2 plots all individual 2006 measurements from the trench in bay 17. The 6 traces represent the variation of the wall thickness in the horizontal direction while the traces themselves extend from the bottom of the trench (left hand side) to the top of the trench (right hand side). The

undulations of the 6 traces, which are at times (at the same elevation) in synch and at other times out of phase clearly depict the nature of the “golf ball type” surface described in AmerGen literature (Ref. 1 pg. 4). Where the undulations are in synch one can estimate that the extent of the pit at that location extends over an area larger than just one inch in diameter<sup>3)</sup>. It should also be noted that the average amplitude of the undulations in Fig. 2 are of the order of 0.1 inch, i.e. the roughness of the surface at this point is only of that order of magnitude. AmerGen estimated the “roughness” of the surface to be rather of the order of 0.2 inches (Ref. 5 pg. 5).

The most striking observation is that the corrosion is most severe at the top, almost uniform in severity over most of the depth of the sandbed and again somewhat more severe at the very bottom.

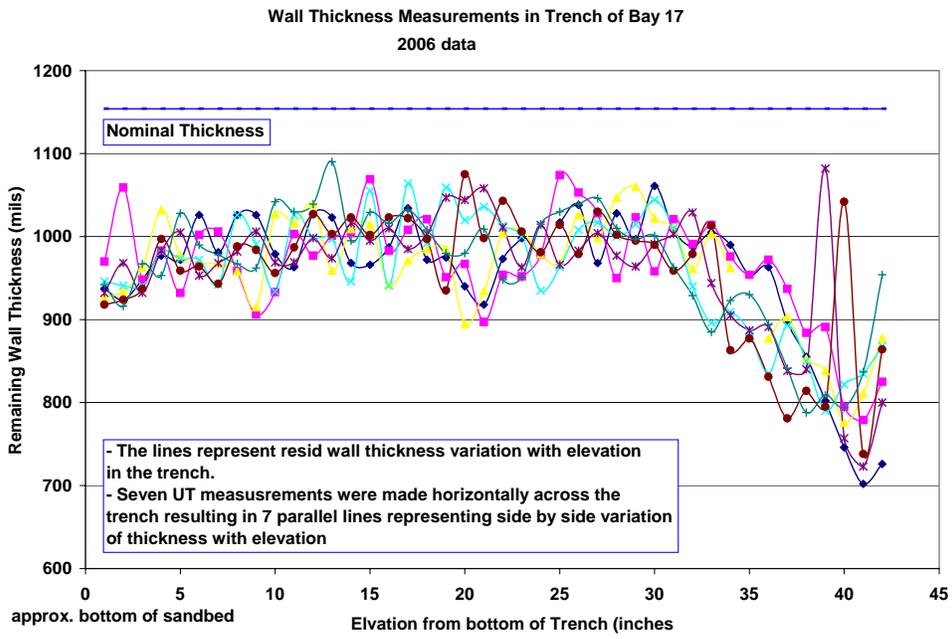
In Figure 3 an effort is being made to compare the average remaining wall thickness from trench measurements (averaged over the horizontal direction) with the average of the 6 by 6 grid measurement from the inside and the direct UT measurements from the outside. Also graphed in this figure are the averages of the outside measurements for the three zones for which data are reported (Ref. 5). What one can see is that the averages for the grid and the trench data overlap quite well at the same elevation. However, the average outside measurements are significantly lower at comparable elevations.<sup>4)</sup> This is probably because the choice of location for the external measurements was deliberately biased towards thin spots.

Comparison of Various Thickness Measurements in Bay 17  
2006 data

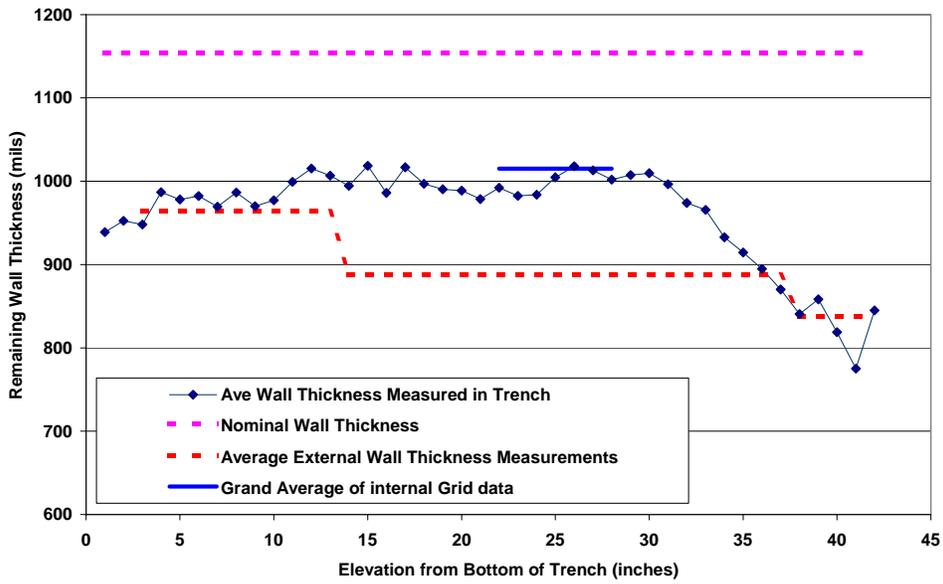
Finally in Figure 4 we see the spread of the 6 by 6 inch inside grid measurements superimposed on the averages of the other measurements.

**Conclusion: What the superposition of the UT measurements in Bay 17 demonstrates is that wall loss ranges from zero to 33 percent, however, only the trench and outside measurements come close to represent the most severe corrosion at the highest elevations. It should also be remembered that the grid measurements at the inside curb cutout as well as those in the trench are only 6 inches wide. One does not have, therefore any indications as to how far serious corrosion may have spread laterally around the circumference of the bay.**

Comparison of Various Thickness Measurements in Bay 17  
2006 data

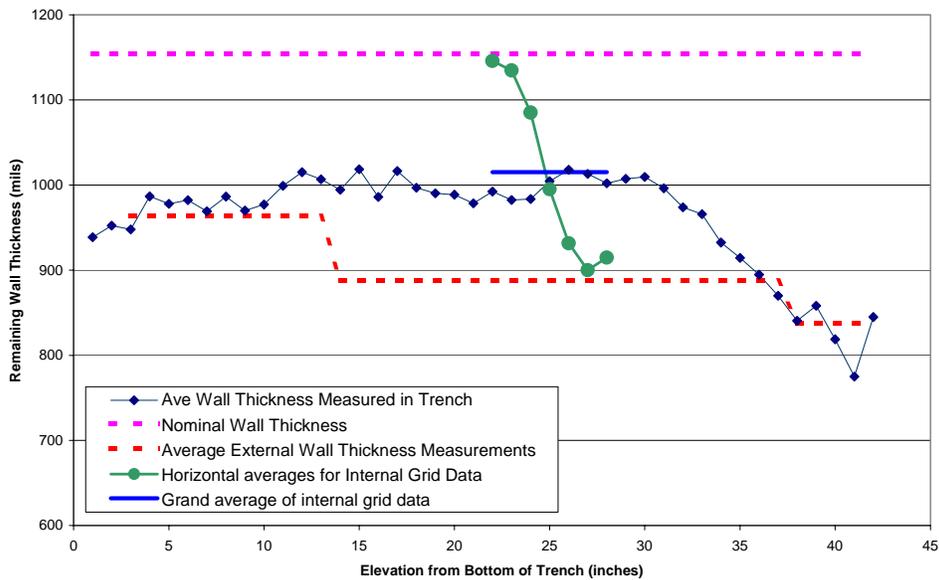
Figure 5 shows an analysis of the available 2006 data for Bay 13. Bay 13 is probably the second worst corroded bay apart from Bay 1. The averages for the external measurements for each zone are fairly similar, as are the 95% limits for the data spread. There is a 95% percent probability for the deepest penetration to be of the order of 48% of the original wall thickness. The superposition of the internal grid data shows a higher average and a narrower distribution of the data spread. Again one recognizes that the internal 6 by 6 inch grid measurements do not represent the worst corrosion degradation.

External 2006 UT Measurements in Bay 13  
averages and 95% limits of data spread

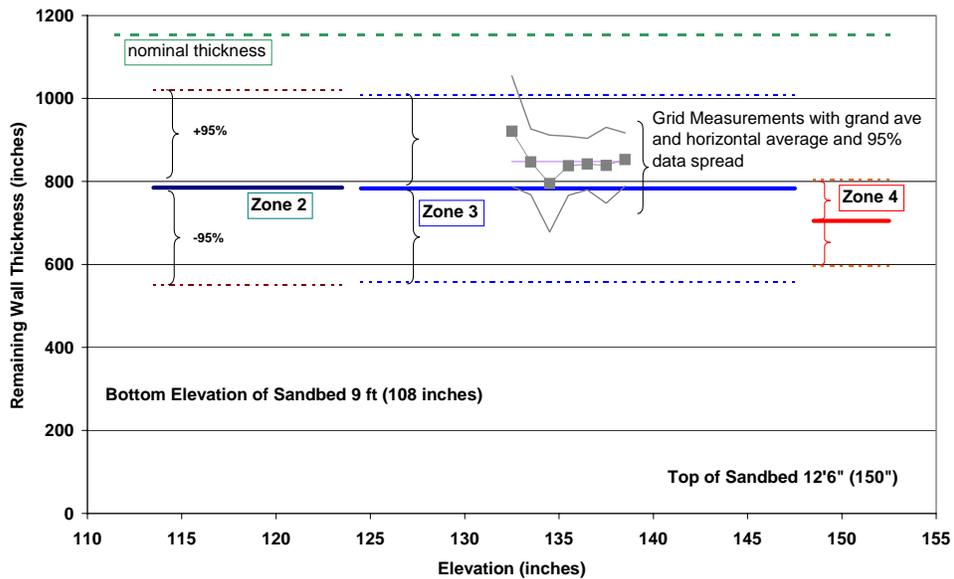
Finally in Figure 6 we show the distribution of the external measurements for Bay 1. One observes that the 95% lower limit of the data spread is around 40% of the original wall thickness, or indeed at a remaining wall thickness of 450 mils, which is 0.04 inches below the required sandbed thickness for the Design Pressure and Temperature. Because the external sampling in Bay 1 was designed to capture the thinnest points, this is a conservative estimate of the minimum wall thickness. However, given the need for a very high degree of confidence that the drywell shell is ready to withstand accident pressures and the uncertainty created by the sparse data set, I believe that a conservative approach is required in this case.

External UT Measurements 2006 in Bay 1  
Averages and 95% limits of data spread

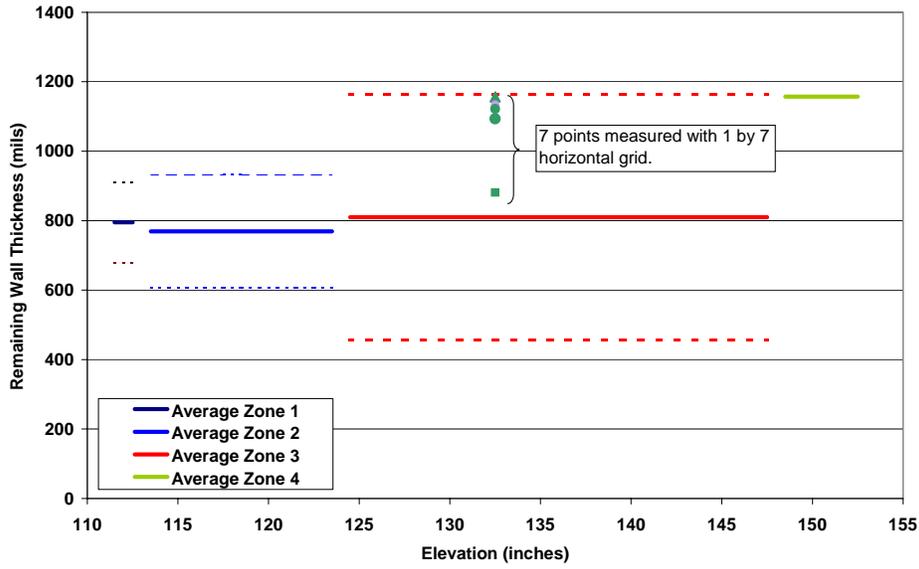
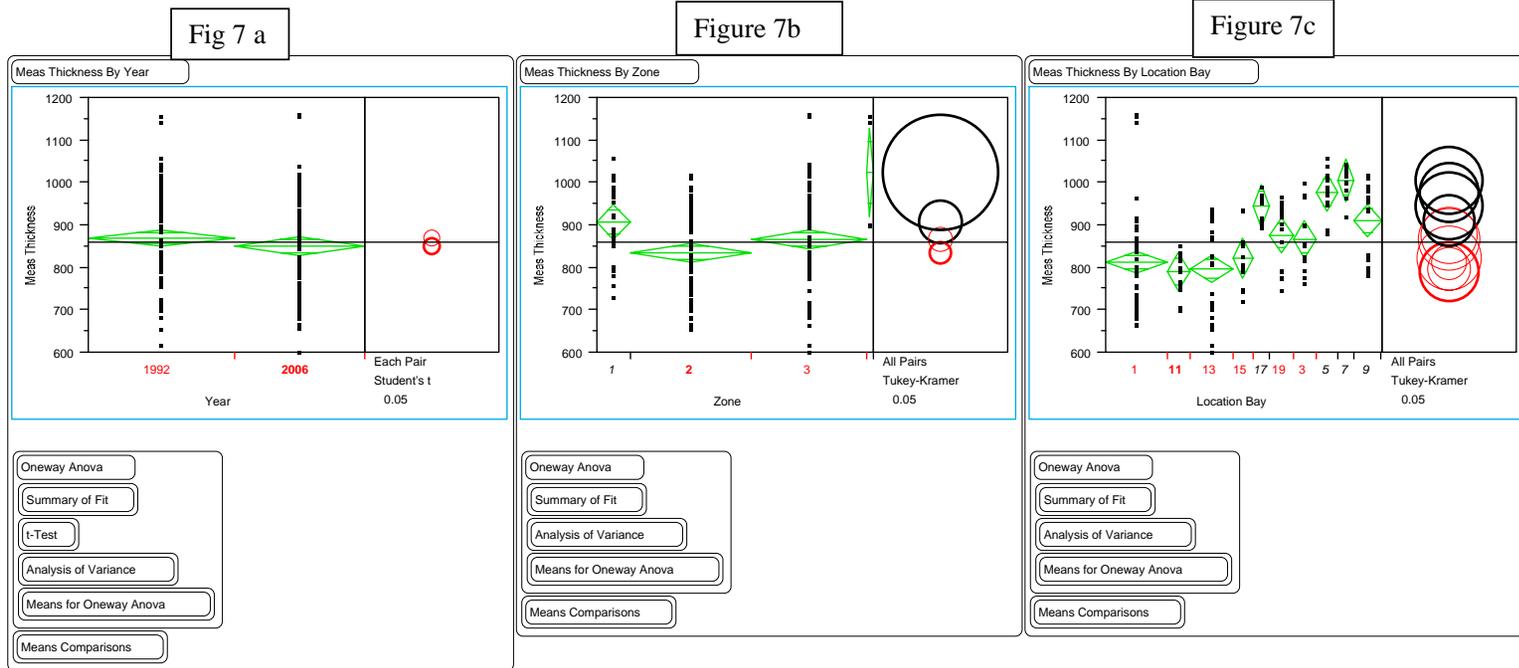
Figure 7

It was found that there is no significant effect of the time (Fig.7a). While there is a decrease of 19 mils between 1992 and 2006, this difference is not statistically significant within the variability of the data. The differences between the zones, however are significant. Zone 2 is by far the most corrosive zone. When the bays are compared, one finds as expected that some bays have experienced little corrosion in contrast to others. The importance of these observations is obvious: they point again to the fact that the intensity of corrosion is a clear function of elevation and bay. Hence, averaging data and generalization may lead to doubtful conclusions.

Statistical Analysis of all External UT Measurements

Comments: Figure 7a: Comparison between measurements I 1992 and 2006 show no significant difference. The means from 1992 and 2006 show a bias of 0.018 inches, but the bias is statistically not significant despite of the many data points. Fig. 7b: The comparison between the “zones” (elevations) is significant. Zones 1 is significantly different from zones 2 and 3. For zone 4 there are not enough data for statistical significance. Fig. 7c: Some bays, red ones, are significantly different from the black ones.

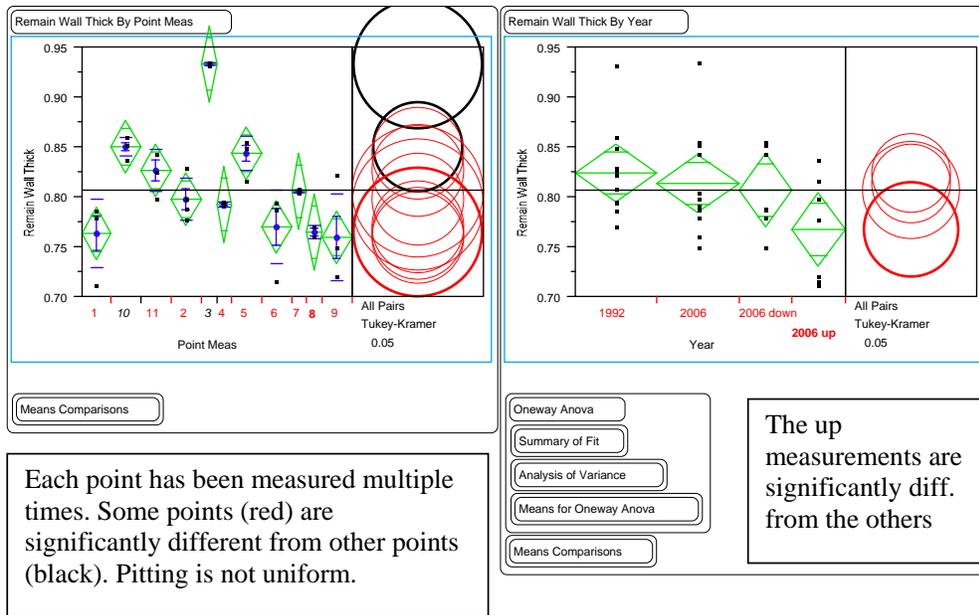
**Figure 8: External UT Measurements in Bay 15**

In 2006 the validity of some of the external UT measurements was explored by measuring around the nominal original locations. These data were statistically evaluated in Figures 8, 9, 10 for Bays 15, 1 and Bay 19. The additional data collected in Bays 19 and 15 had been identified as “up” or “down”, hence additional data sets

identified as 2006 up and 2006 down were compared with the original 2006 data. It turns out for Bay 19 for instance that the UT penetrations identified as 2006 up were significantly lower than the measurements of 1992 with a probability of better than 95%. The difference between the 1992 and 2006 up data is 0.1 inch. Similarly for Bay 15 one finds that the 2006 up data are significantly lower than the original 1992 data by about 0.06 inches, although this difference is not significant at the 5% level. For Bay 1 there is practically no difference between the 2006 and the 1992 data sets, because of the two or three measurements in the non-corroded areas. Summarizing these results in Table 1, one finds that the lower 95% confidence limits for Bays 1, 15 are marginally within the 0.736-inch limit. Since one does not know exactly how extensive the “cancer of corrosion” in the sand bed area really is, it is very difficult to put this interpretation in perspective with the assessments made by AmerGen relative to areal criteria for thinned areas (see discussion below).

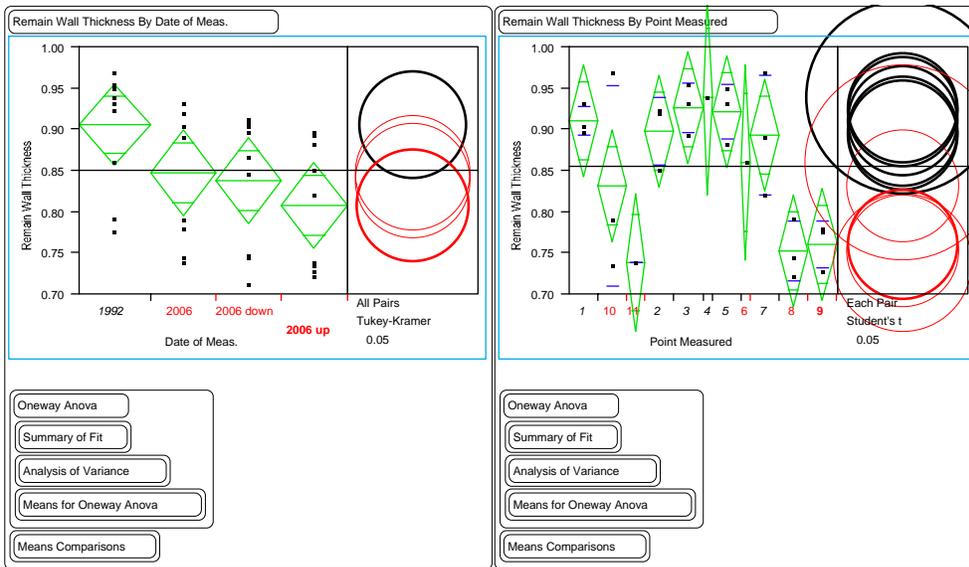
**Figure 10: External UT measurements in Bay 19**

Again one finds that the “up” measurements are significantly lower from the 1992 measurements.
