Subject: Oyster Creek Nuclear Generating Station (OCNGS)  
Docket No. 50-219  
License No. DPR-16  
Oyster Creek Drywell Containment

GPUN Detailed Summary Addressing Water Intrusion  
and Leakage Effects Related to the Oyster Creek Drywell

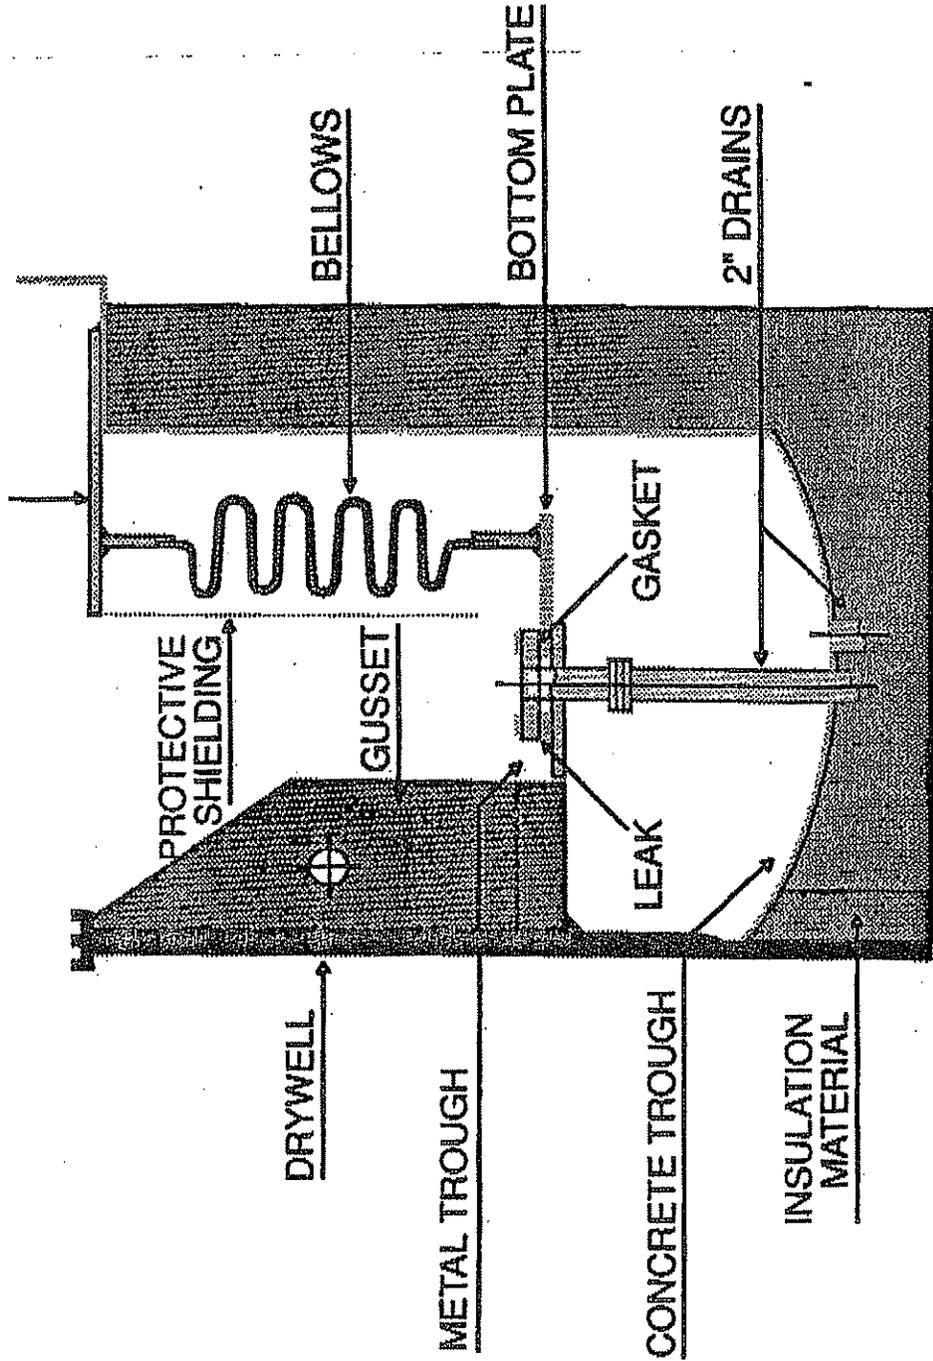
# DRYWELL TO CAVITY SEAL

The bellows allow for expansion between the drywell and the refueling cavity and are made of stainless steel. They were repeatedly tested using helium (external) and air (internal) without any indication of leakage. Any leaks from the refueling bellows would wind up in the concrete trough, which has a leakage detection/collection system. No leakage has been observed for the last two refuelings.
