In the Matter of )  
 )  
AMERGEN ENERGY COMPANY, LLC )  
 )  
(License Renewal for the Oyster Creek )  
Nuclear Generating Station) )  
 )

Docket No. 50-0219-LR

**PRE-FILED DIRECT TESTIMONY OF DR. RUDOLF H. HAUSLER**

**AFFIDAVIT OF DR. RUDOLF H. HAUSLER  
REGARDING HIS PREFILED TESTIMONY  
IN SUPPORT OF  
CITIZENS' DRYWELL CONTENTION**

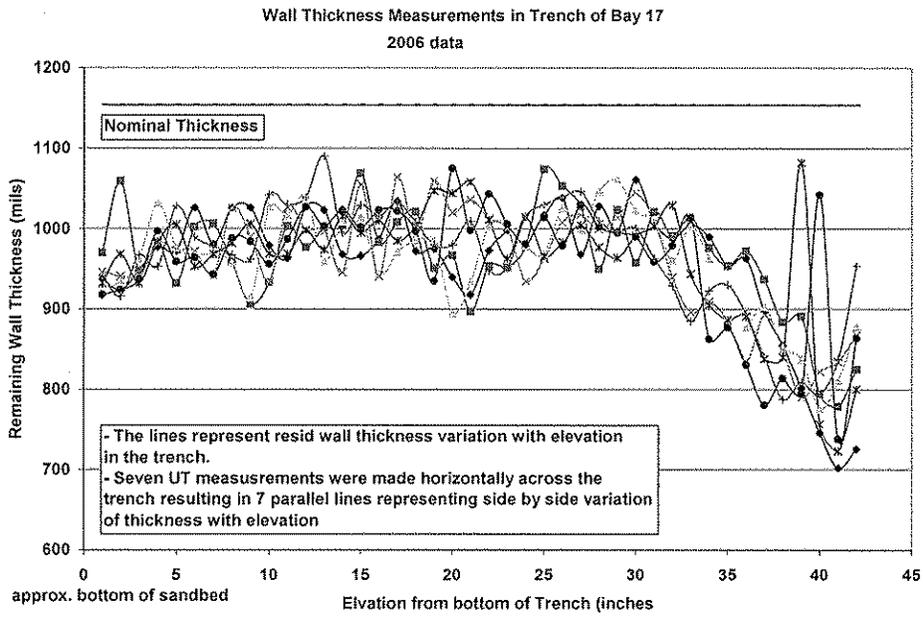
We take issue with this statement. In support of this contention, an effort was made to show graphically the remaining wall thickness observed in all of these various locations. Thus Figure 2 shows, by way of example, the remaining wall thickness from the 2006 UT measurements made with the help of 6 by 6 inch grids as a function of elevation in the **trench of Bay 17**. It is understood, as is described in Ref. 3 that 6 such grids were placed one on top of the other in the trench in order to capture the corrosion from the bottom to the top of the sandbed. Hence, if the bottom of the trench had the elevation about 9 feet, then the top of the 6 grids would have had an elevation of about 12 feet, which according to Figure 1 corresponds to the top of the sandbed and is at least 9 inches higher than the top of the grid used for UT measurements from the inside. (Note, none of these elevations is terribly accurate, however, the top of the trench measurements were definitely lower (deeper pits) by a good margin than the inside grid measurements). Figure 2 plots all individual 2006 measurements from the trench in bay 17. The 6 traces represent the variation of the wall thickness in the horizontal direction while the traces themselves extend from the bottom of the trench (left hand side) to the top of the trench (right hand side). The

undulations of the 6 traces, which are at times (at the same elevation) in synch and at other times out of phase clearly depict the nature of the “golf ball type” surface described in AmerGen literature (Ref. 1 pg. 4). Where the undulations are in synch one can estimate that the extent of the pit at that location extends over an area larger than just one inch in diameter <sup>3)</sup>. It should also be noted that the average amplitude of the undulations in Fig. 2 are of the order of 0.1 inch, i.e. the roughness of the surface at this point is only of that order of magnitude. AmerGen estimated the “roughness” of the surface to be rather of the order of 0.2 inches (Ref. 5 pg. 5).

The most striking observation is that the corrosion is most severe at the top, almost uniform in severity over most of the depth of the sandbed and again somewhat more severe at the very bottom.

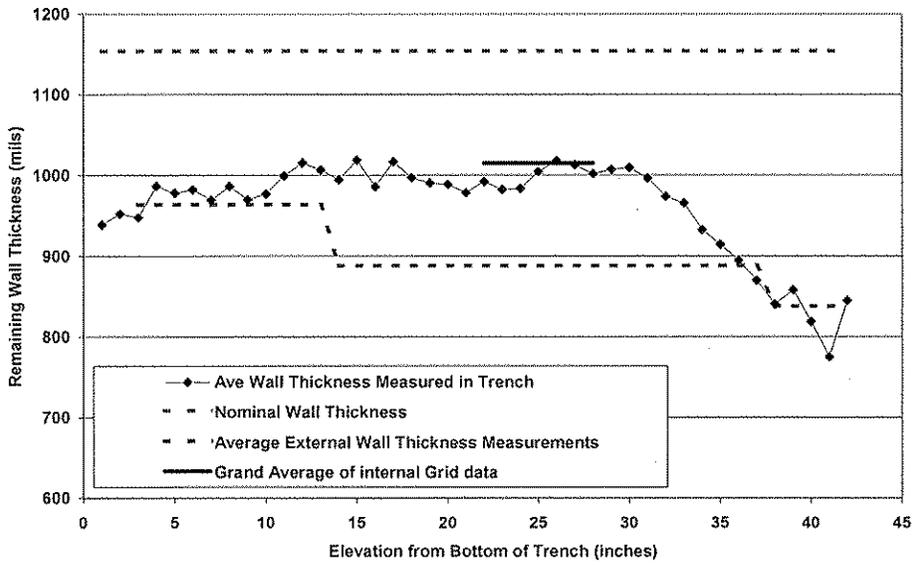
Figure 3

**Conclusion:** What the superposition of the UT measurements in Bay 17 demonstrates is that wall loss ranges from zero to 33 percent, however, only the trench and outside measurements come close to represent the most severe corrosion at the highest elevations. It should also be remembered that the grid measurements at the inside curb cutout as well as those in the trench are only 6 inches wide. One does not have, therefore any indications as to how far serious corrosion may have spread laterally around the circumference of the bay.

Comparison of Various Thickness Measurements in Bay 17  
2006 data

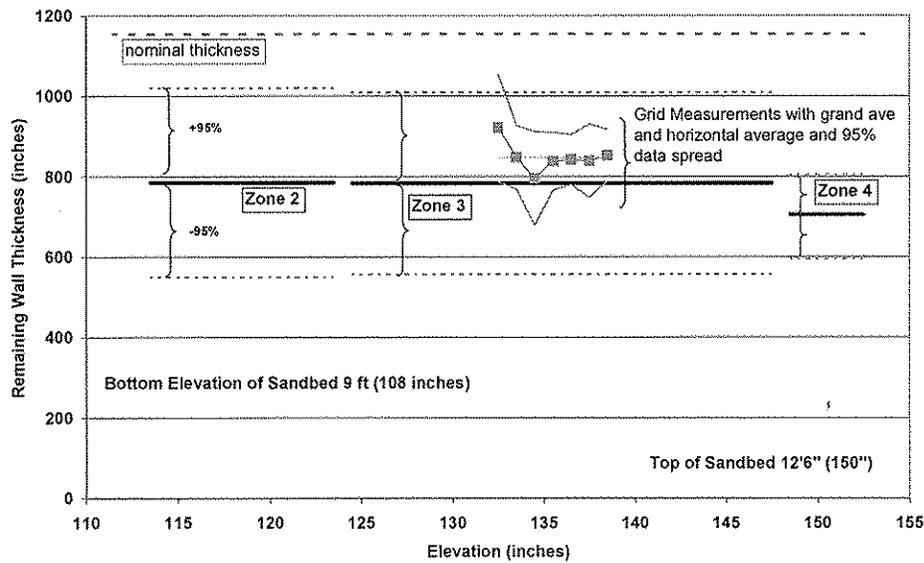
Figure 5 shows an analysis of the available 2006 data for Bay 13. Bay 13 is probably the second worst corroded bay apart from Bay 1. The averages for the external measurements for each zone are fairly similar, as are the 95% limits for the data spread. There is a 95% percent probability for the deepest penetration to be of the order of 48% of the original wall thickness. The superposition of the internal grid data shows a higher average and a narrower distribution of the data spread. Again one recognizes that the internal 6 by 6 inch grid measurements do not represent the worst corrosion degradation.

External 2006 UT Measurements in Bay 13  
averages and 95% limits of data spread

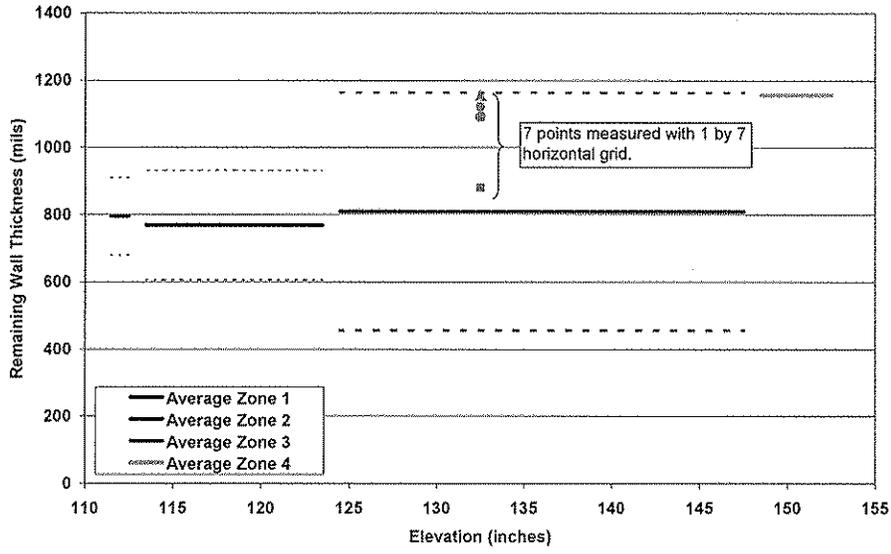
Figure 6

External UT Measurements 2006 in Bay 1  
Averages and 95% limits of data spread

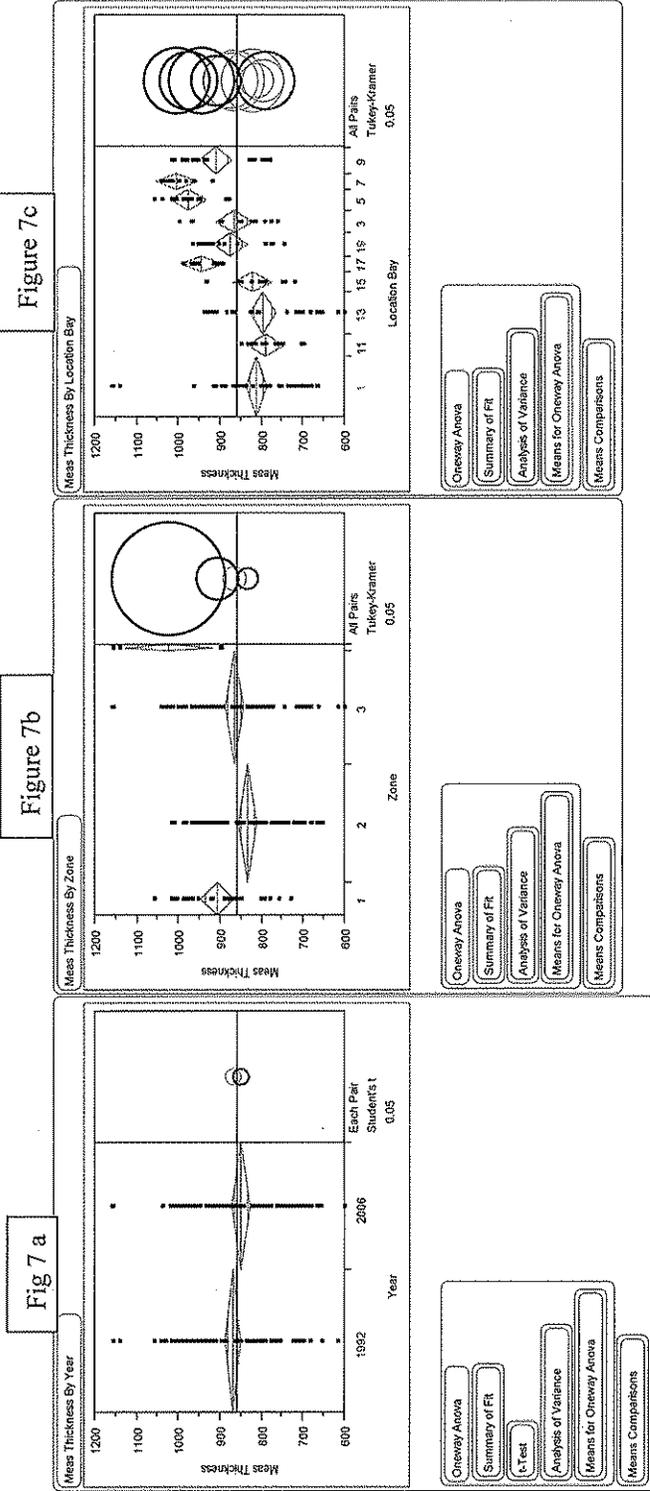
Figure 7

It was found that there is no significant effect of the time (Fig.7a). While there is a decrease of 19 mils between 1992 and 2006, this difference is not statistically significant within the variability of the data. The differences between the zones, however are significant. Zone 2 is by far the most corrosive zone. When the bays are compared, one finds as expected that some bays have experienced little corrosion in contrast to others. The importance of these observations is obvious: they point again to the fact that the intensity of corrosion is a clear function of elevation and bay. Hence, averaging data and generalization may lead to doubtful conclusions.

Statistical Analysis of all External UT Measurements

Comments: Figure 7a: Comparison between measurements I 1992 and 2006 show no significant difference. The means from 1992 and 2006 show a bias of 0.018 inches, but the bias is statistically not significant despite of the many data points. Fig. 7b: The comparison between the "zones" (elevations) is significant. Zones 1 is significantly different from zones 2 and 3. For zone 4 there are not enough data for statistical significance. Fig. 7c: Some bays, red ones, are significantly different from the black ones.

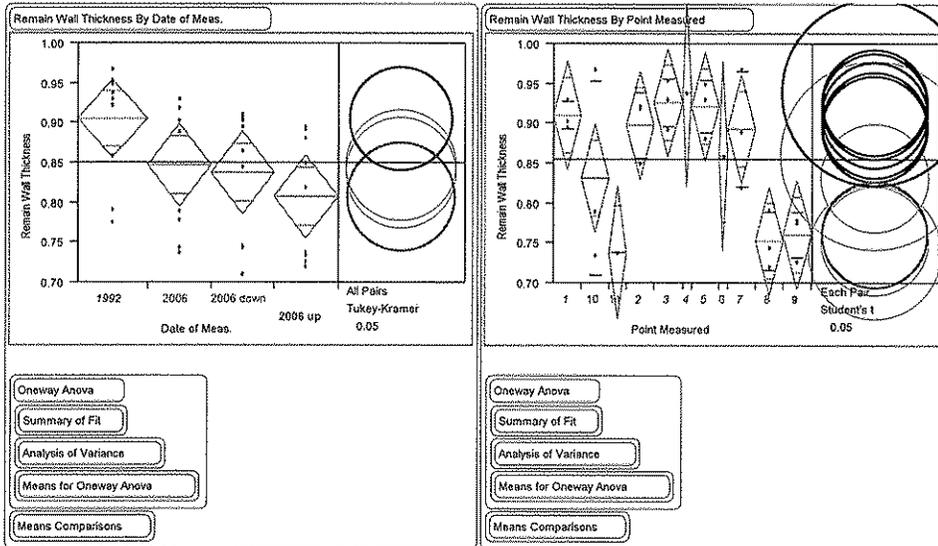
**Figure 10: External UT measurements in Bay 19**

Again one finds that the “up” measurements are significantly lower from the 1992 measurements.
