CORRO-CONSULTA

MEMORANDUM

July 25, 2006

Subject: Oyster Creek, Drywell Liner
Integrity Assurance and Monitoring Frequencies

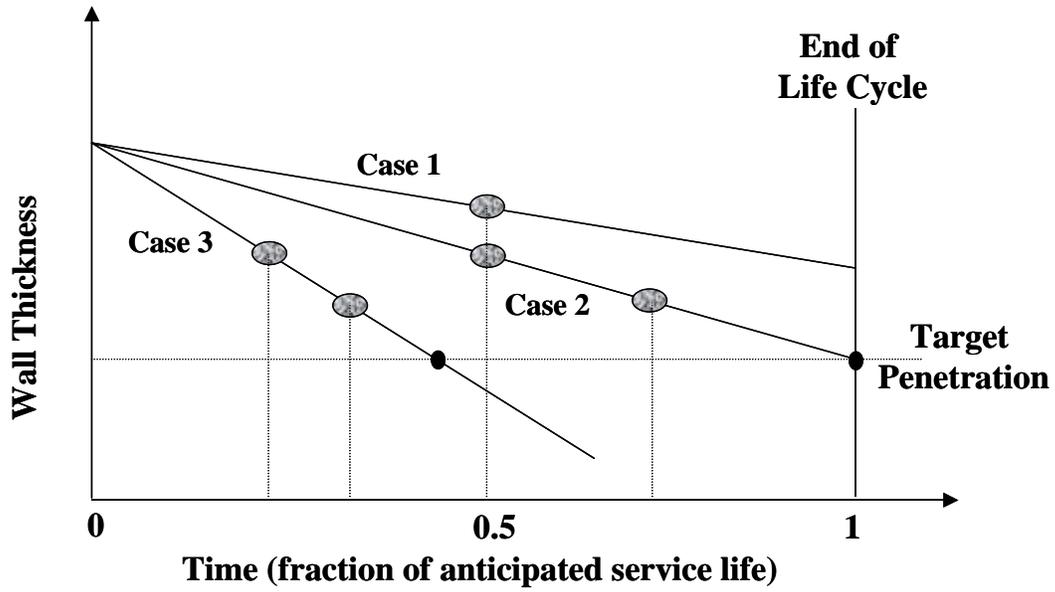
Figure 1

In Case 1 the prevailing corrosion rate (loss of wall thickness with time) appears to be low enough such that at the end of the projected service life the remaining wall

In Case II, the known corrosion rate predicts the minimum target wall thickness to be reached at the end of the service life. In this case verification would occur at the half-life of the structure, and again half way between it and the end of the service life. Simultaneously, changes of the environment, or changes in corrosion rate would be monitored continuously. In this case the latter is all the more important.

In Case III, the corrosion rate is such that the structure would have to be abandoned prior to the expected full service life. Nevertheless, the structure would be routinely examined in order to obtain as long a service life as possible. This situation prevailed at Oyster Creek in 1992, prior to preventive measures having been applied (Ref. 2)

Schematic Monitoring Frequencies depending on corrosion Rate and Limiting Target Wall Thickness

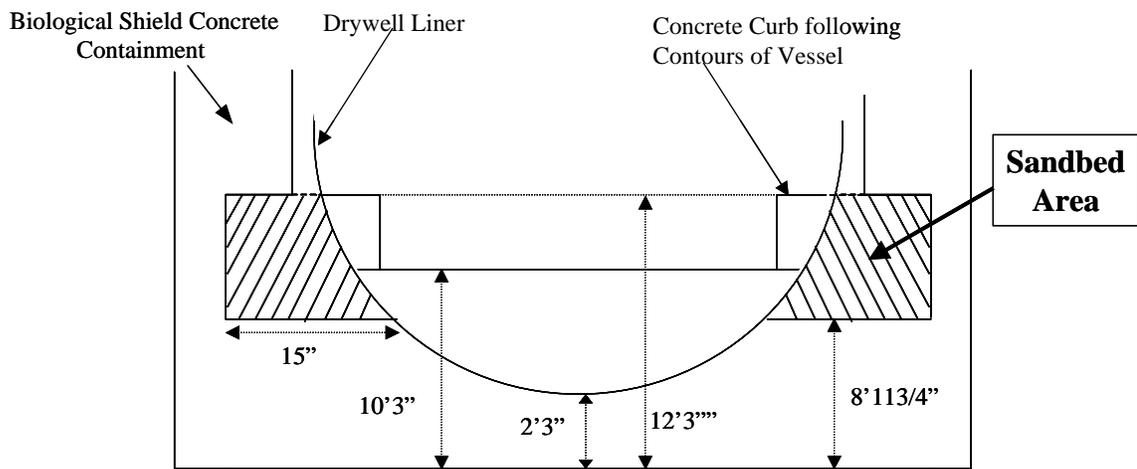
Figure 3

**Schematic Drawing of Lower Spherical Section of Drywell Liner
(not to size)**

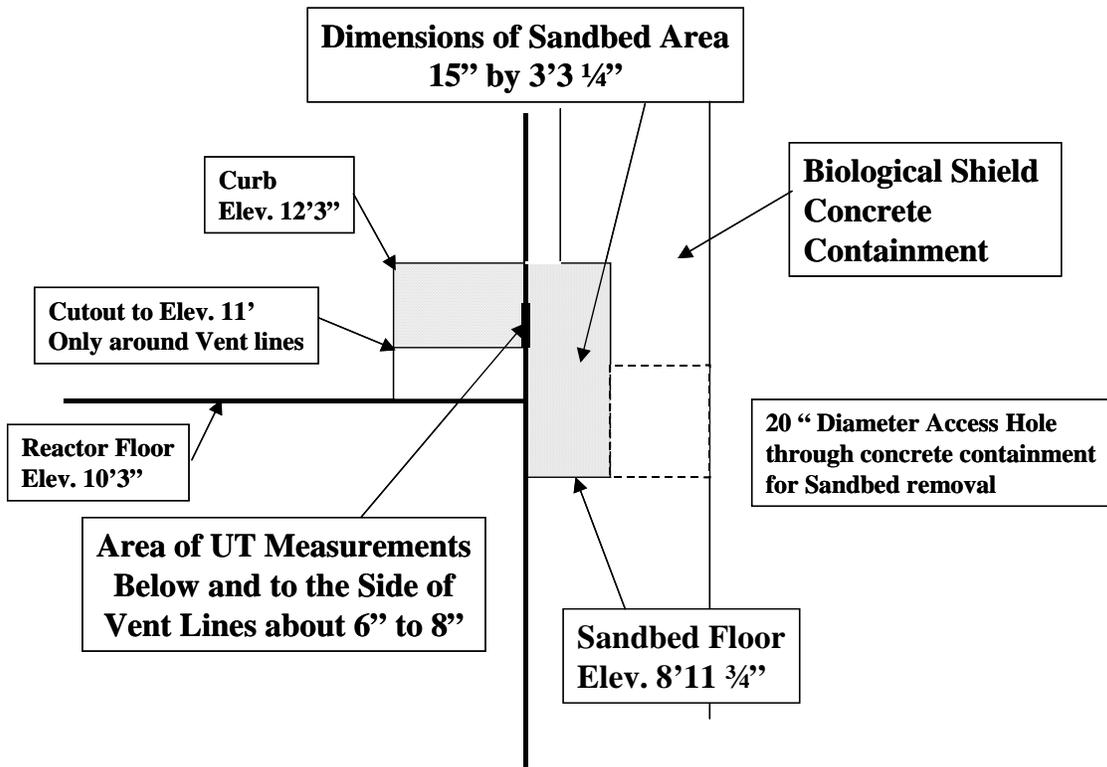
Figure 4

Schematic Cross Section through Sandbed Area
(not to size)
