Corro-Consulta

MEMORANDUM

July 26, 2006

Subject: Oyster Creek, Drywell Liner
Embedded Region Issues

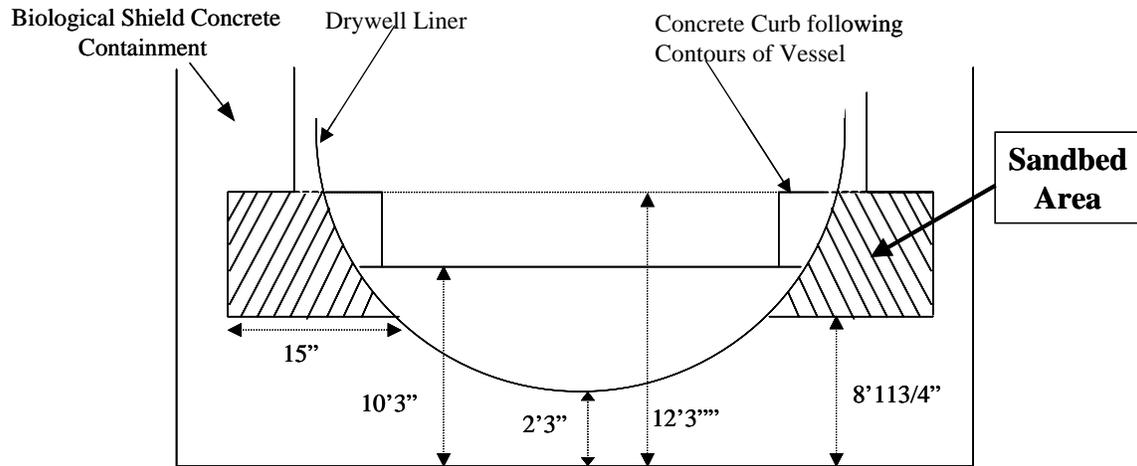
Figure 3

Figures 1 and 2 are sketches of the location of the sandbed area and its dimensions (Fig. 2). In view of the small access hole (20" diameter) and the even smaller sandbed dimensions (15" wide) and the resulting very confined work area one needs to wonder just how effective the repairs of the concrete floor and subsequent coating and sealing of the crevice might have been. Similarly, considering the extension of the sandbed area of 5 to 7 feet either side of the access hole, and its narrowness, one needs to ask just how thorough visual inspection can really be.

Schematic Drawing of Lower Spherical Section of Drywell Liner
(not to size)

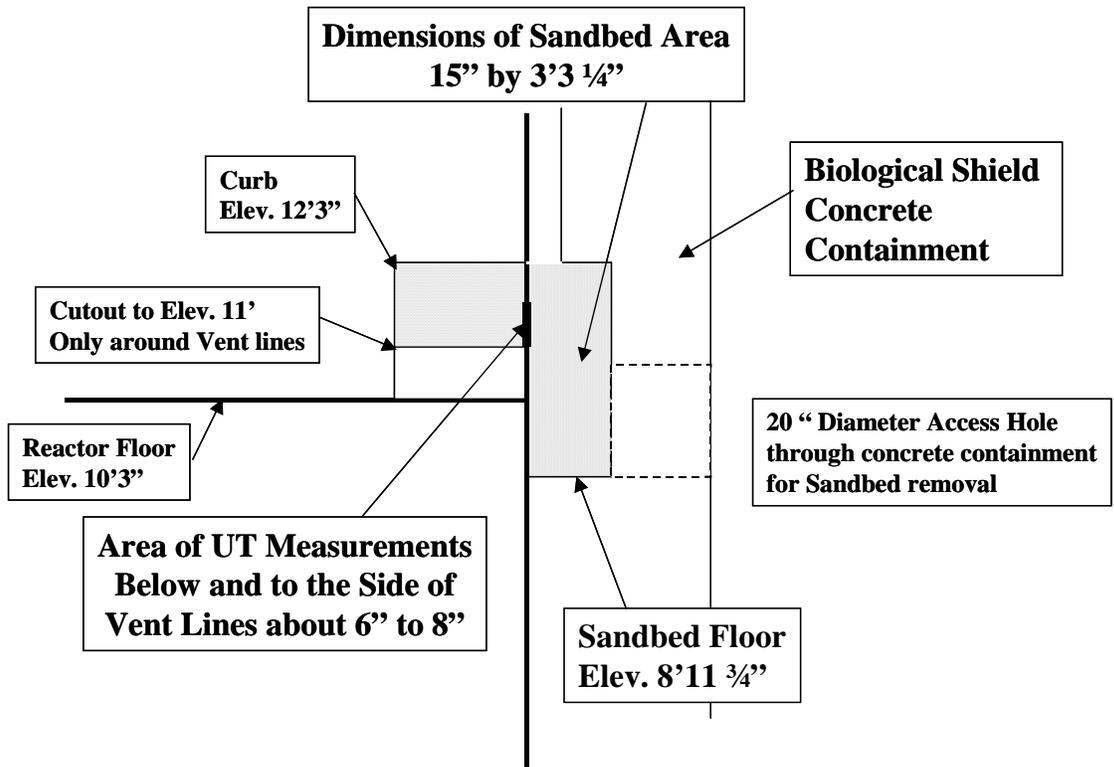
Figure 4

Schematic Cross Section through Sandbed Area
