**CORRO-CONSULTA**

**MEMORANDUM – REDACTED VERSION – JULY 19, 2007**

**Subject:** Update of Current Knowledge Regarding the State of Integrity of OCNCS Drywell Liner and Comments Pertaining to Aging Management Thereof

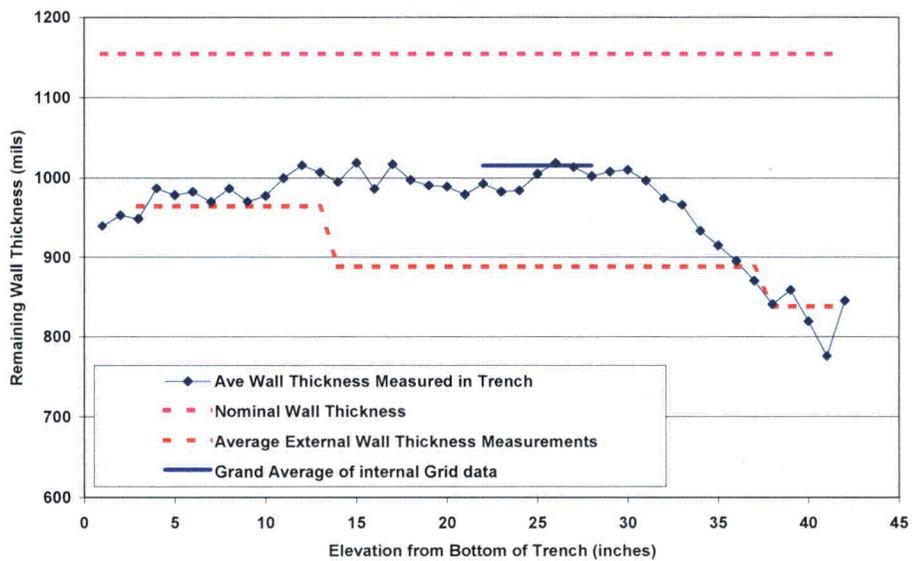
Figure 3

**Conclusion:** What the superposition of the UT measurements in Bay 17 demonstrates is that wall loss ranges from zero to 33 percent, however, only the trench and outside measurements come close to represent the most severe corrosion at the highest elevations. It should also be remembered that the grid measurements at the inside curb cutout as well as those in the trench are only 6 inches wide. One does not have, therefore any indications as to how far serious corrosion may have spread laterally around the circumference of the bay.

Comparison of Various Thickness Measurements in Bay 17  
2006 data

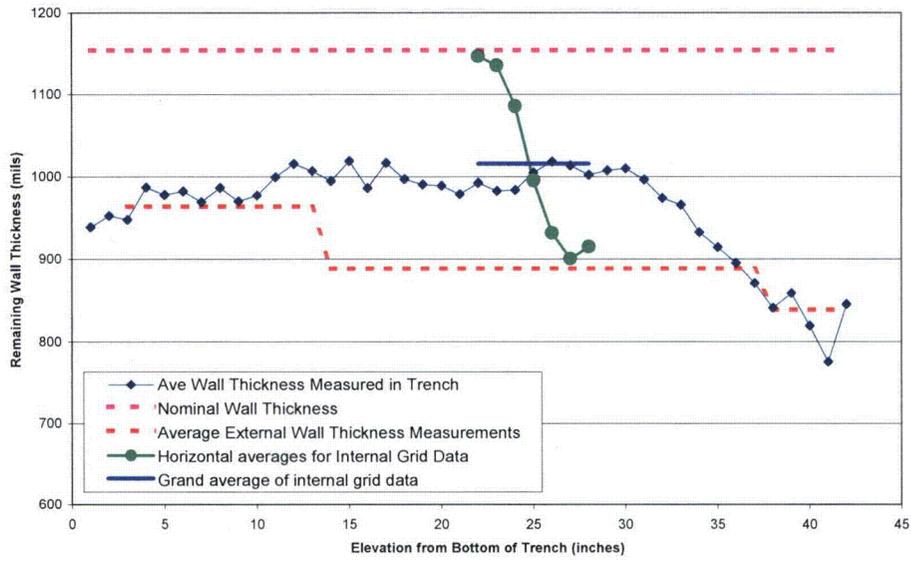
Figure 4

Comparison of Various Thickness Measurements in Bay 17  
2006 data

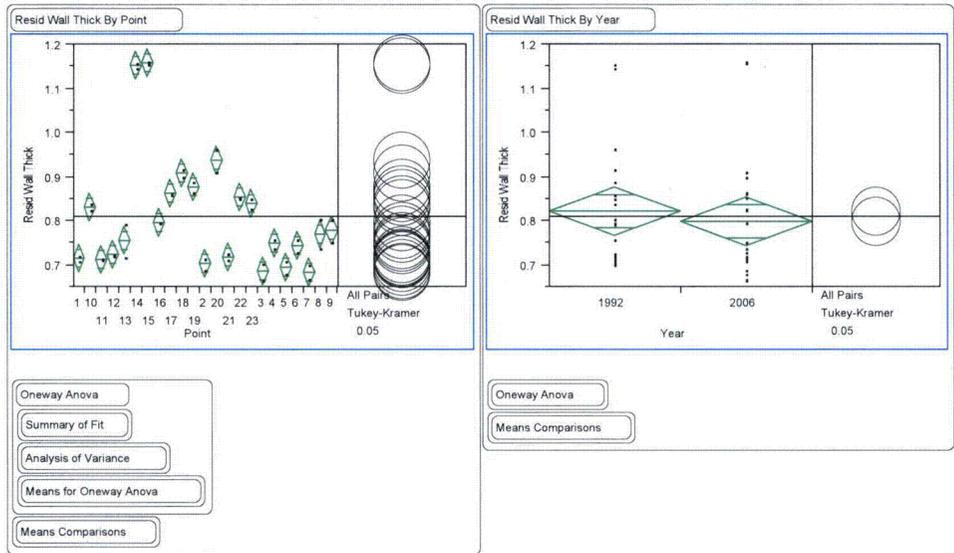
Figure 9: External UT Measurements in Bay 1.

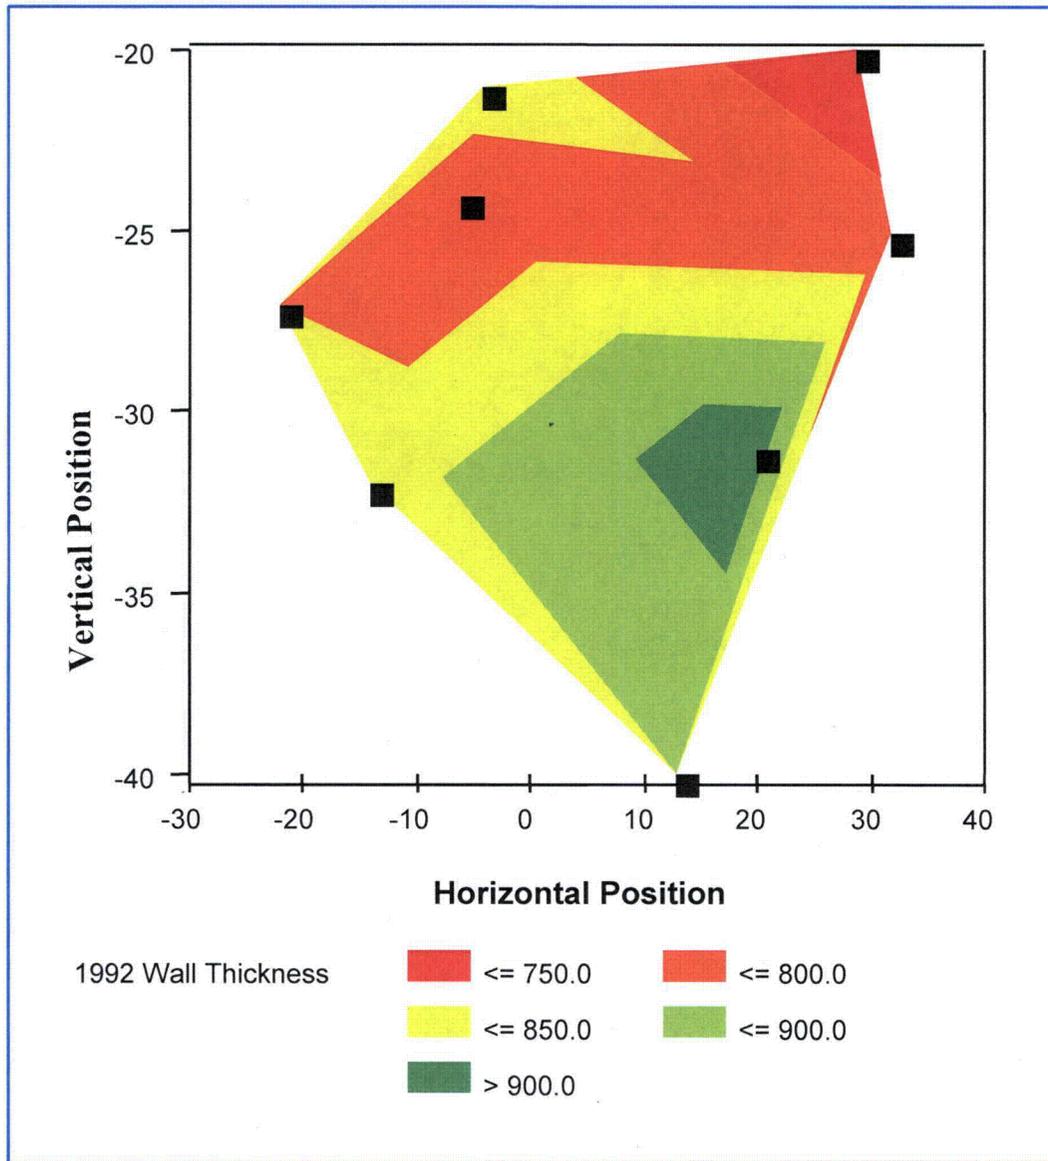
Figure 7

**Figure 7** shows the contours for Bay 11. Again there is a suggestion of severe corrosion at elevation -20 and no further exploration into the bathtub ring area. Once again, the extent of this area is highly uncertain because it was not further defined by additional UT measurements.

Contour Plot for External UT 1992 Data Bay 11
