# **Oyster Creek License Renewal Presentation to ACRS**

February 1, 2007

# Summary of Drywell Corrosion

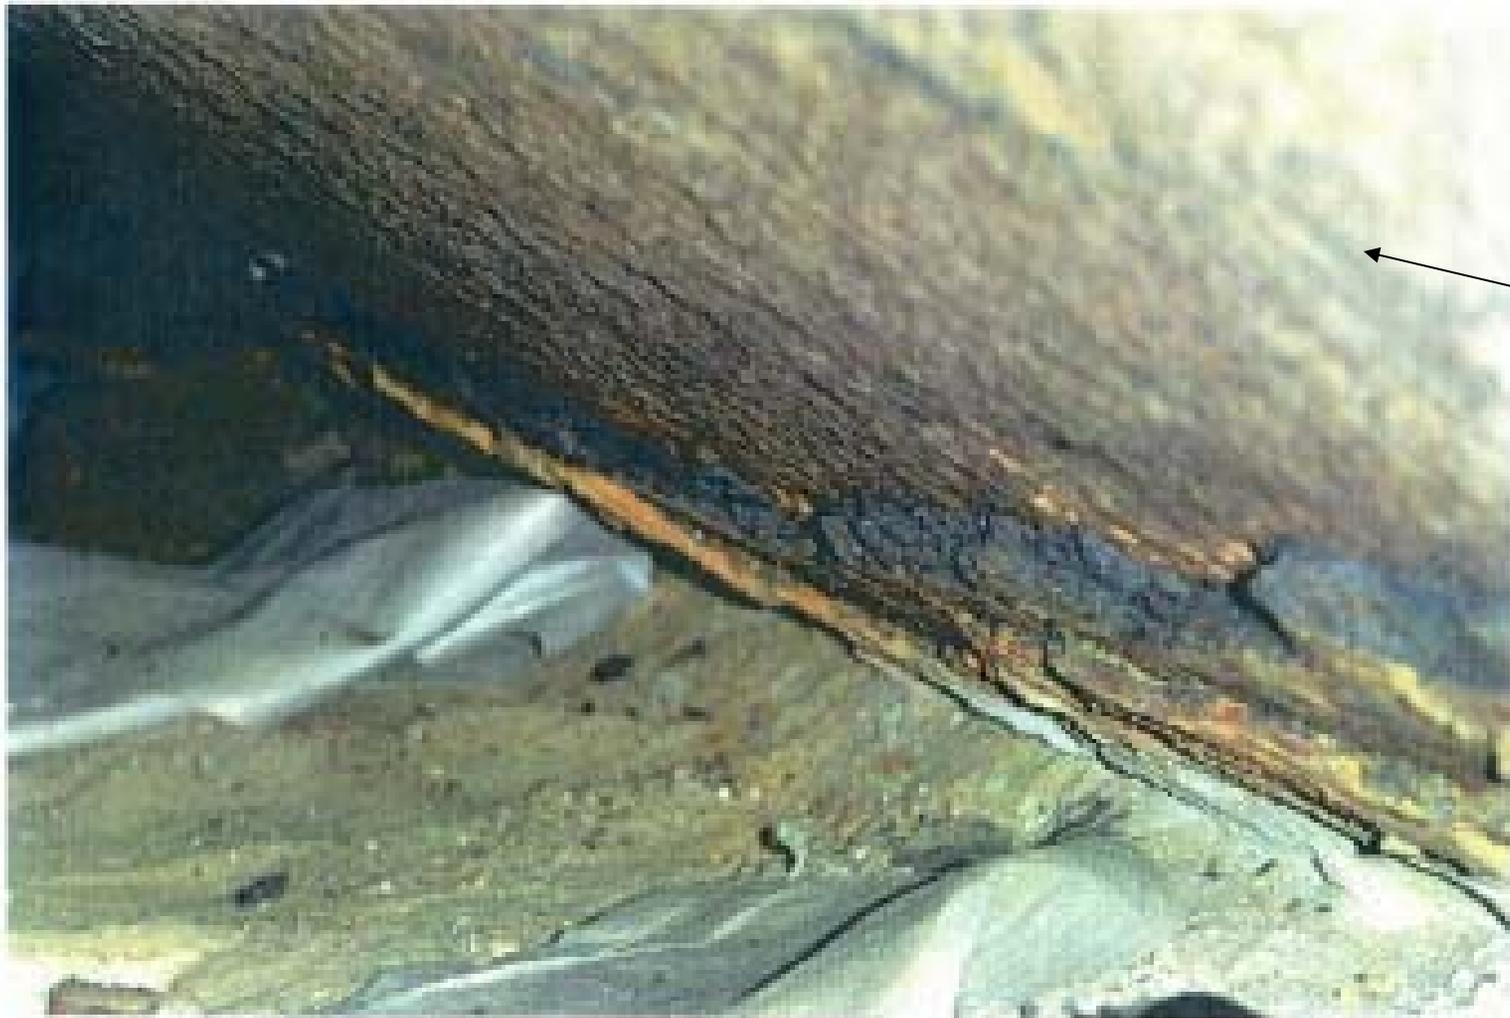
# Sand Bed Region 1992

Corrosion product on drywell vessel

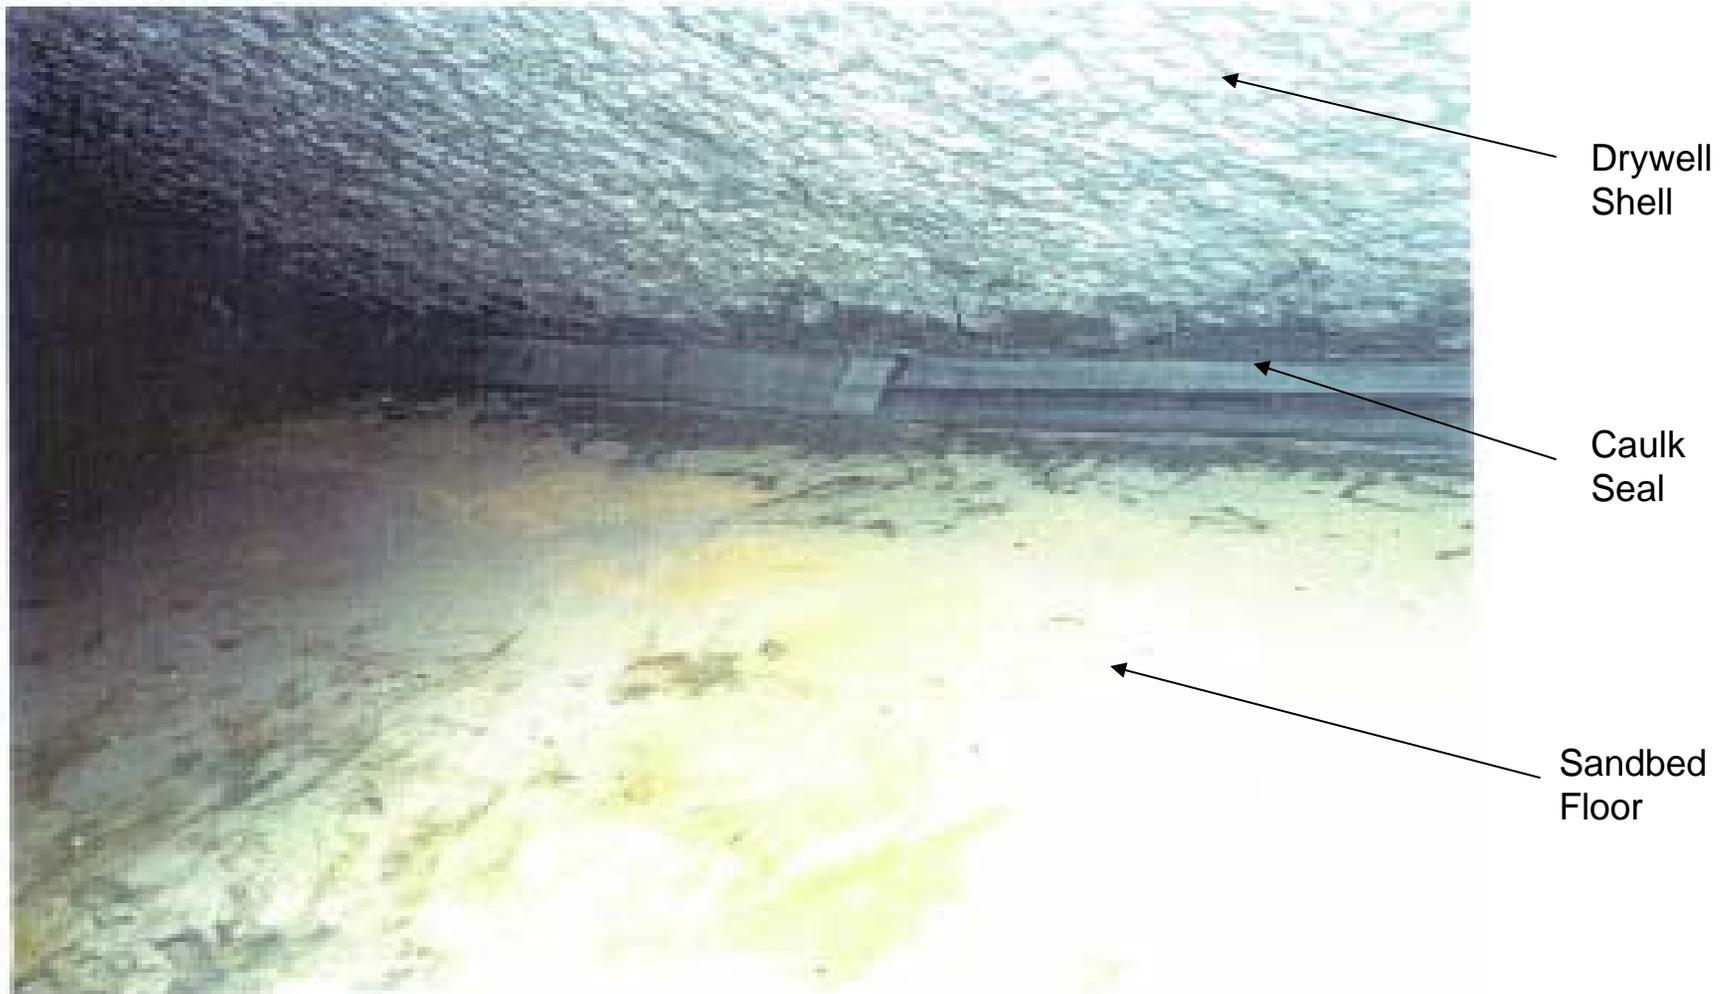
# Sand Bed Region 1992

Finished floor, vessel with two top coats – caulking material applied

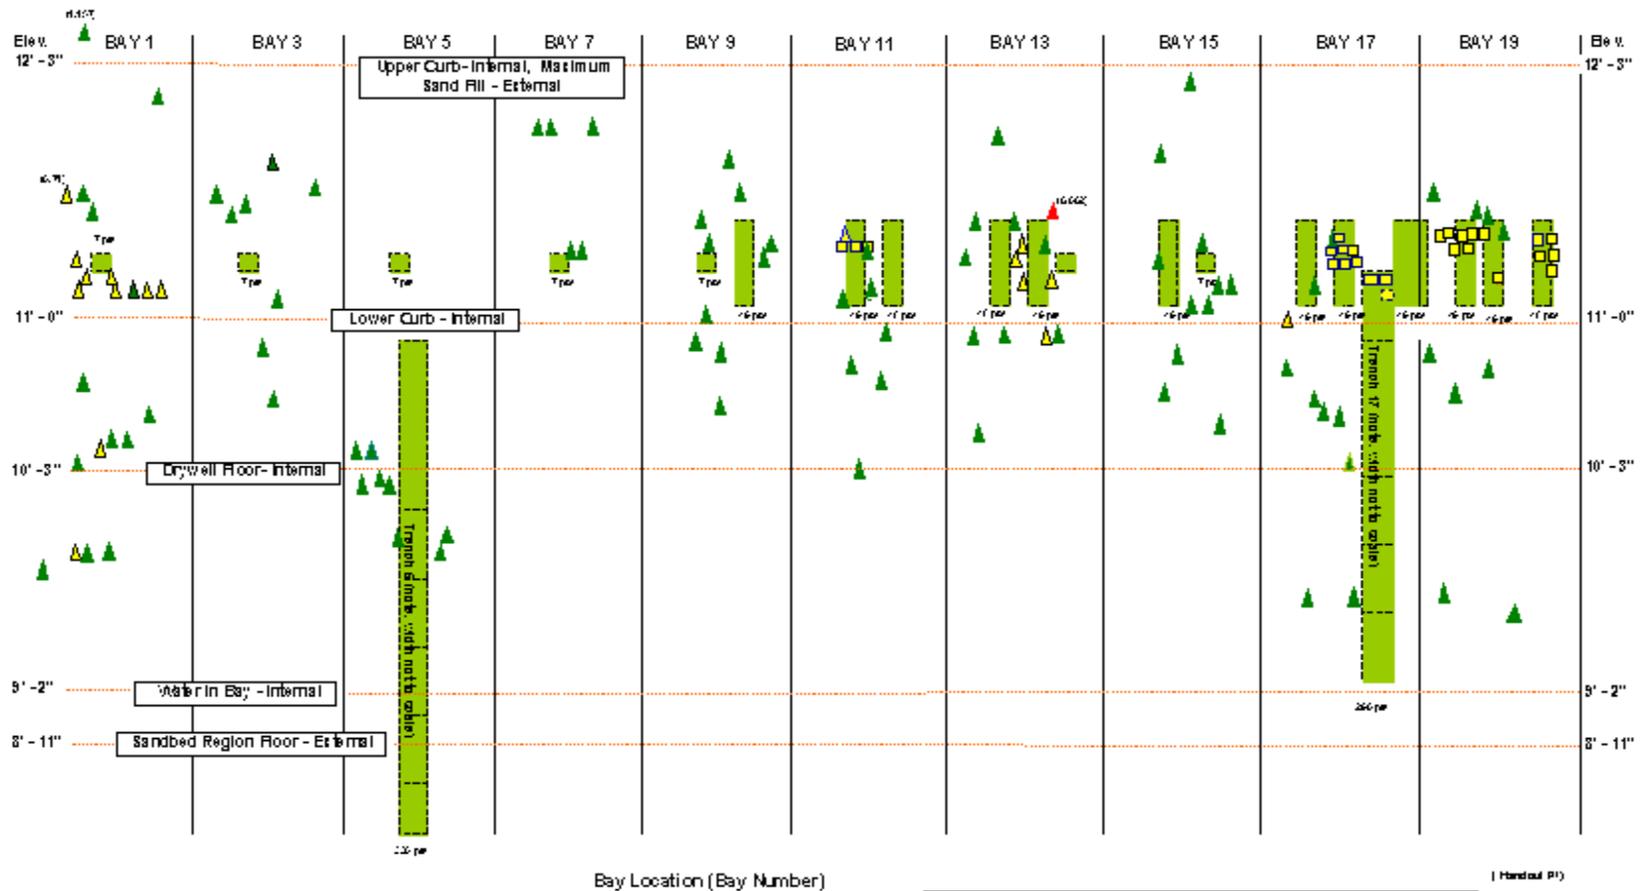
### 2006 Measurement Locations in the Sandbed Region

- Green = UT Measurements > 736 Mils
- Yellow = UT Measurements Between 636 and 736 Mils
- Red = UT Measurements Between 536 and 636 Mils

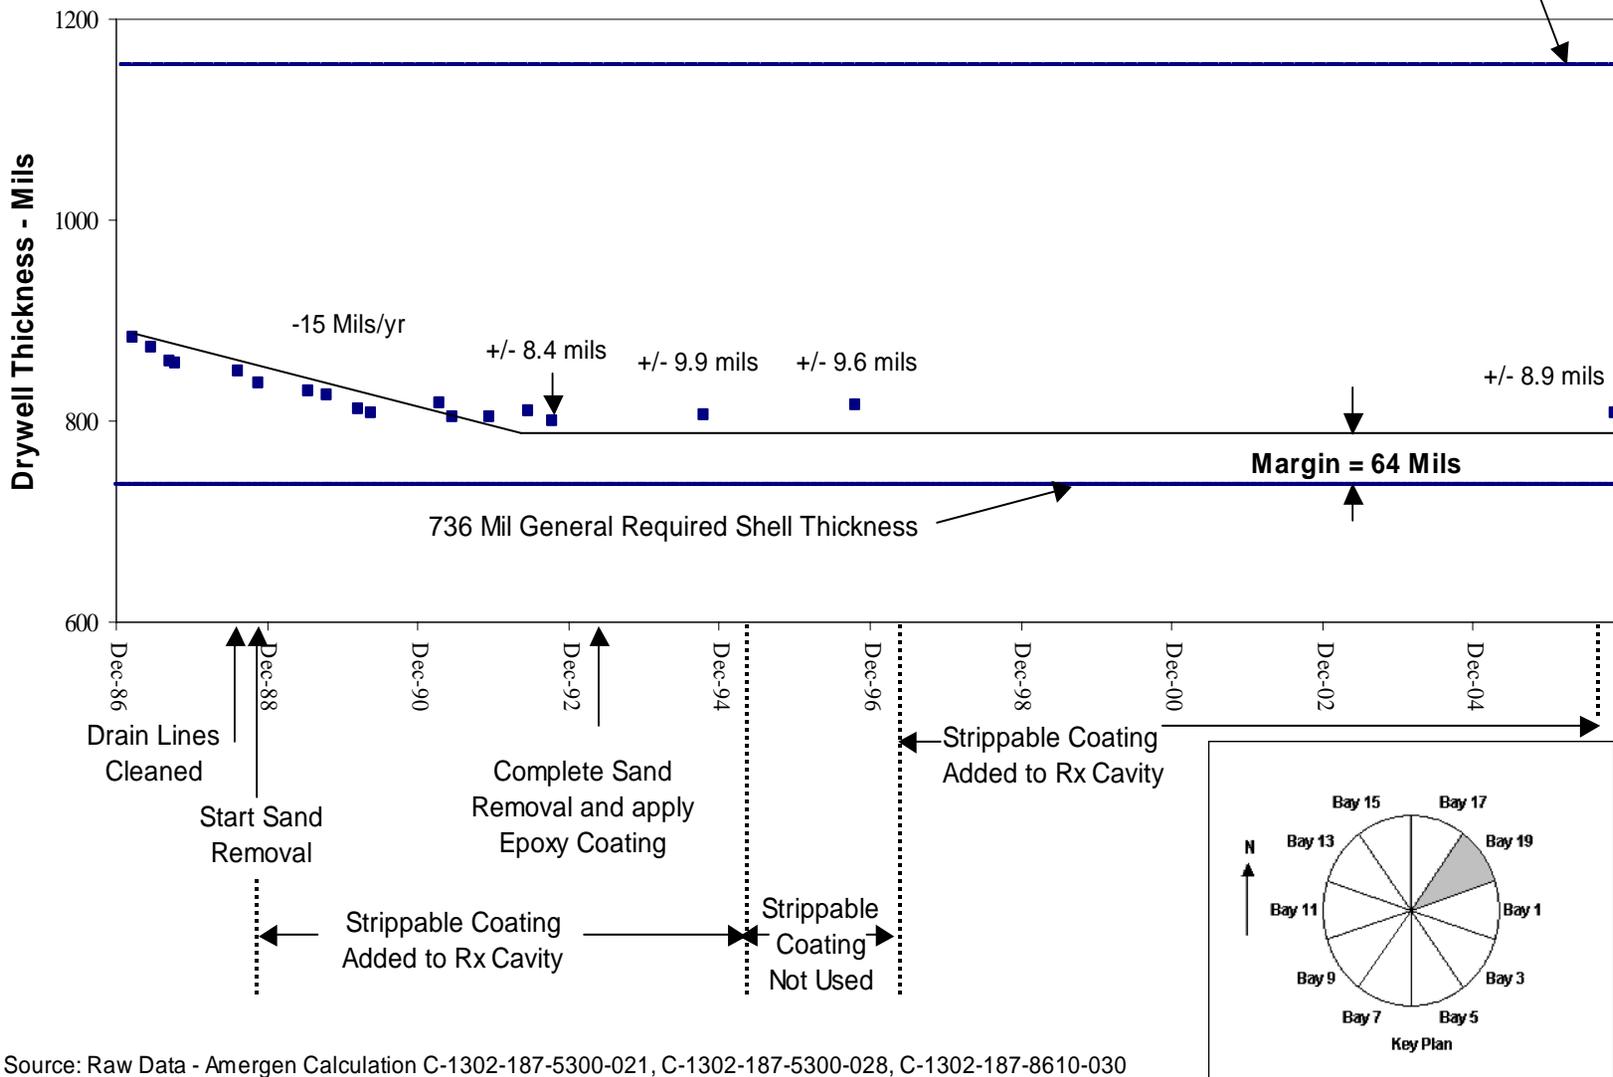
**Figure 21 Sandbed Bay # 19A**

1154 Mil Nominal Shell Plate Thickness

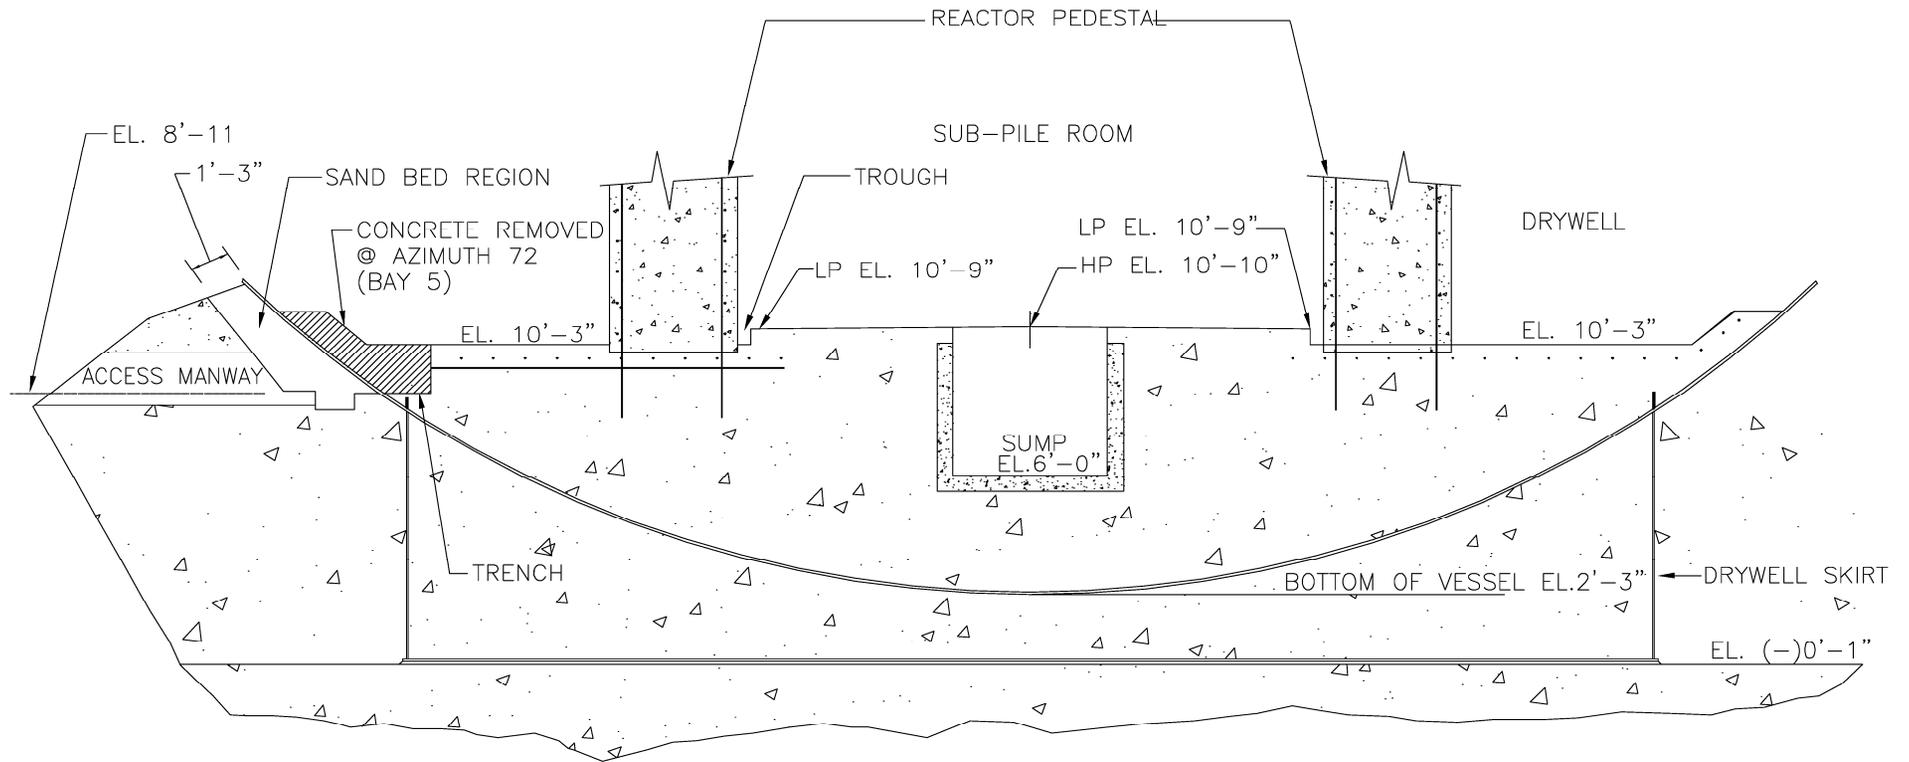
## LOWER DRYWELL- SANDBED, TRENCH & SUMP

The trenches in the drywell floor should not be restored to the design configuration until sufficient monitoring is completed to verify corrective actions to eliminate water on the interior drywell shell have been effective.

The water source has been identified and corrective actions have been implemented. Corrosion of steel embedded in concrete is mitigated by the high pH of the water and by the passive, protective film on the steel surface.

- Inspect during refueling outages for water.
- Visual/UT exams of shell within trenches.
- After confirming in 2 consecutive refueling outages there is no water in the trenches, restore the trenches to their original design condition.
