Enclosure - Table of Contents

This package of historical information and 2006 outage information is being provided to the ACRS Subcommittee reviewing the License Renewal Application for Oyster Creek. The purpose of the information is to respond to questions that were raised at the ACRS Subcommittee meeting on October 3, 2006 concerning the corrosion of the drywell shell and to update the Subcommittee on the results of recent inspection activities. This package is meant to help the ACRS members understand the information that the NRC staff has already reviewed over the course of weeks of audits and inspections. As such, the information set forth in this package consists of documents and responses to questions that were available to the NRC staff during the NRR AMR and AMP audits in January and February 2006, during the NRC Region 1 inspection in March 2006, in response to NRC RAls during the review of the Oyster Creek License Renewal Application, in docketed correspondence between GPUN or AmerGen and the NRC, and in documents reviewed by NRC Region 1 during the 2006 refueling outage. The information provided also includes some historical information that serves as the basis or supp

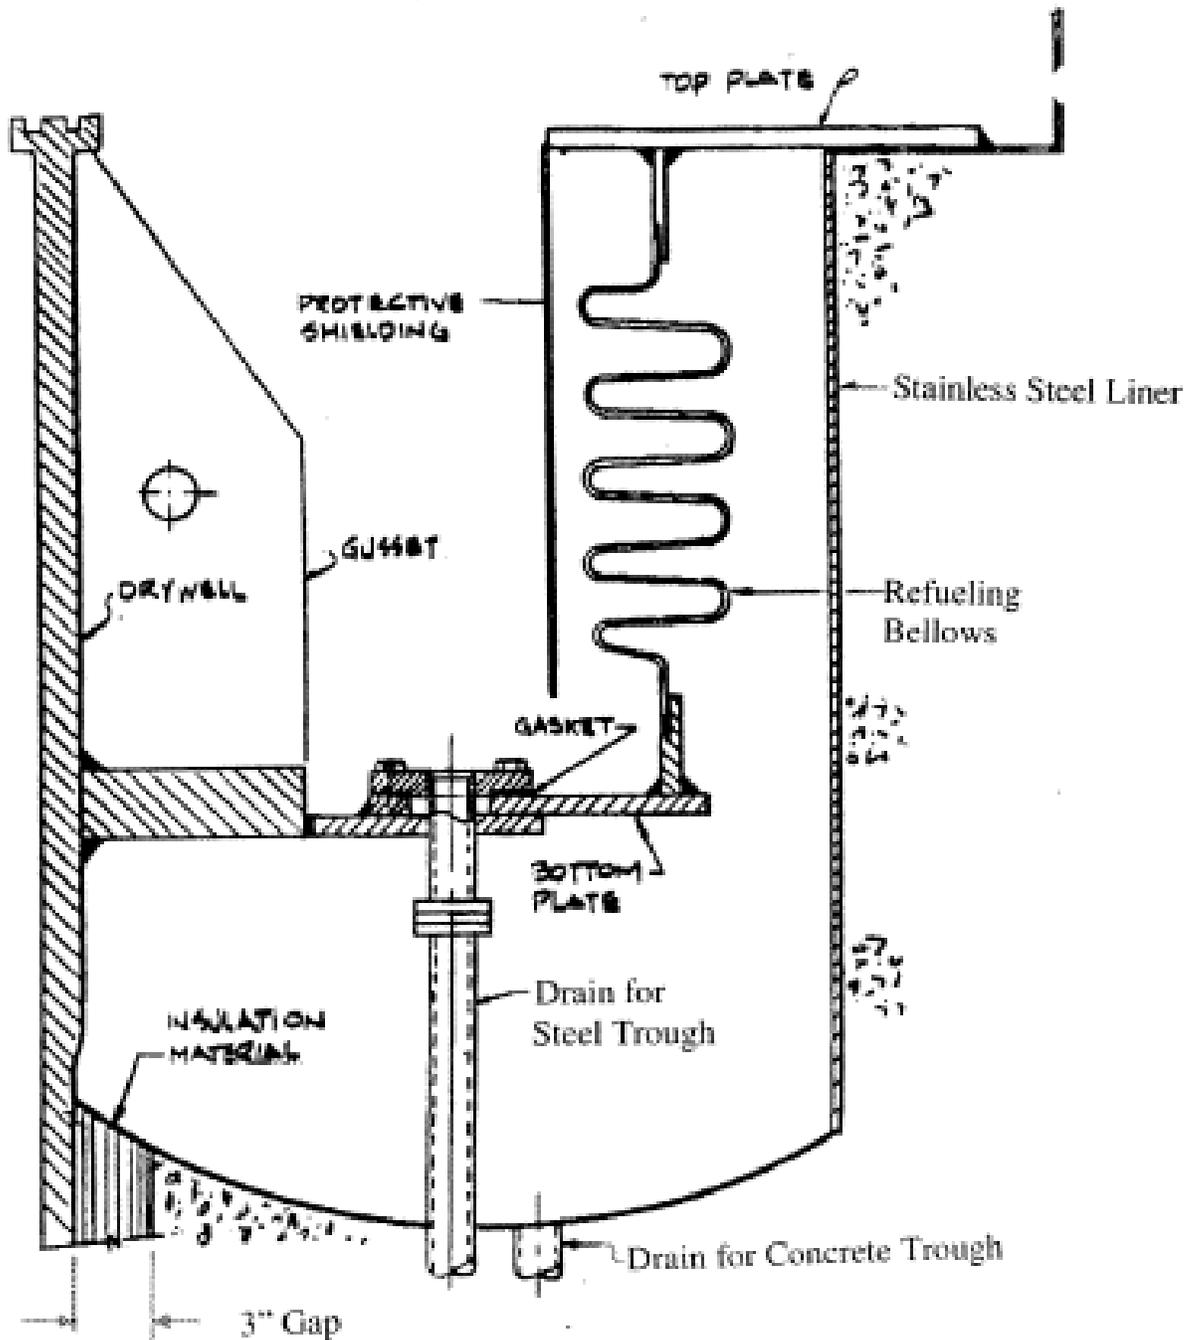
FIGURE 6 – REACTOR CAVITY TROUGH DRAIN

At the top of the Reactor Building concrete shield wall, a concrete trough is located below the reactor cavity seal to collect any water that might leak from the reactor cavity during refueling outages. This trough is equipped with a drain line designed to direct any leakage to the Reactor Building equipment drain tank and prevent it from entering the gap between the drywell shell and the Reactor Building concrete shield wall ([See Figure 6](#)).

- The leakage path was from the reactor cavity, to the concrete trough (later found to have been degraded – see Section C below) and through the drywell expansion gap down to the sandbed region within the reactor building (See [Figure 6 of Section 3](#) of this Enclosure).

- Replaced reactor cavity metal trough drain gasket, which was found to be leaking (See [Figure 6 of Section 3](#) of this Enclosure).
 - Removed water from the sand bed region.

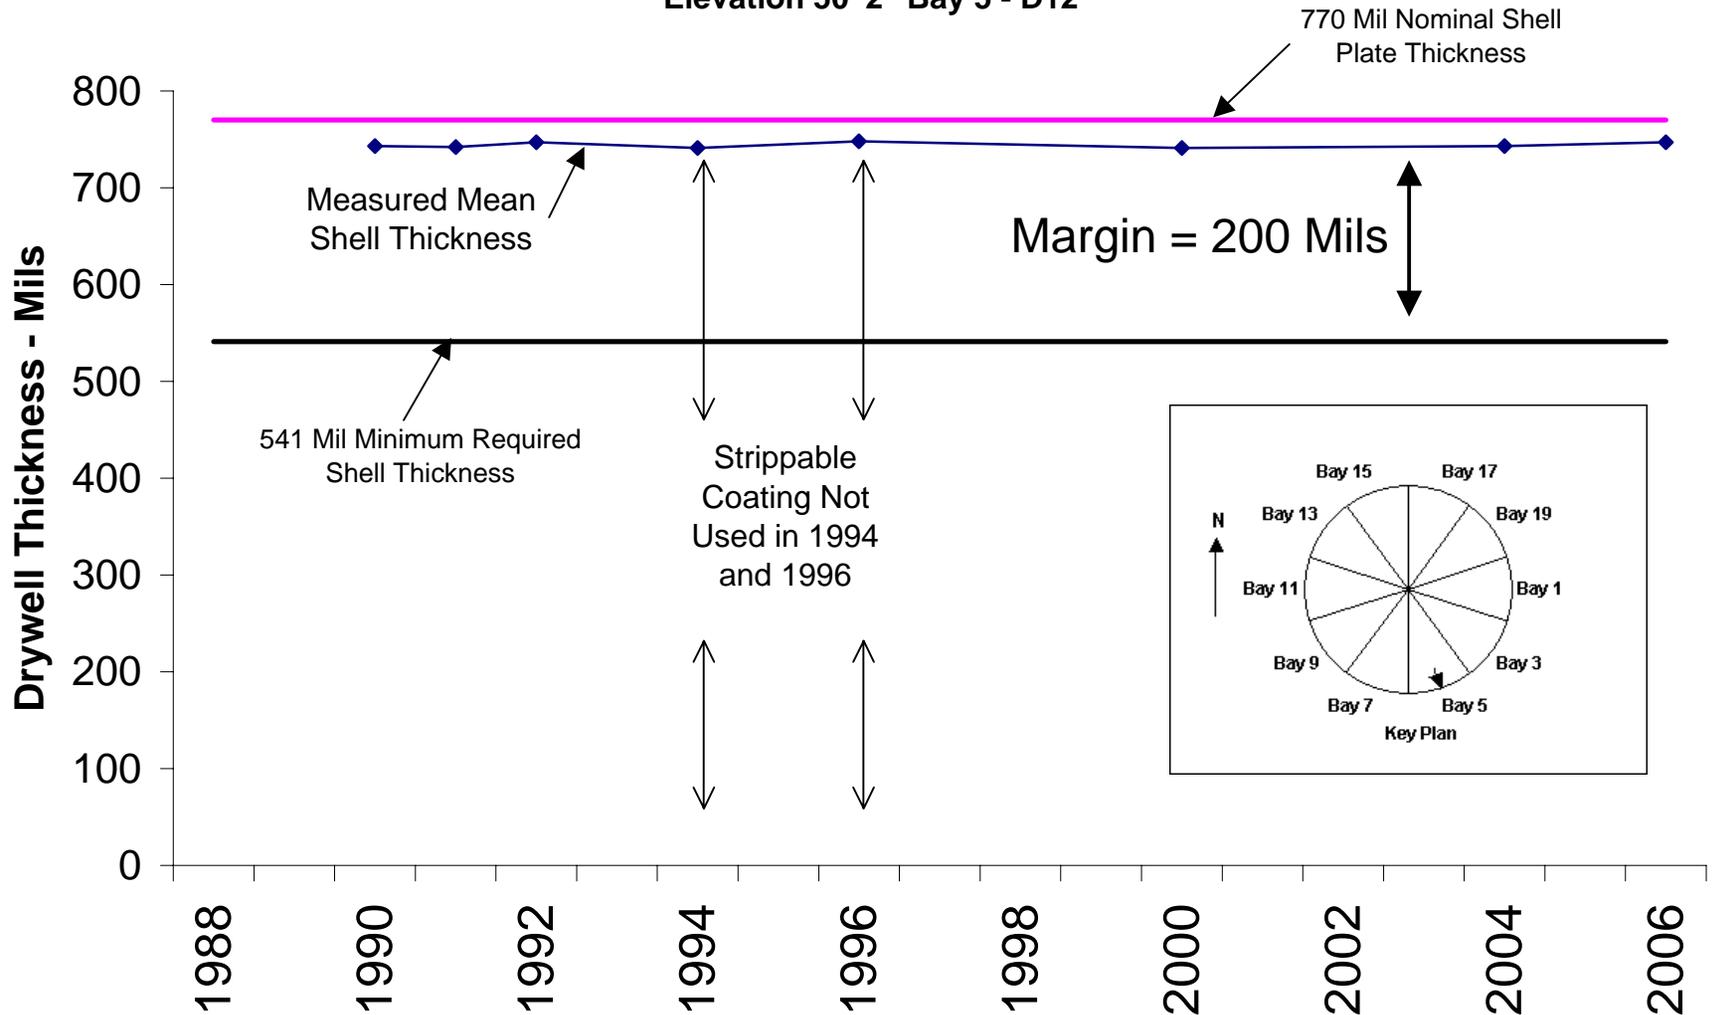
1. Upper Drywell Corrosion Trend and Margin

Elevation 50' 2" Bay 5 - D12

Instrument Uncertainty \pm 10 Mils

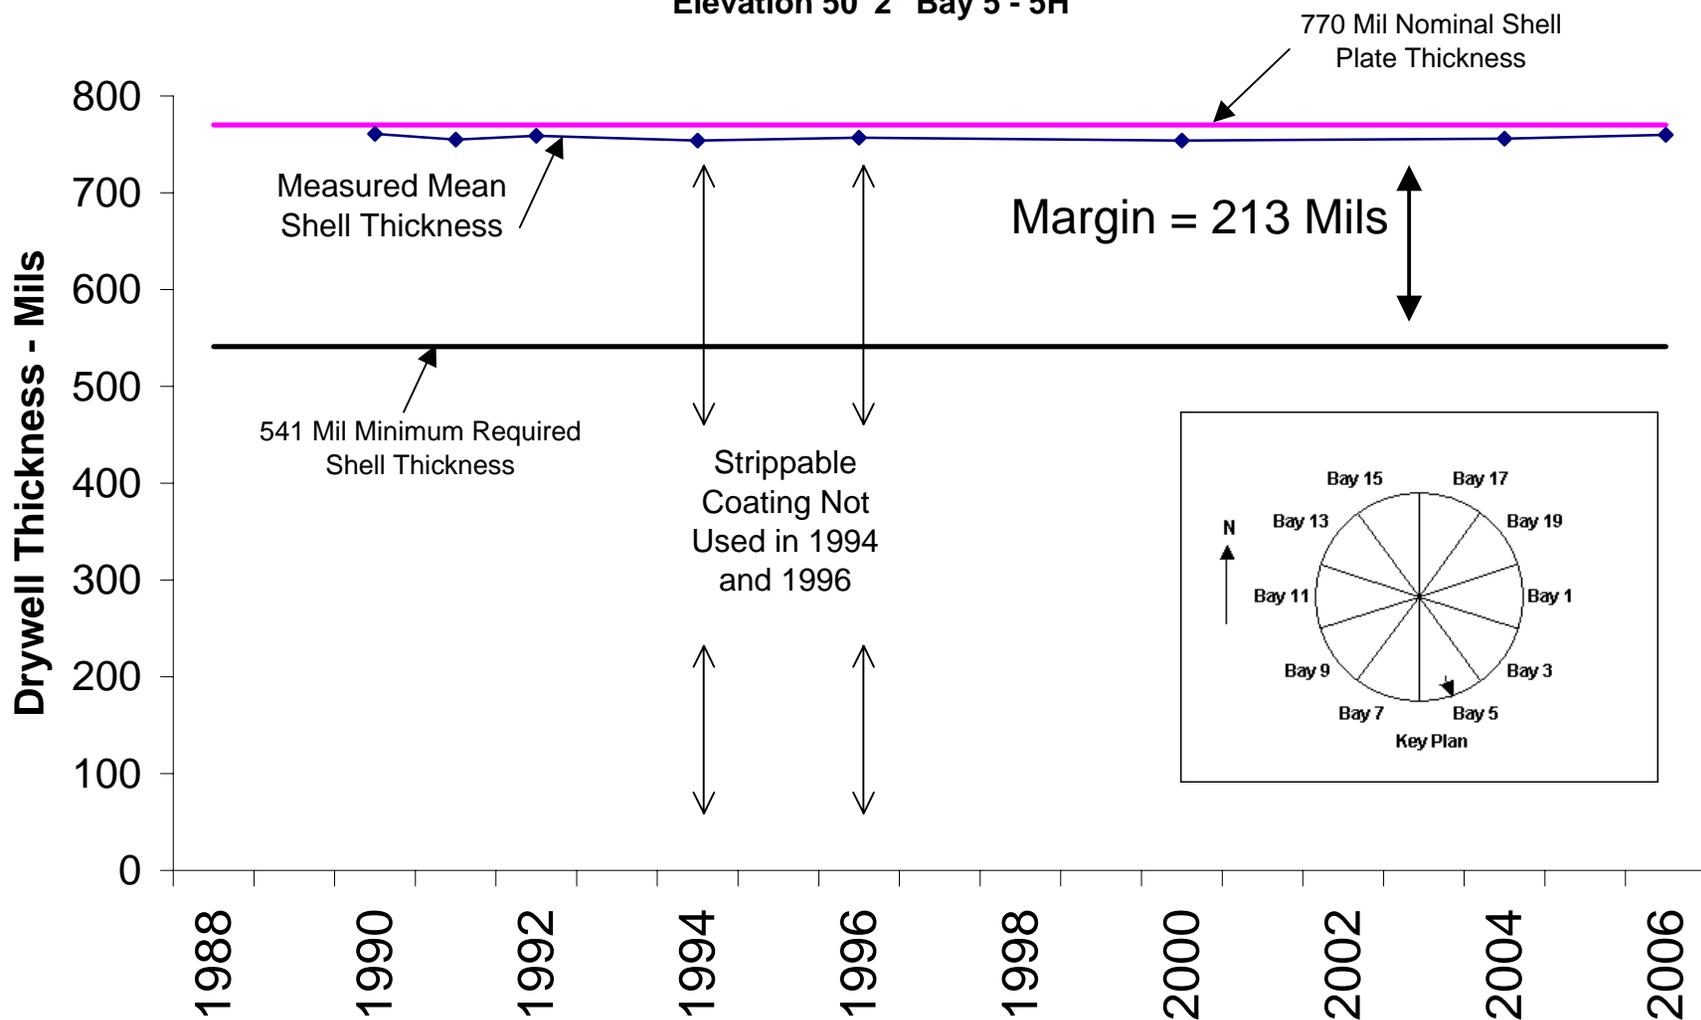
2. Upper Drywell Corrosion Trend and Margin

Elevation 50' 2" Bay 5 - 5H

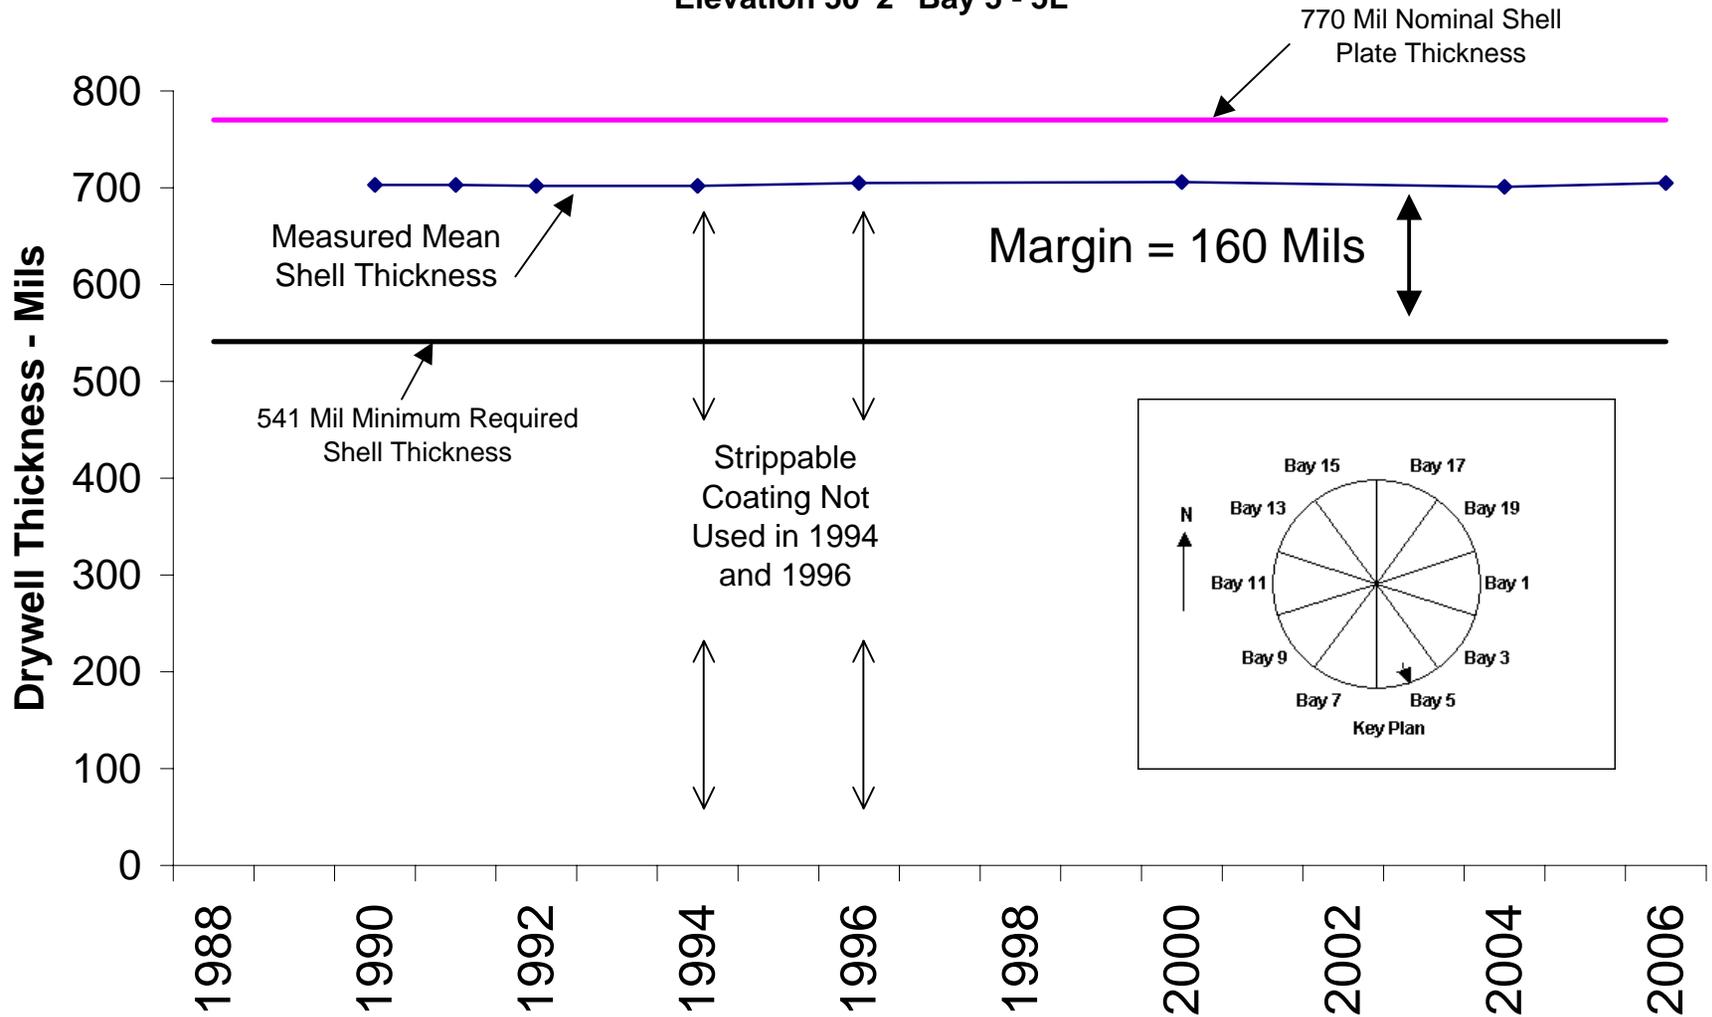
3. Upper Drywell Corrosion Trend and Margin

Elevation 50' 2" Bay 5 - 5L

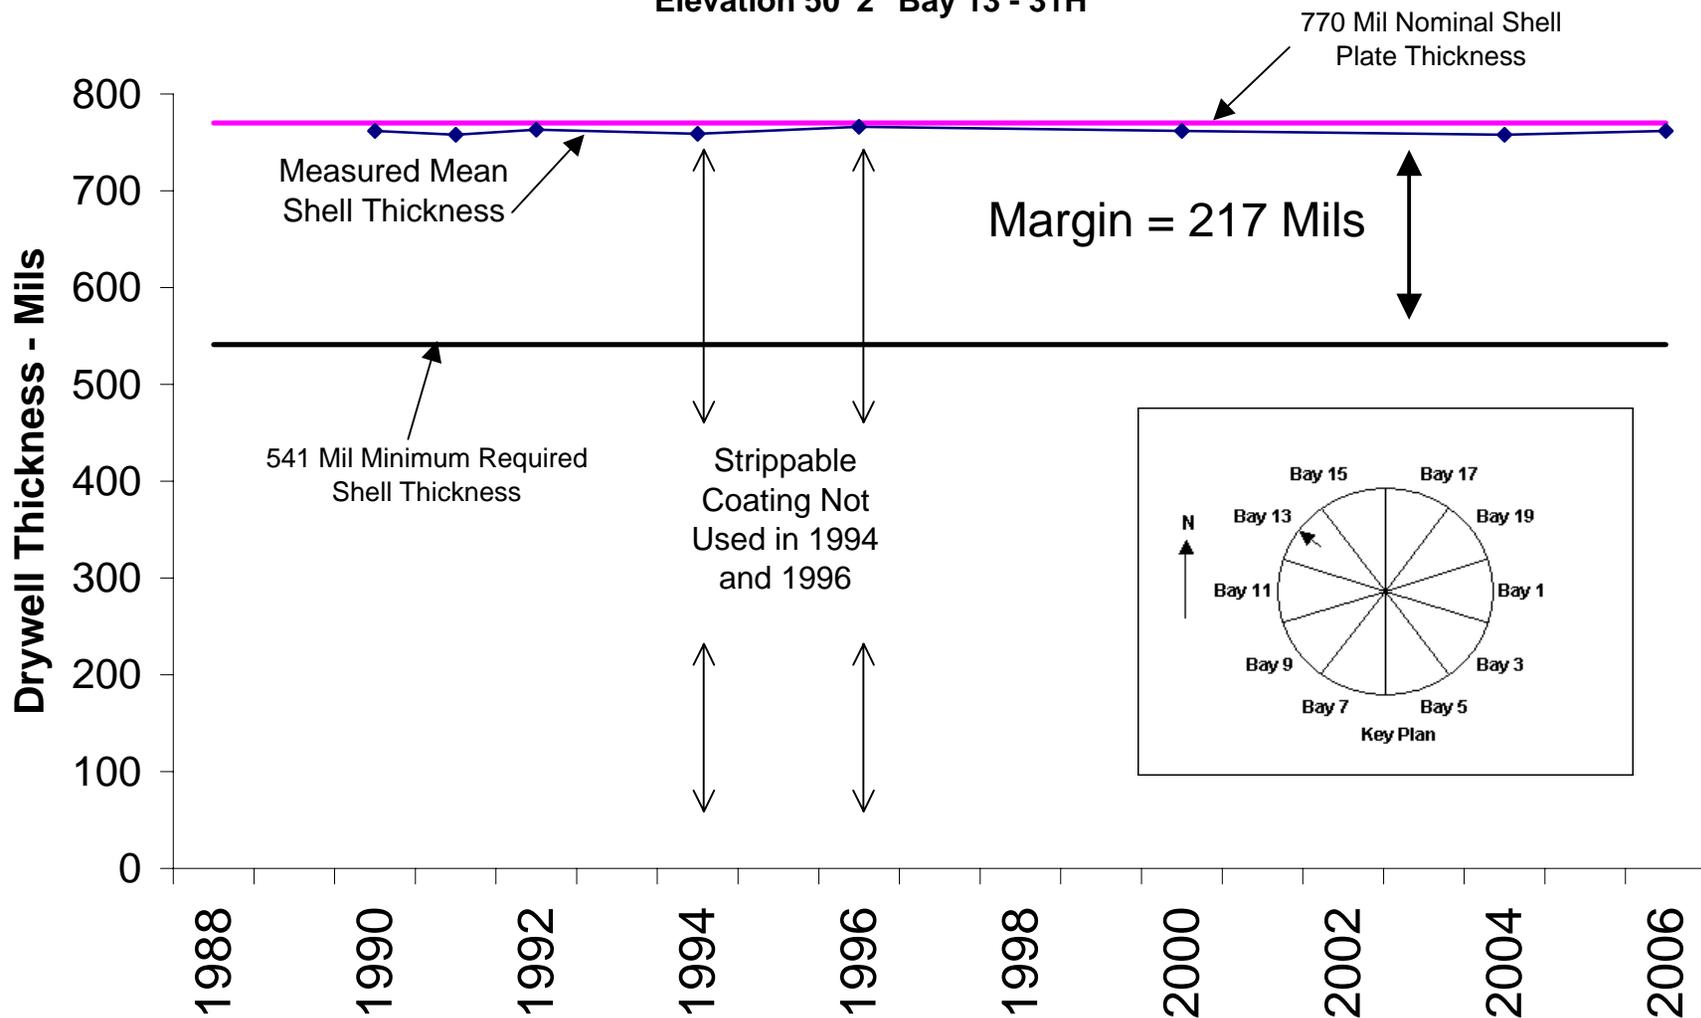
4. Upper Drywell Corrosion Trend and Margin

Elevation 50' 2" Bay 13 - 31H

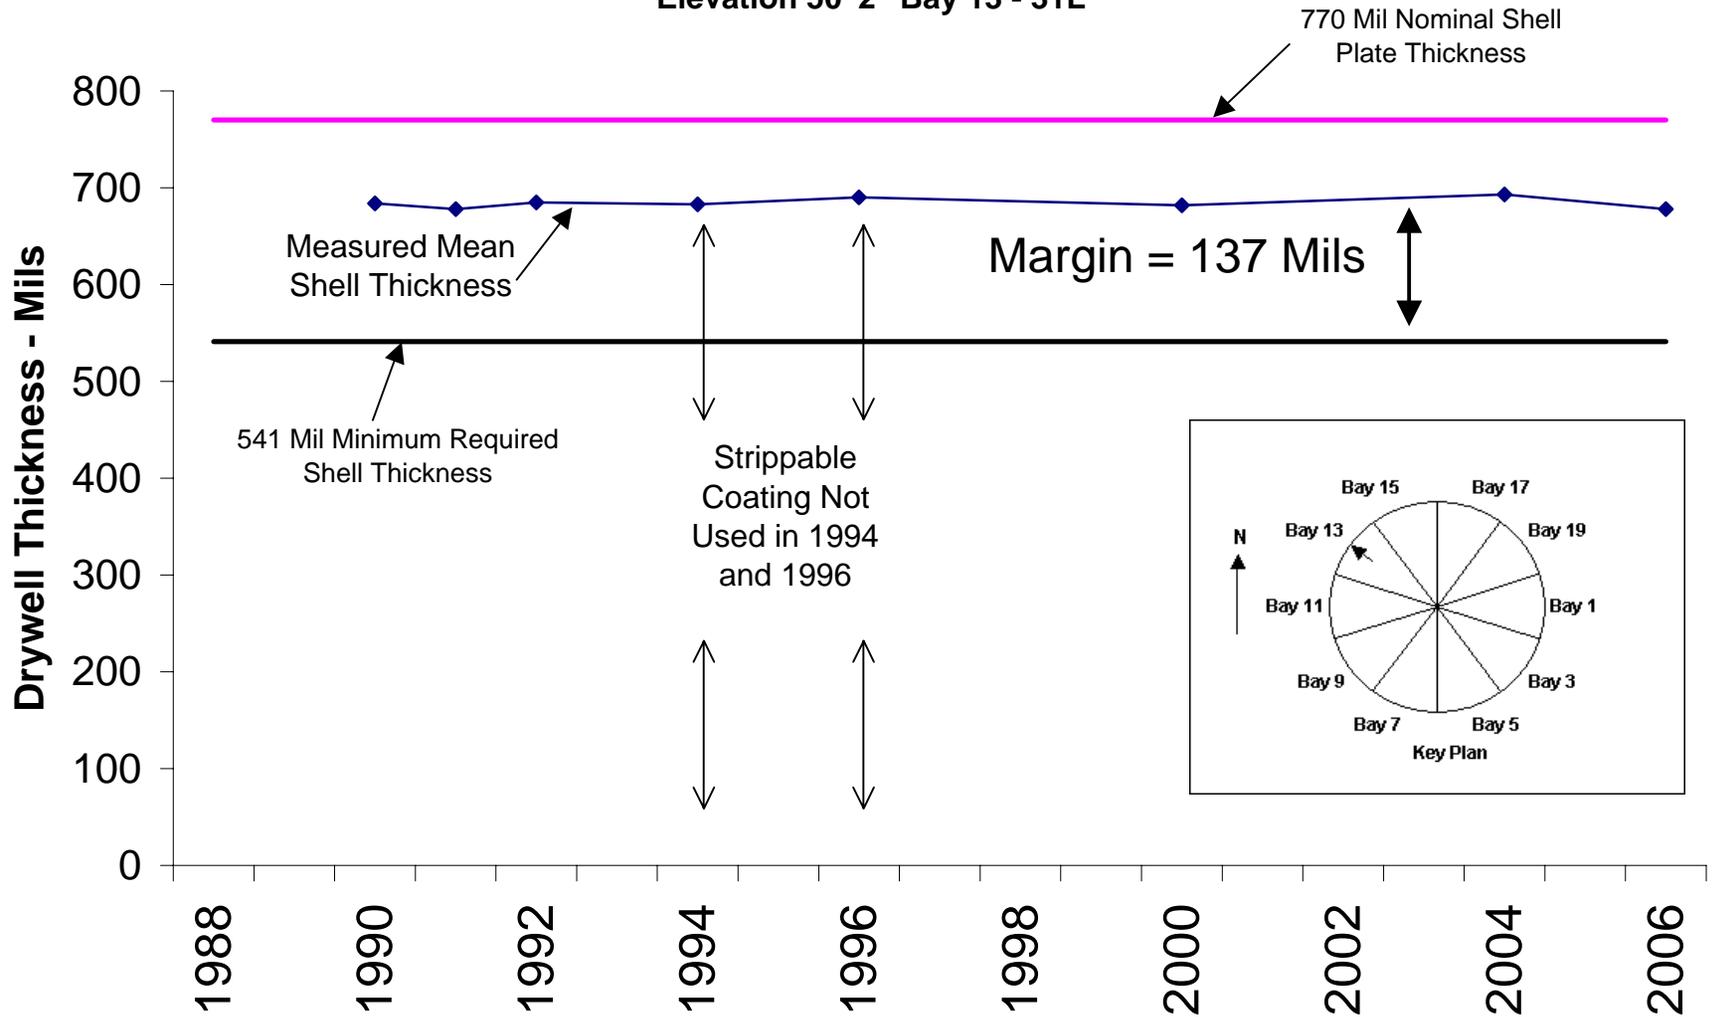
5. Upper Drywell Corrosion Trend and Margin

Elevation 50' 2" Bay 13 - 31L

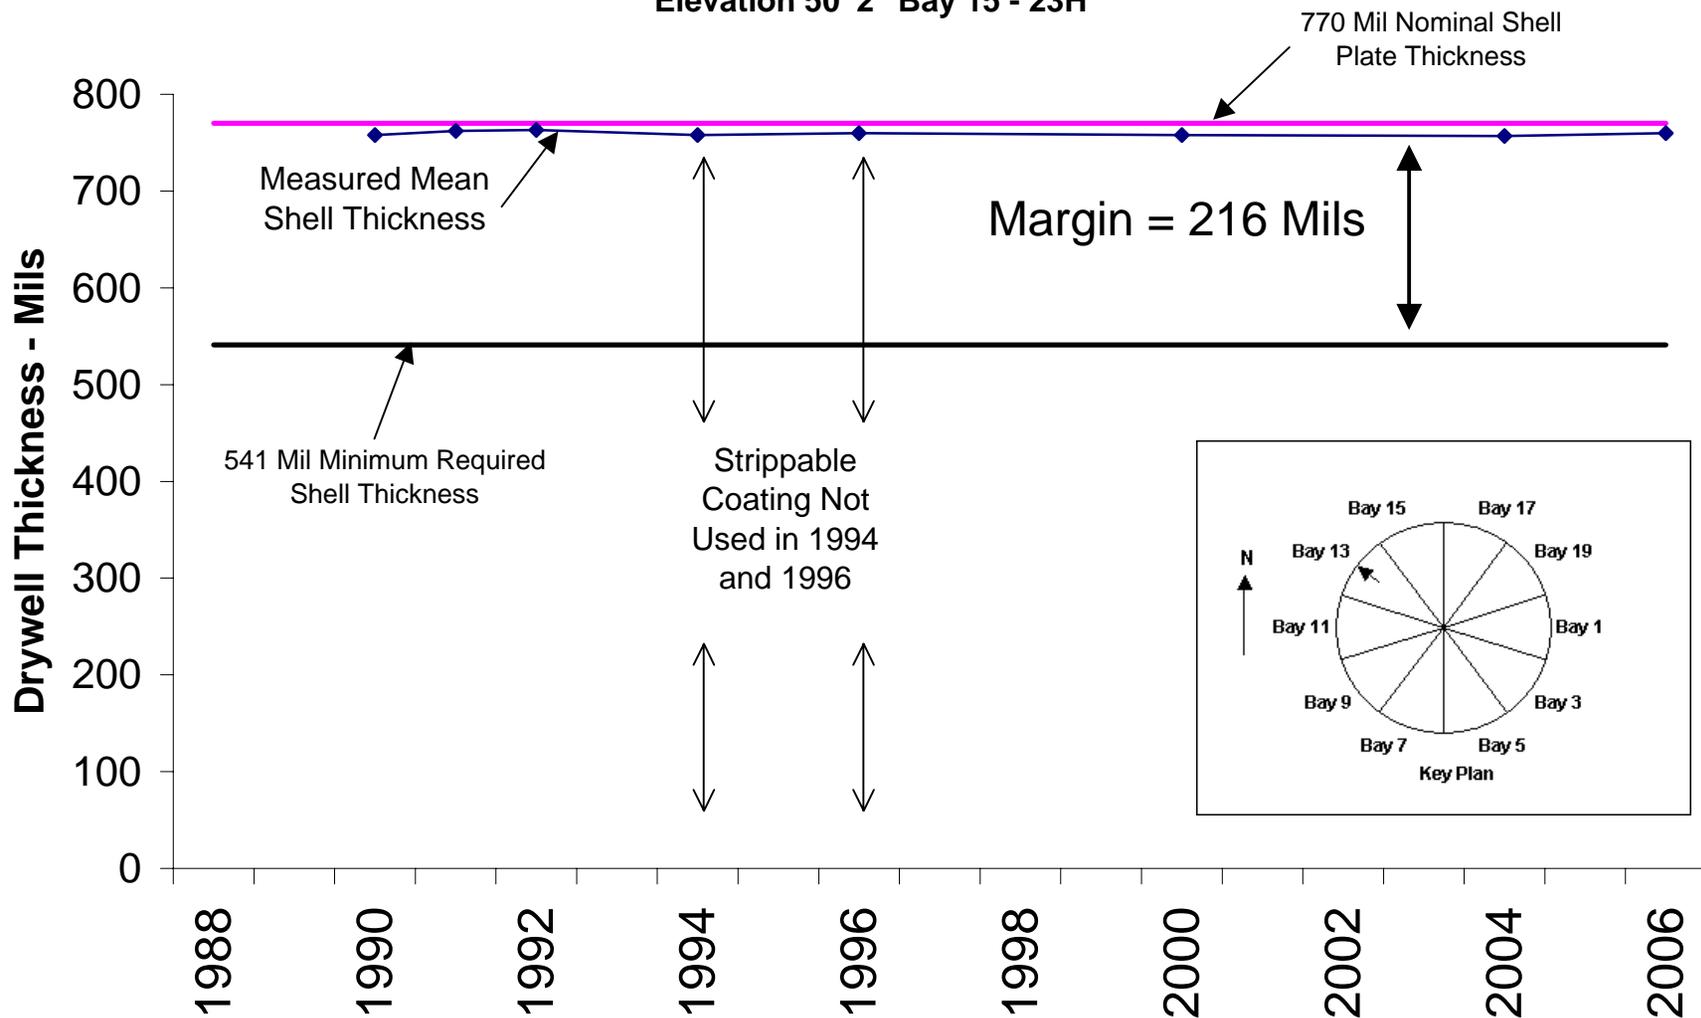
6. Upper Drywell Corrosion Trend and Margin

Elevation 50' 2" Bay 15 - 23H

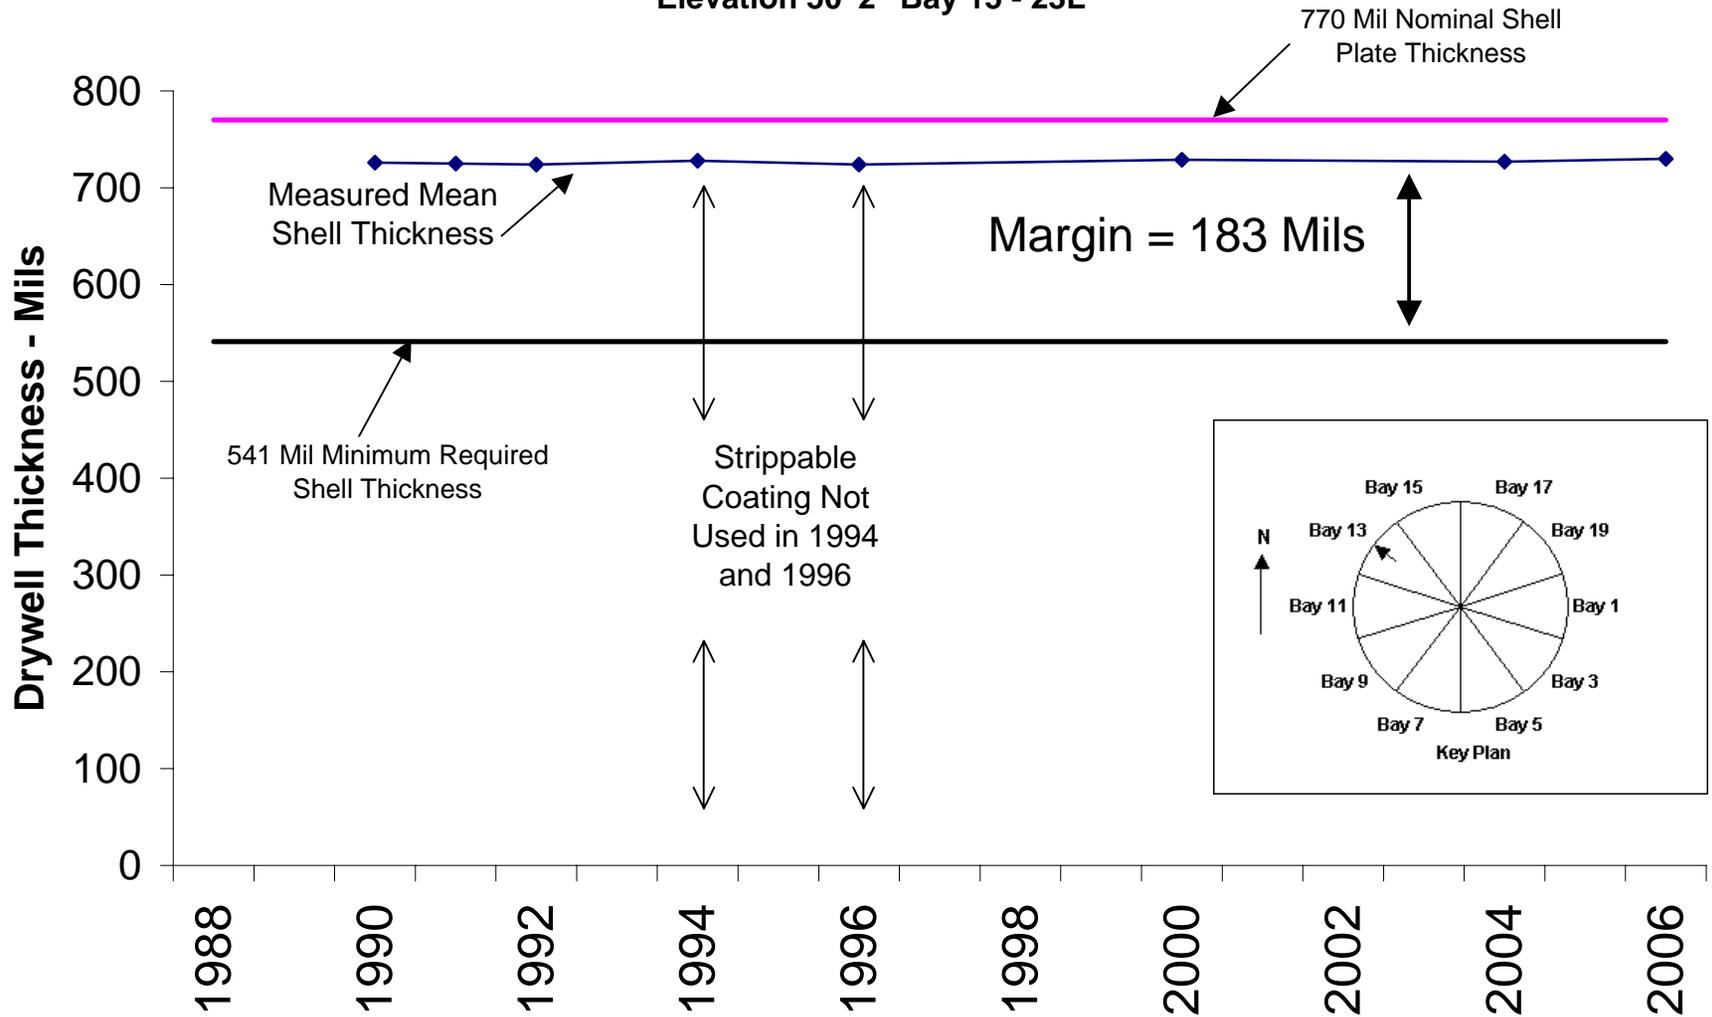
7. Upper Drywell Corrosion Trend and Margin

Elevation 50' 2" Bay 15 - 23L

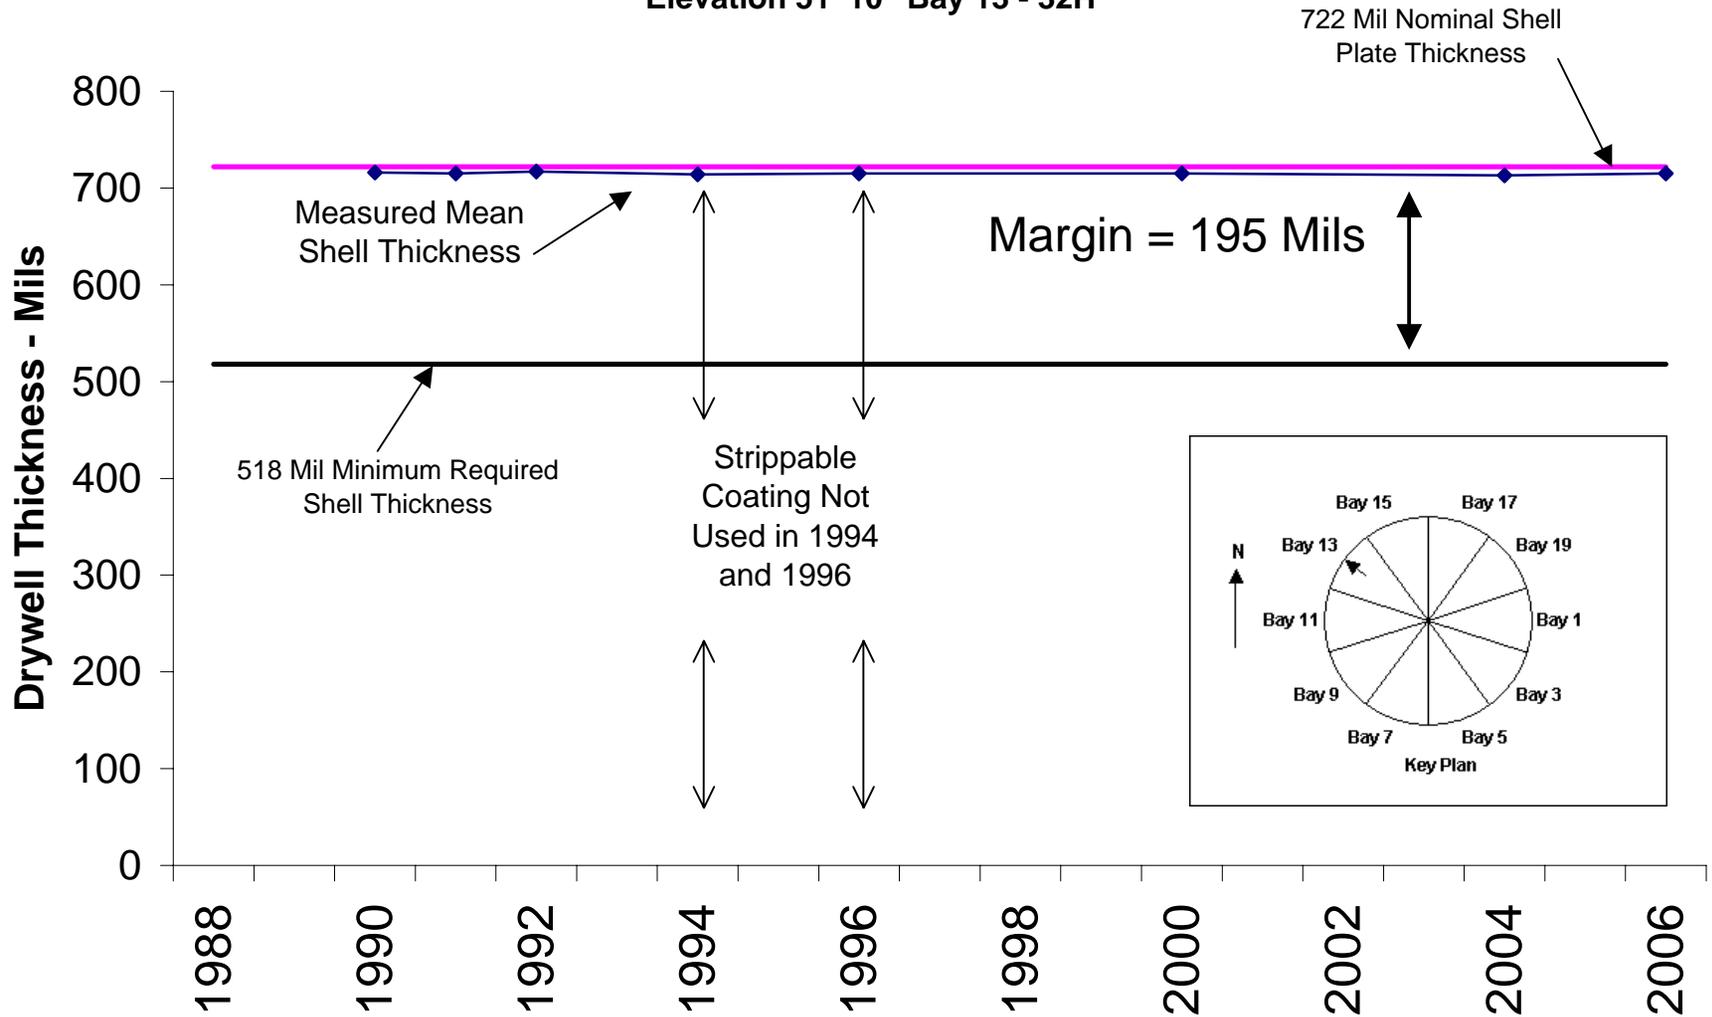
8. Upper Drywell Corrosion Trend and Margin

Elevation 51' 10" Bay 13 - 32H

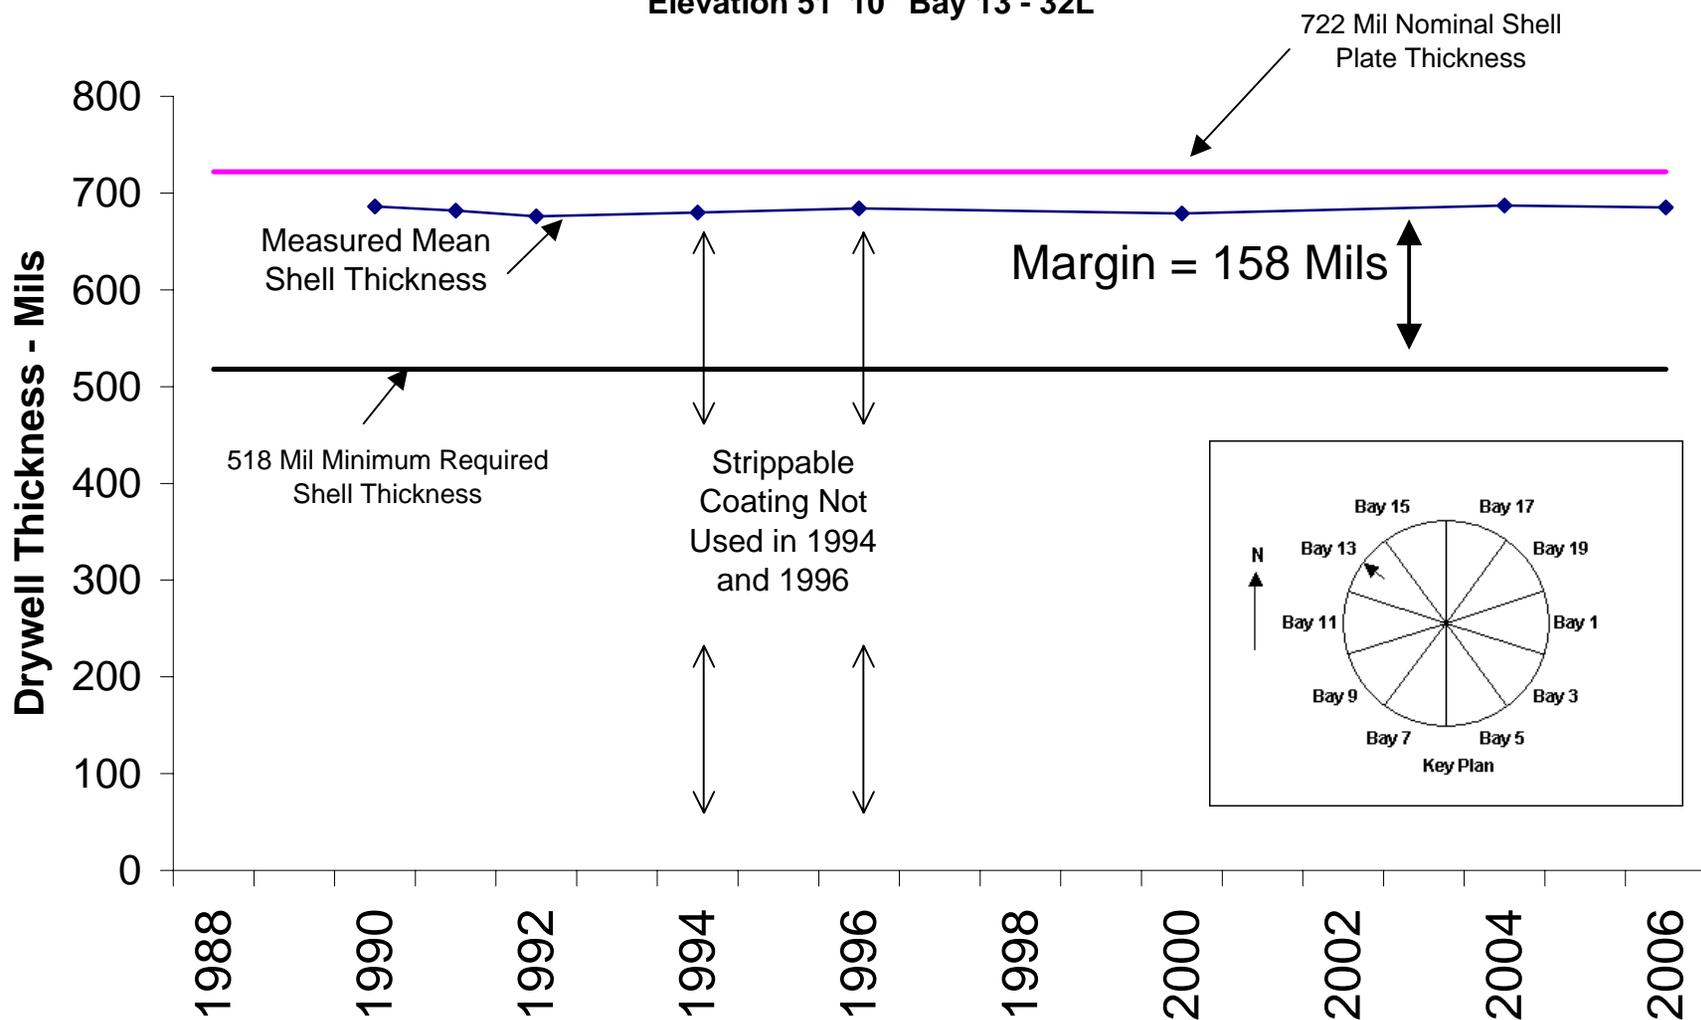
9. Upper Drywell Corrosion Trend and Margin

Elevation 51' 10" Bay 13 - 32L

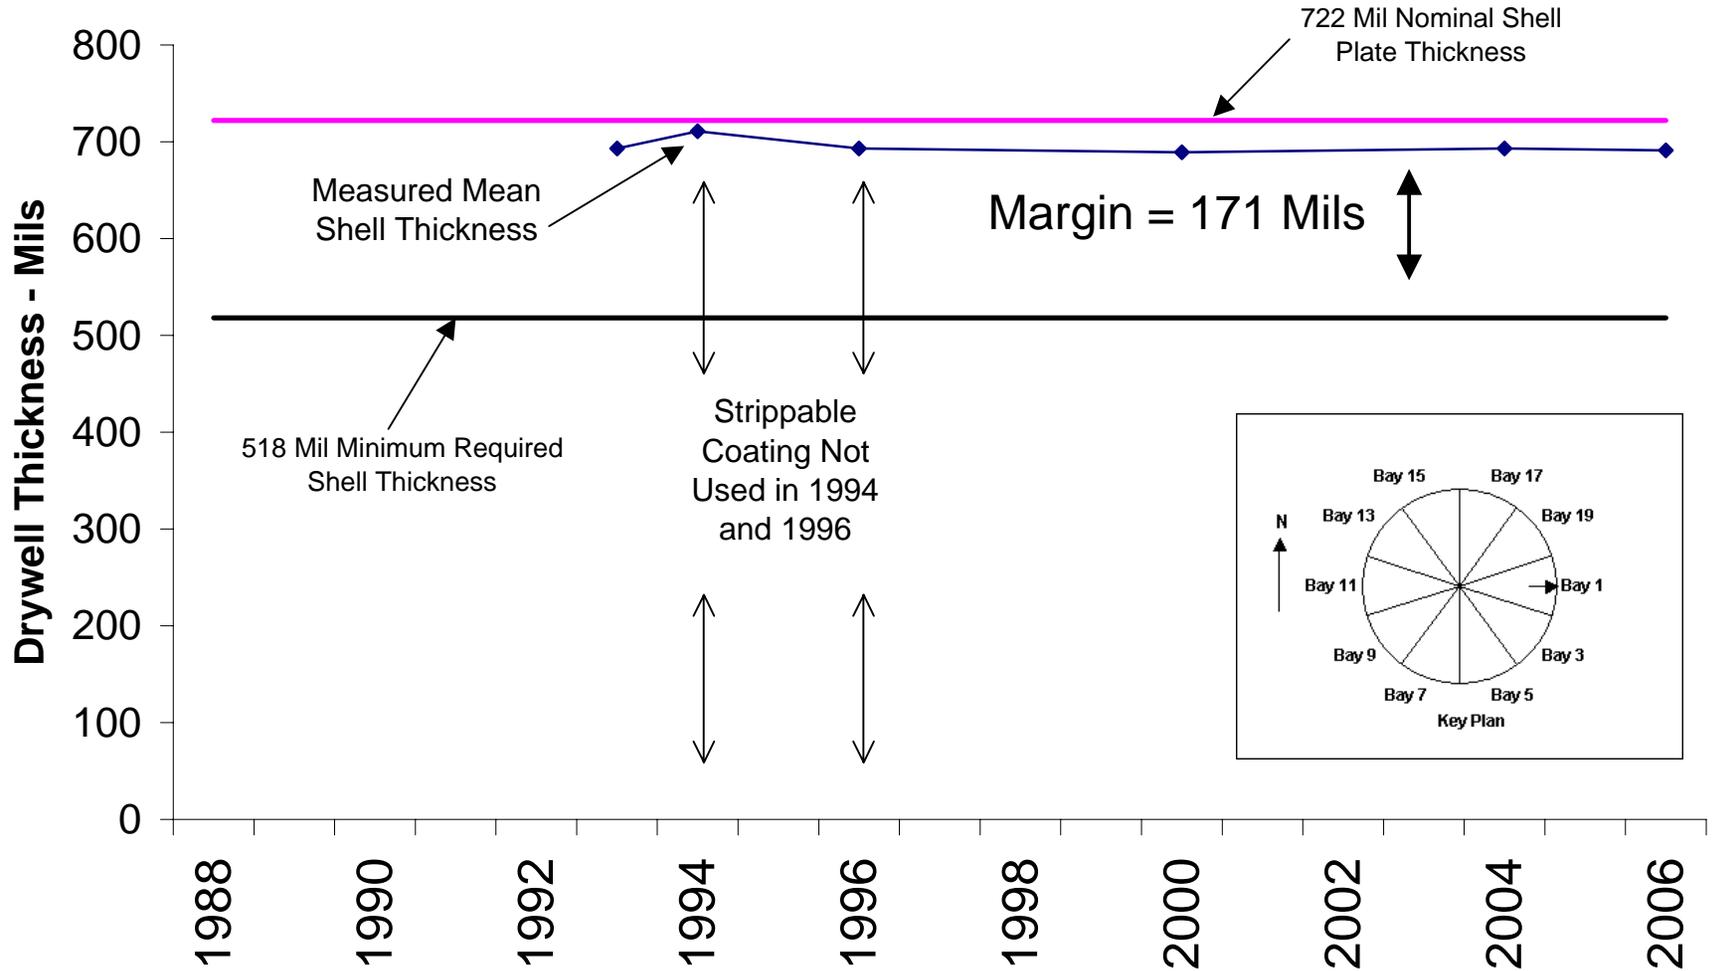
10. Upper Drywell Corrosion Trend and Margin

Elevation 60' 10" Bay 1 - 50 - 22

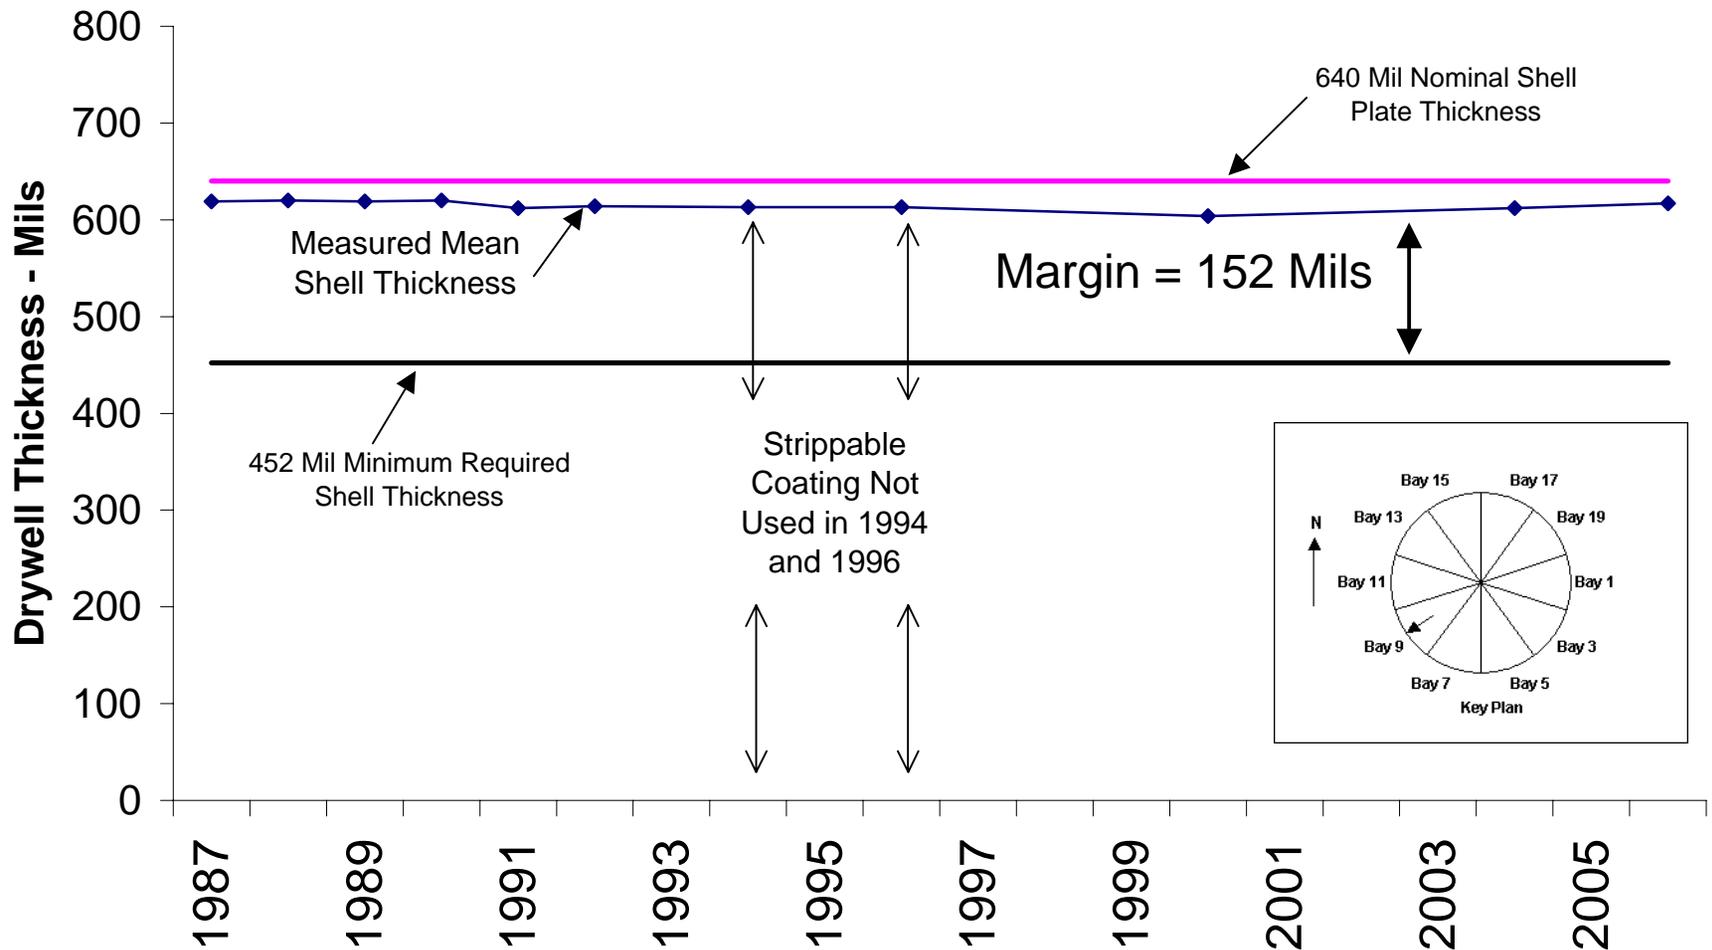
11. Upper Drywell Corrosion Trend and Margin

Elevation 87' 5" Bay 9 - 20

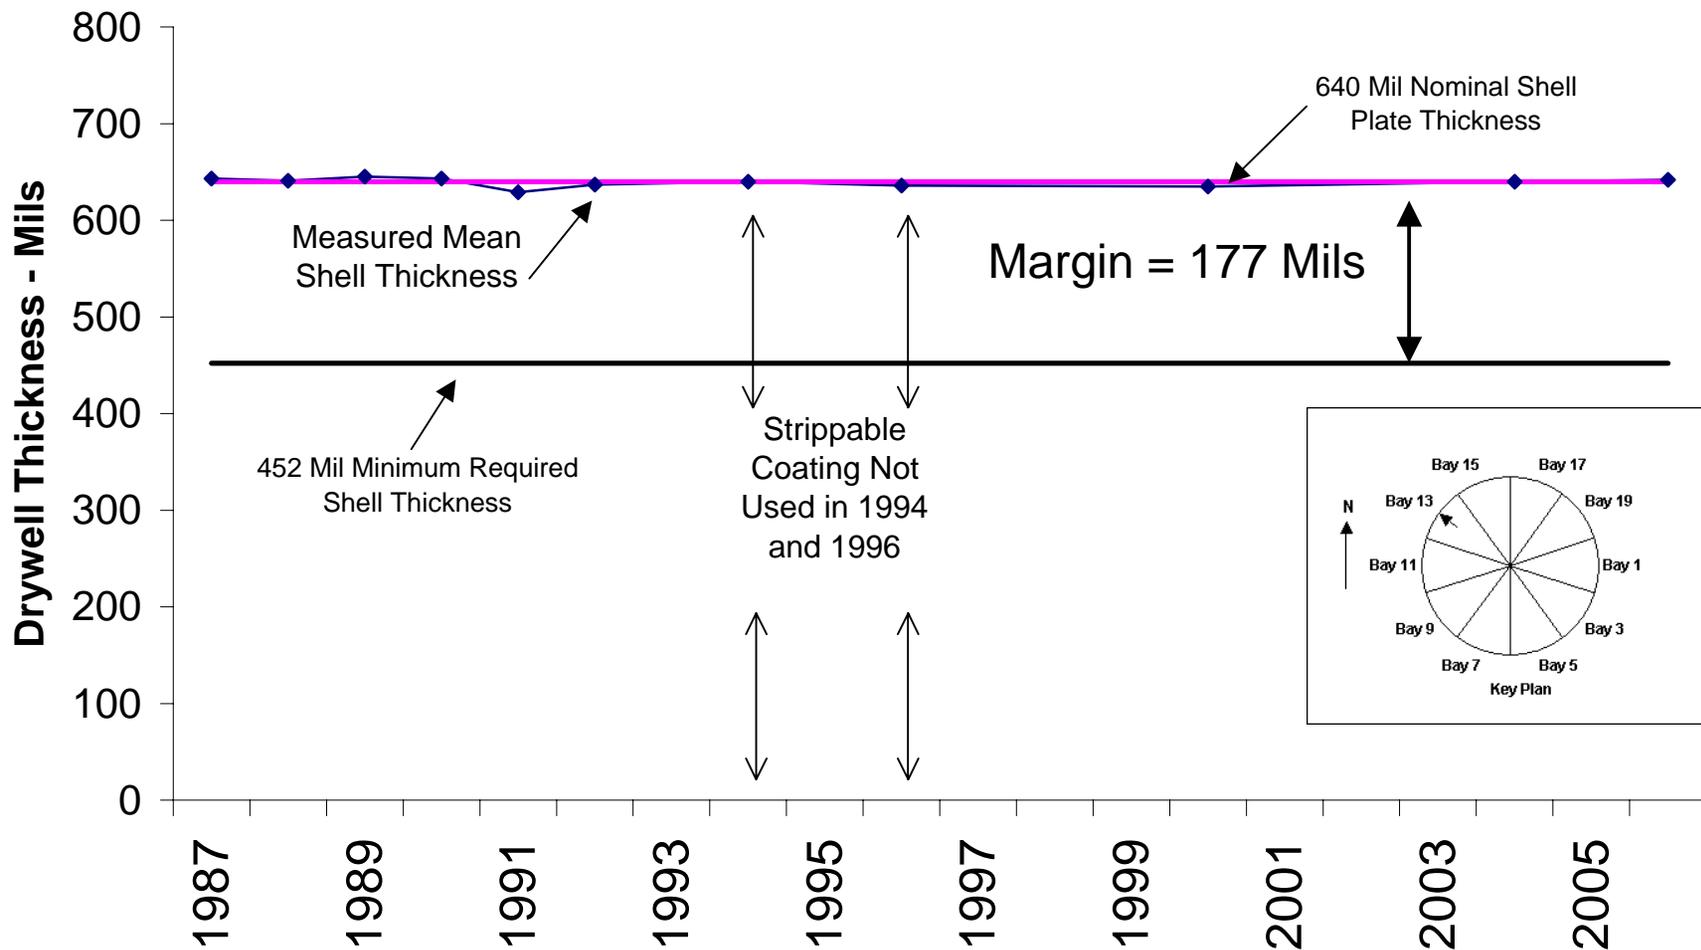
12. Upper Drywell Corrosion Trend and Margin

Elevation 87' 5" Bay 13 - 28
