Enclosure - Table of Contents

This package of historical information and 2006 outage information is being provided to the ACRS Subcommittee reviewing the License Renewal Application for Oyster Creek. The purpose of the information is to respond to questions that were raised at the ACRS Subcommittee meeting on October 3, 2006 concerning the corrosion of the drywell shell and to update the Subcommittee on the results of recent inspection activities. This package is meant to help the ACRS members understand the information that the NRC staff has already reviewed over the course of weeks of audits and inspections. As such, the information set forth in this package consists of documents and responses to questions that were available to the NRC staff during the NRR AMR and AMP audits in January and February 2006, during the NRC Region 1 inspection in March 2006, in response to NRC RAls during the review of the Oyster Creek License Renewal Application, in docketed correspondence between GPUN or AmerGen and the NRC, and in documents reviewed by NRC Region 1 during the 2006 refueling outage. The information provided also includes some historical information that serves as the basis or supp

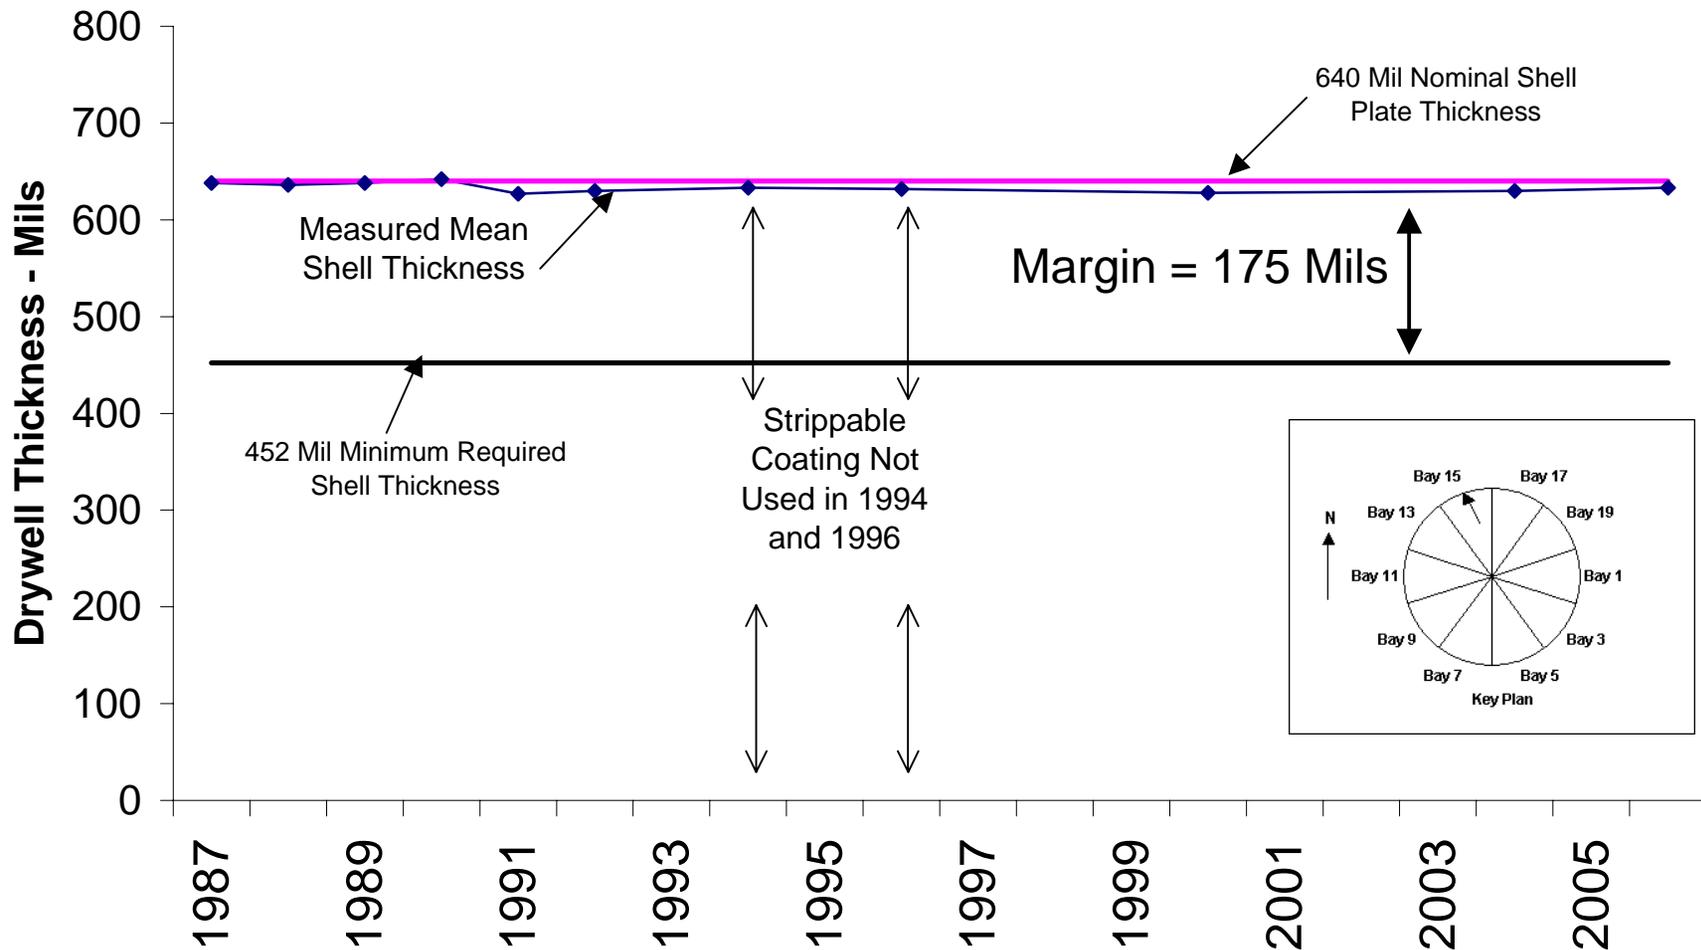
13. Upper Drywell Corrosion Trend and Margin

Elevation 87' 5" Bay 15 - 31
