MEMORANDUM

December 19, 2006

From: Rudolf H. Hausler
Corro-Consulta

Subject: **General Discussion of the Assessment of the Serviceability of the Oyster Creek Nuclear Generating Station Drywell Liner in Light of New Information Contained in recent AmerGen Submissions to the NRC and the ASLB.**

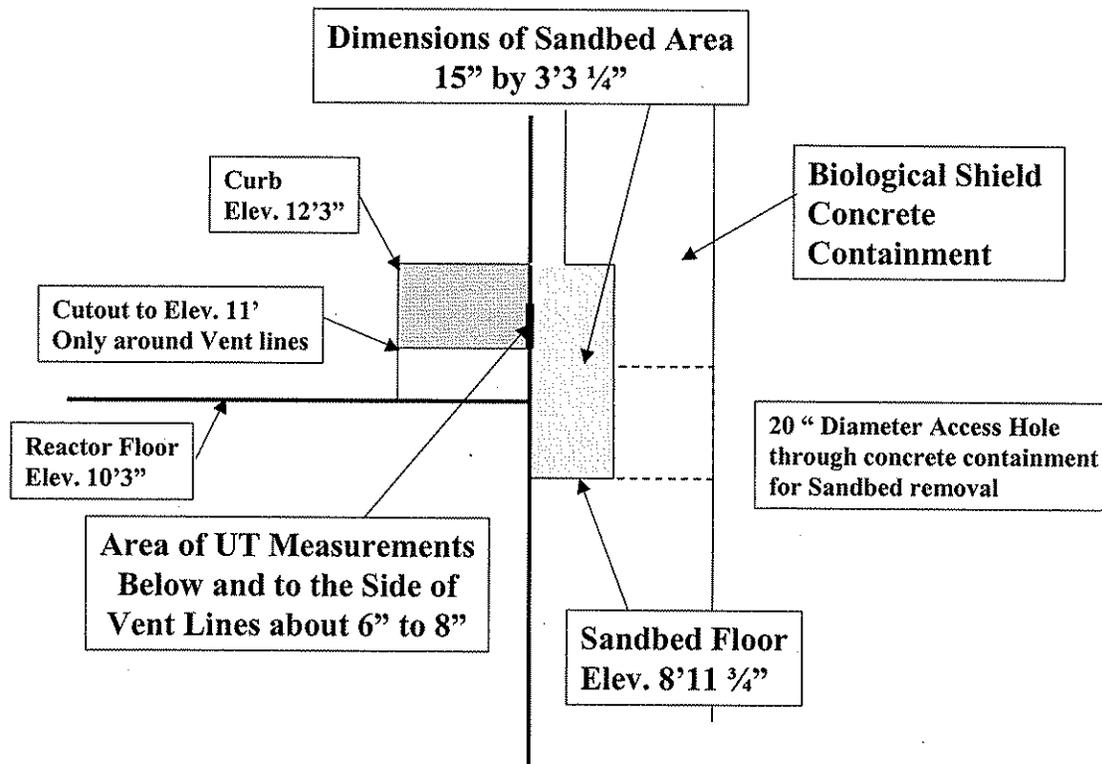
Figure 1

(It should be noted that all the measurements regarding the depth of the trenches relative to the sandbed floor are nominal, i.e. according to the drawings (Fig. 1). Since it had been found that the sandbed drains were 6 to 8 inches above the floor one

might justifiably ask the question whether the floor was at the correct elevation to begin with. Data like these have never been properly verified even after the sandbed had been removed and the floor had been found to be in a bad condition.)

Schematic Cross Section through Sandbed Area
(not to size)
