Enclosure - Table of Contents

This package of historical information and 2006 outage information is being provided to the ACRS Subcommittee reviewing the License Renewal Application for Oyster Creek. The purpose of the information is to respond to questions that were raised at the ACRS Subcommittee meeting on October 3, 2006 concerning the corrosion of the drywell shell and to update the Subcommittee on the results of recent inspection activities. This package is meant to help the ACRS members understand the information that the NRC staff has already reviewed over the course of weeks of audits and inspections. As such, the information set forth in this package consists of documents and responses to questions that were available to the NRC staff during the NRR AMR and AMP audits in January and February 2006, during the NRC Region 1 inspection in March 2006, in response to NRC RAls during the review of the Oyster Creek License Renewal Application, in docketed correspondence between GPUN or AmerGen and the NRC, and in documents reviewed by NRC Region 1 during the 2006 refueling outage. The information provided also includes some historical information that serves as the basis or supp

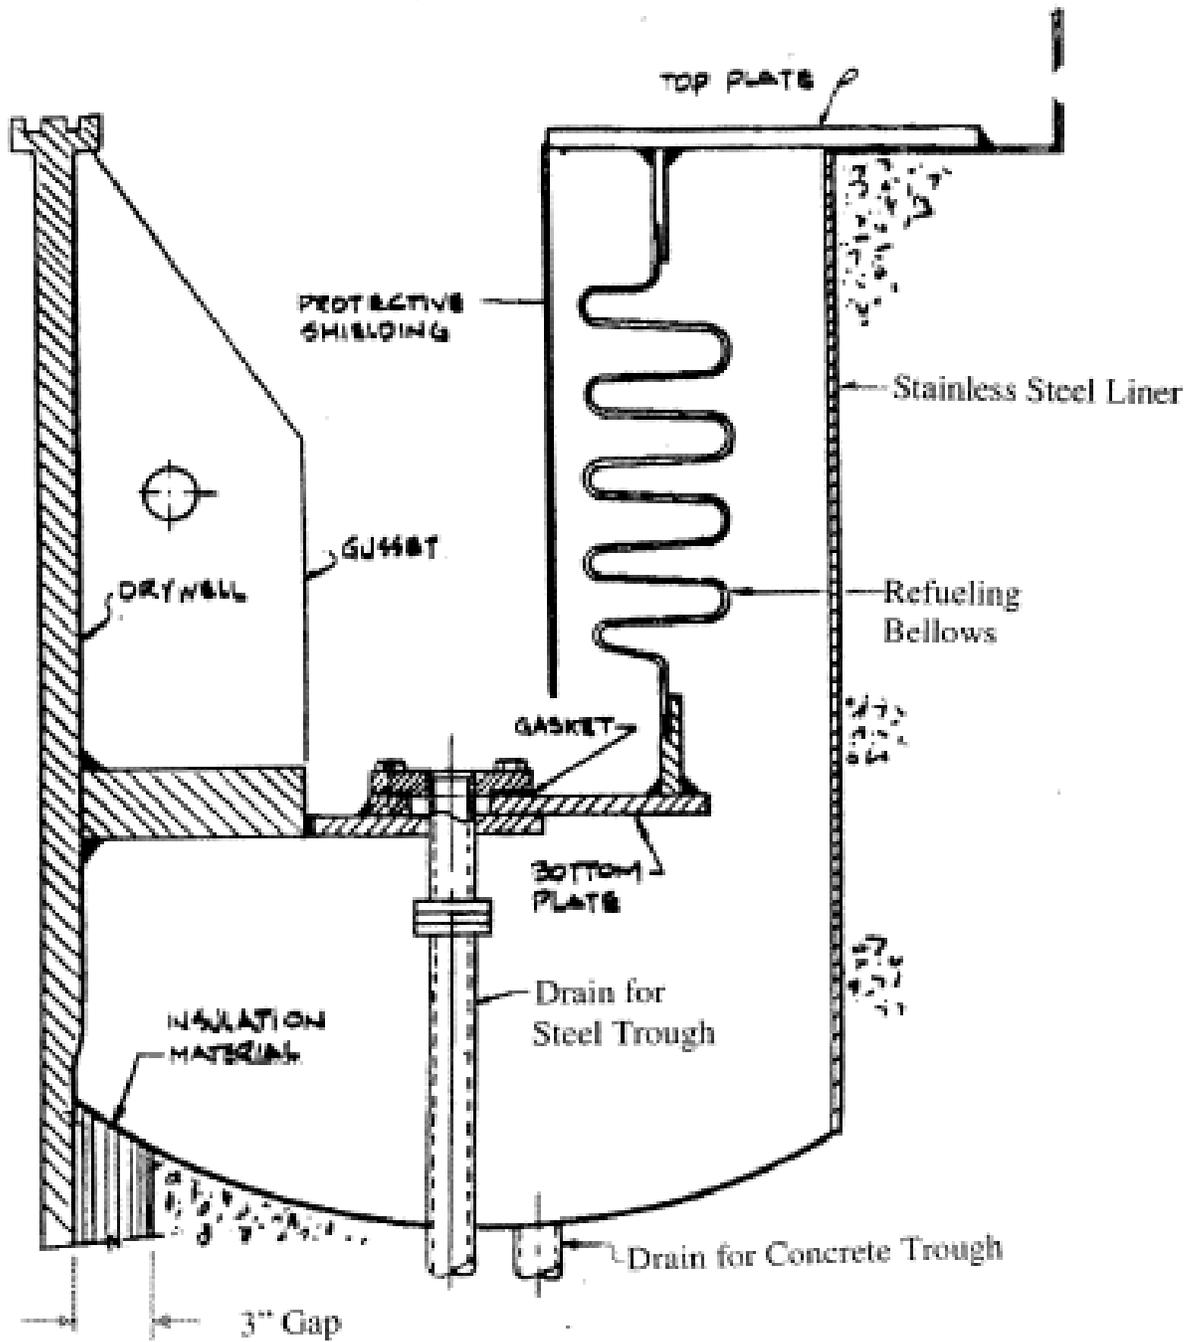
FIGURE 6 – REACTOR CAVITY TROUGH DRAIN

- Leakage was not attributed to the reactor cavity metal trough drain line gasket or the refueling bellows seal (See [Figure 6 of Section 3](#) of this Enclosure).

- The leakage path was from the reactor cavity, to the concrete trough (later found to have been degraded – see Section C below) and through the drywell expansion gap down to the sandbed region within the reactor building (See [Figure 6 of Section 3](#) of this Enclosure).

- Replaced reactor cavity metal trough drain gasket, which was found to be leaking (See [Figure 6 of Section 3](#) of this Enclosure).
 - Removed water from the sand bed region.

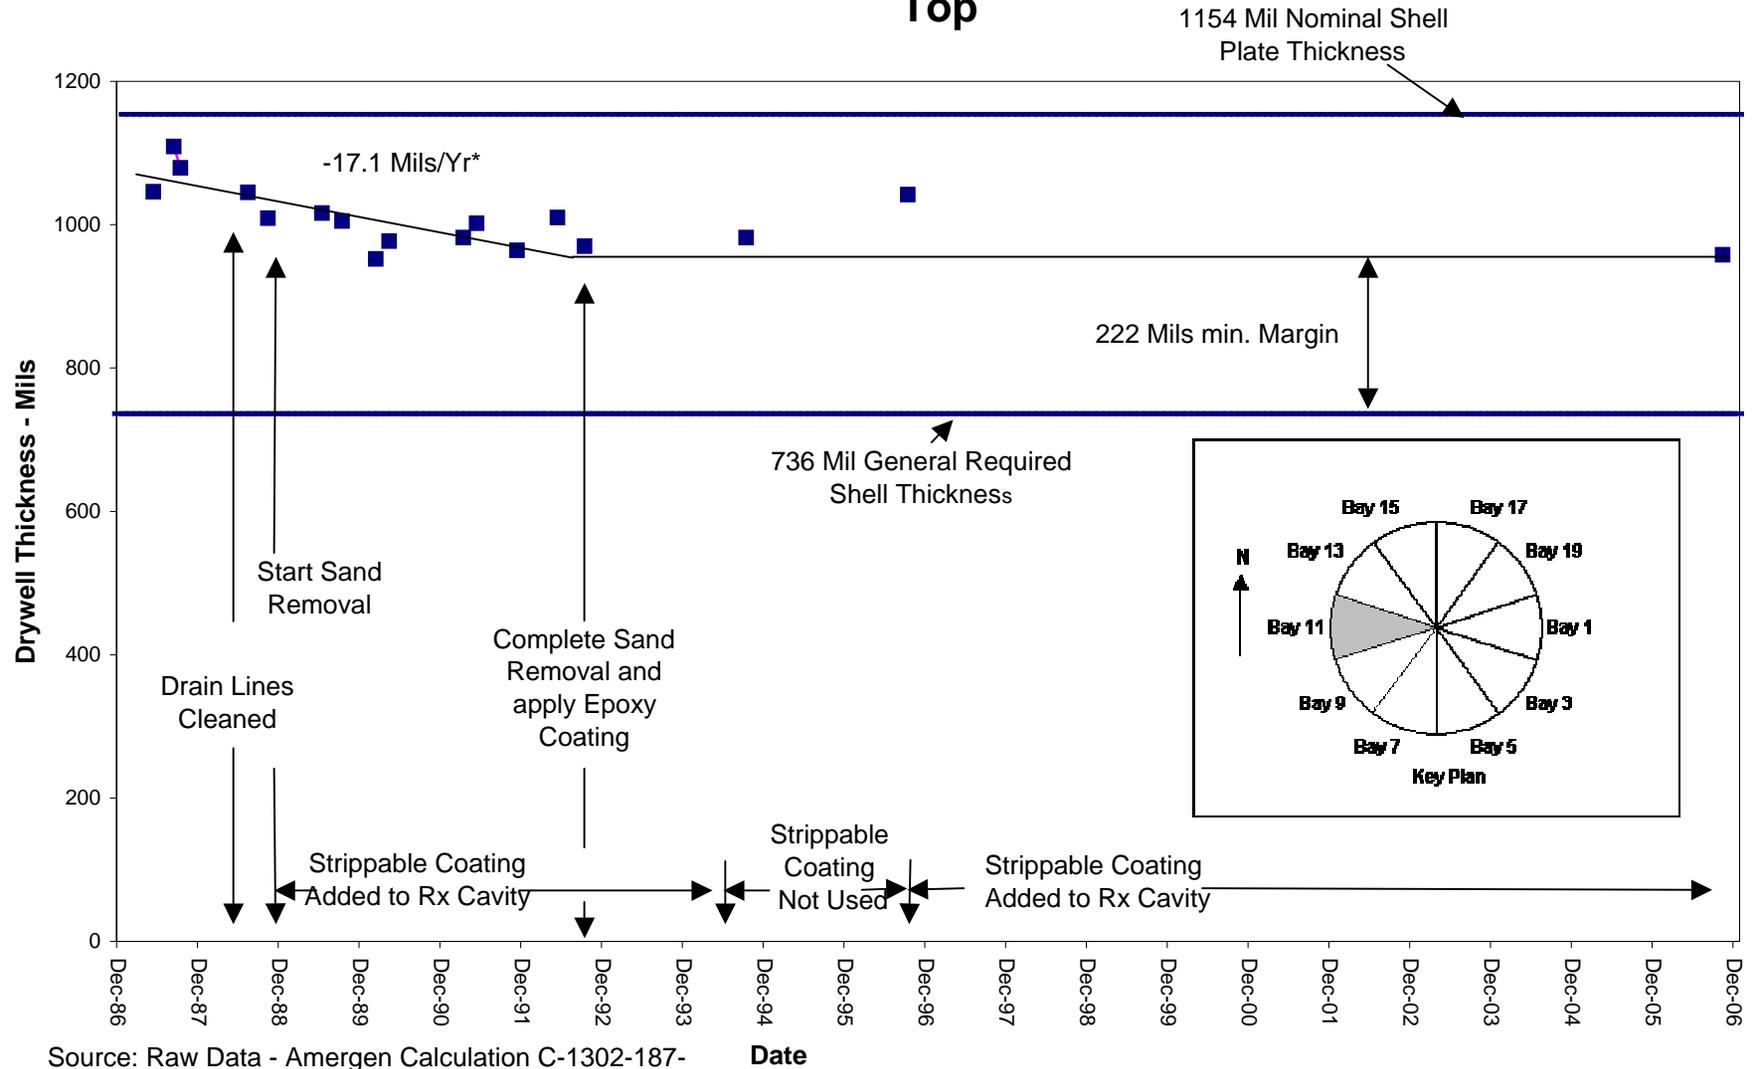
Figure 8. Sandbed Bay #11C Top

(*Maximum calculated rate -35.2 mils/yr 4/91, C-1302-187-5300-011 Rev. 1)

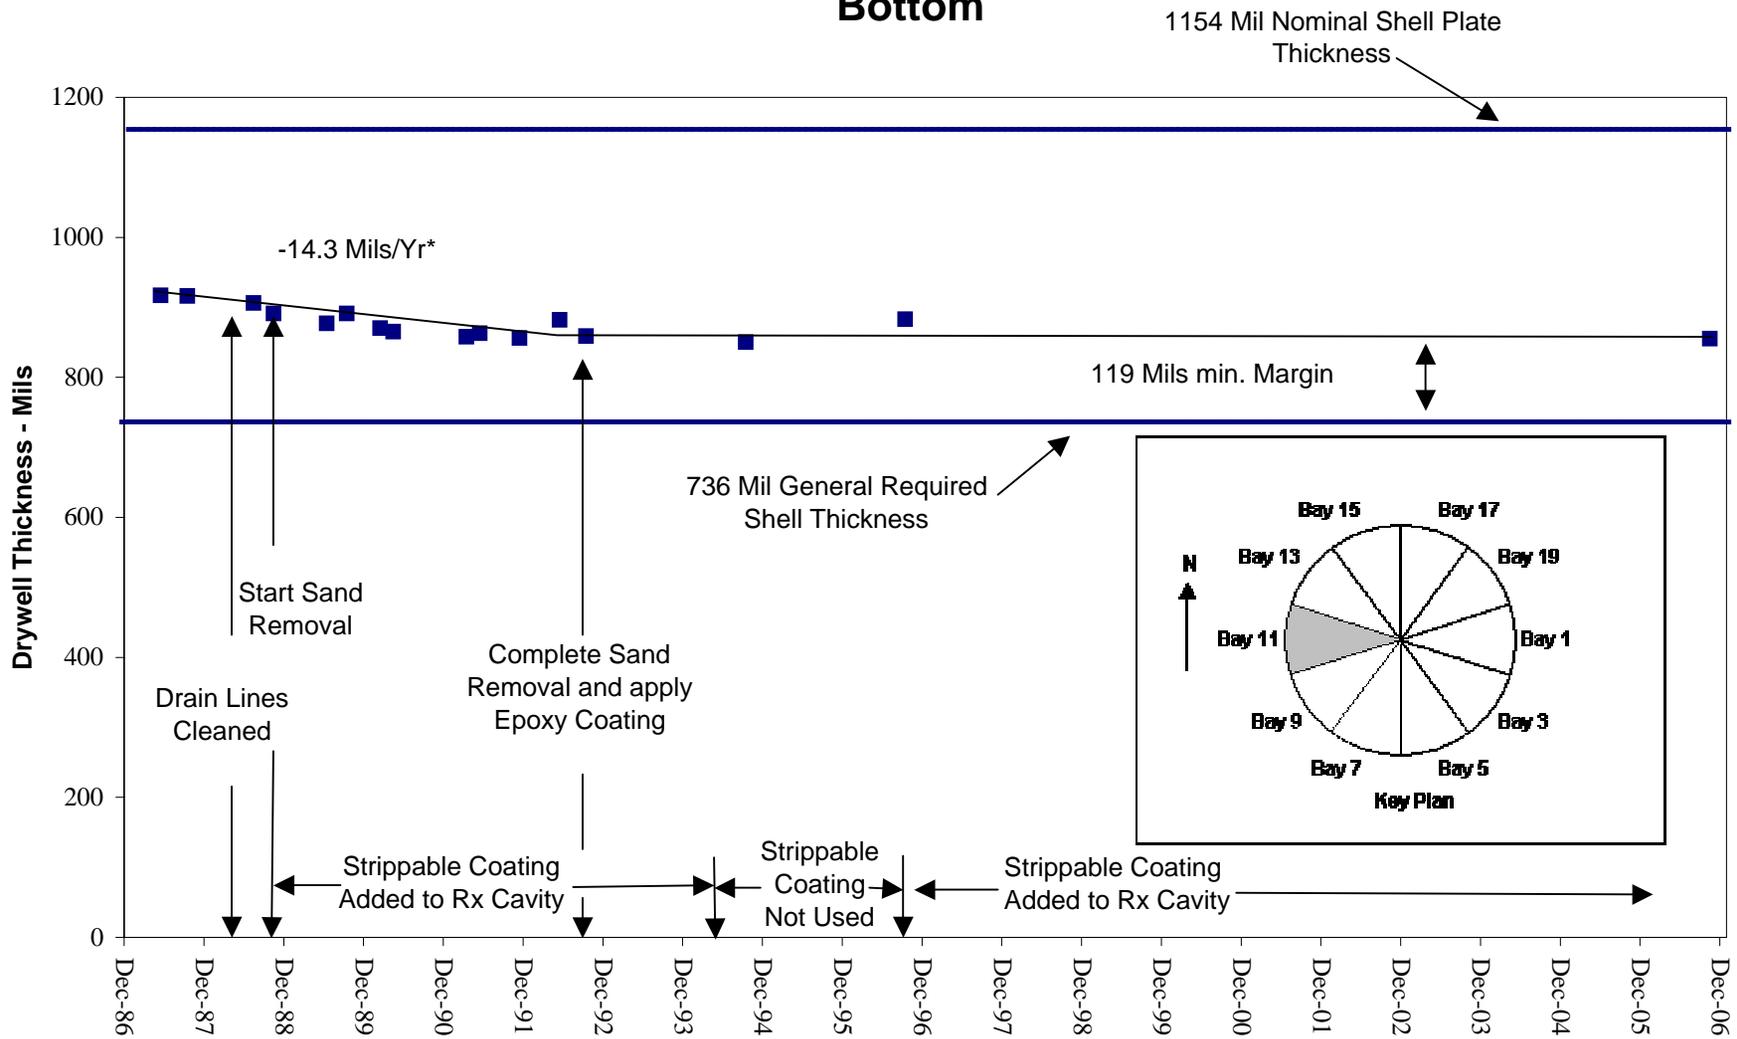
Figure 9. Sandbed Bay #11C Bottom

Date (*Maximum calculated rate -22.4mils/yr 4/91,C-1302-187-5300-011 Rev.1)

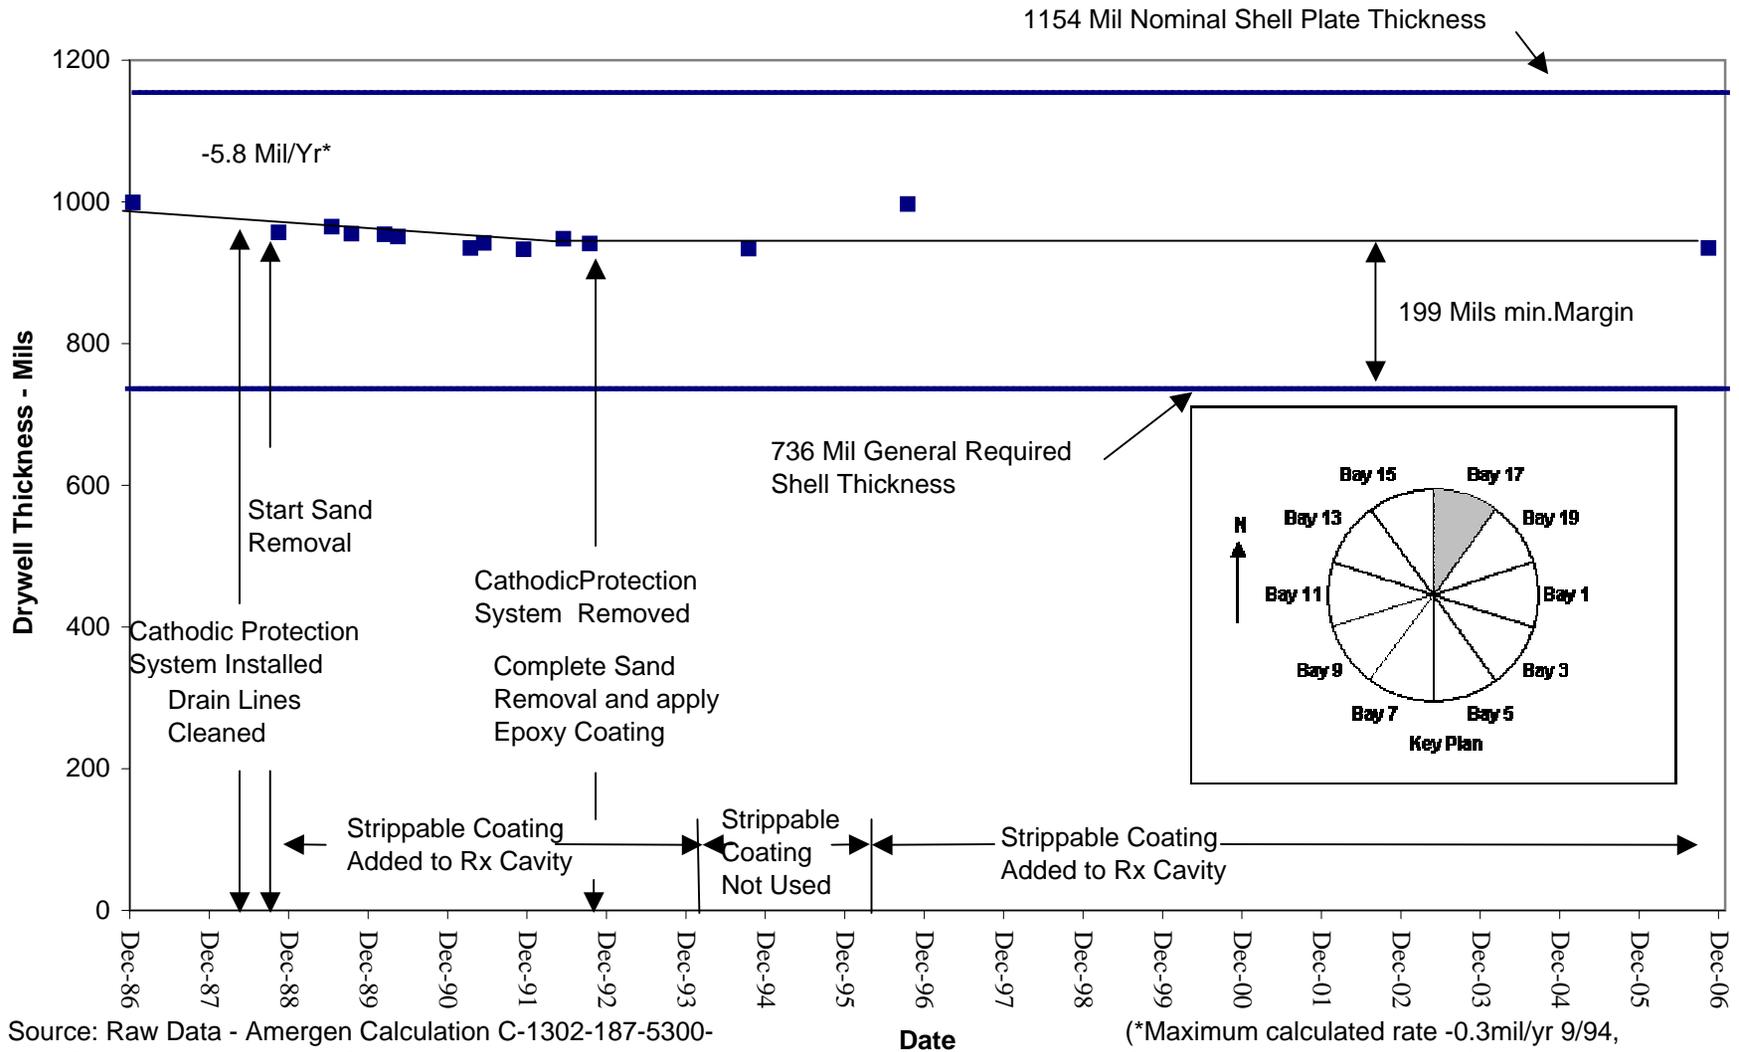
Figure 17. Sandbed Bay #17A Bottom

(*Maximum calculated rate -0.3mil/yr 9/94, C-1302-187-5300-028 Rev. 0)

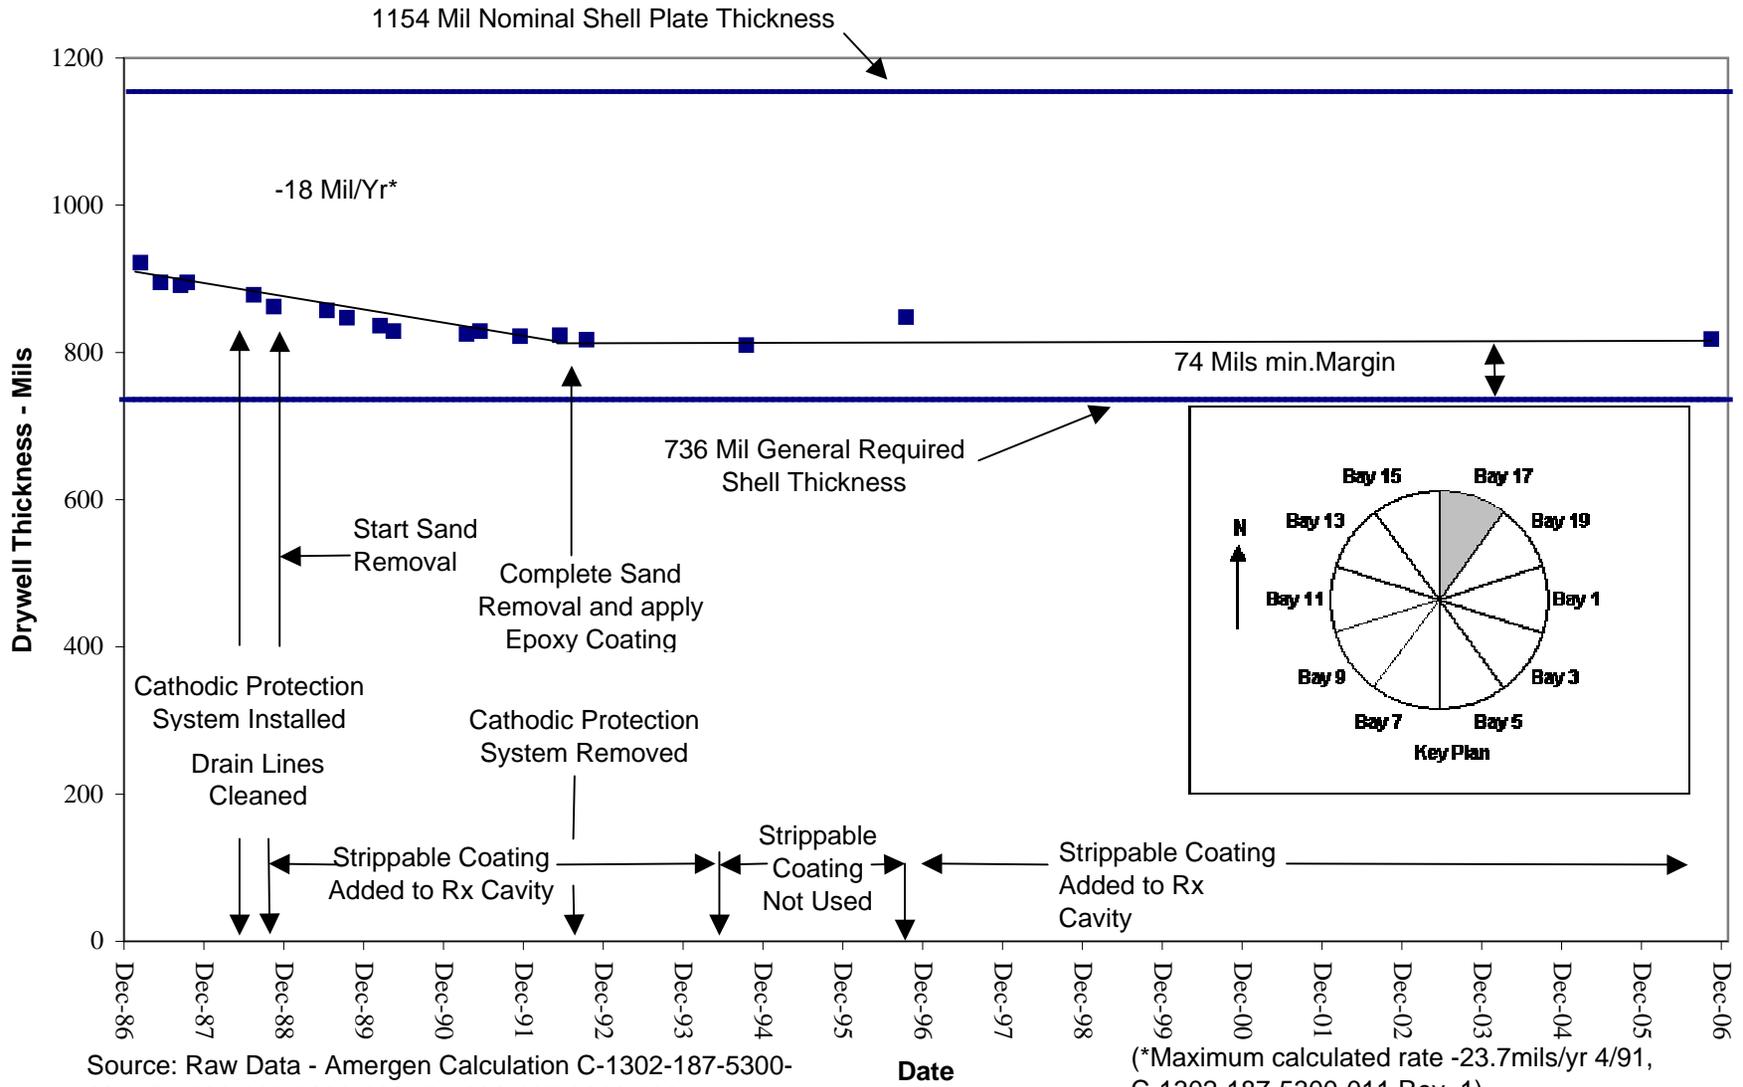
Figure 18. Sandbed Bay #17D

(*Maximum calculated rate -23.7mils/yr 4/91, C-1302-187-5300-011 Rev. 1)

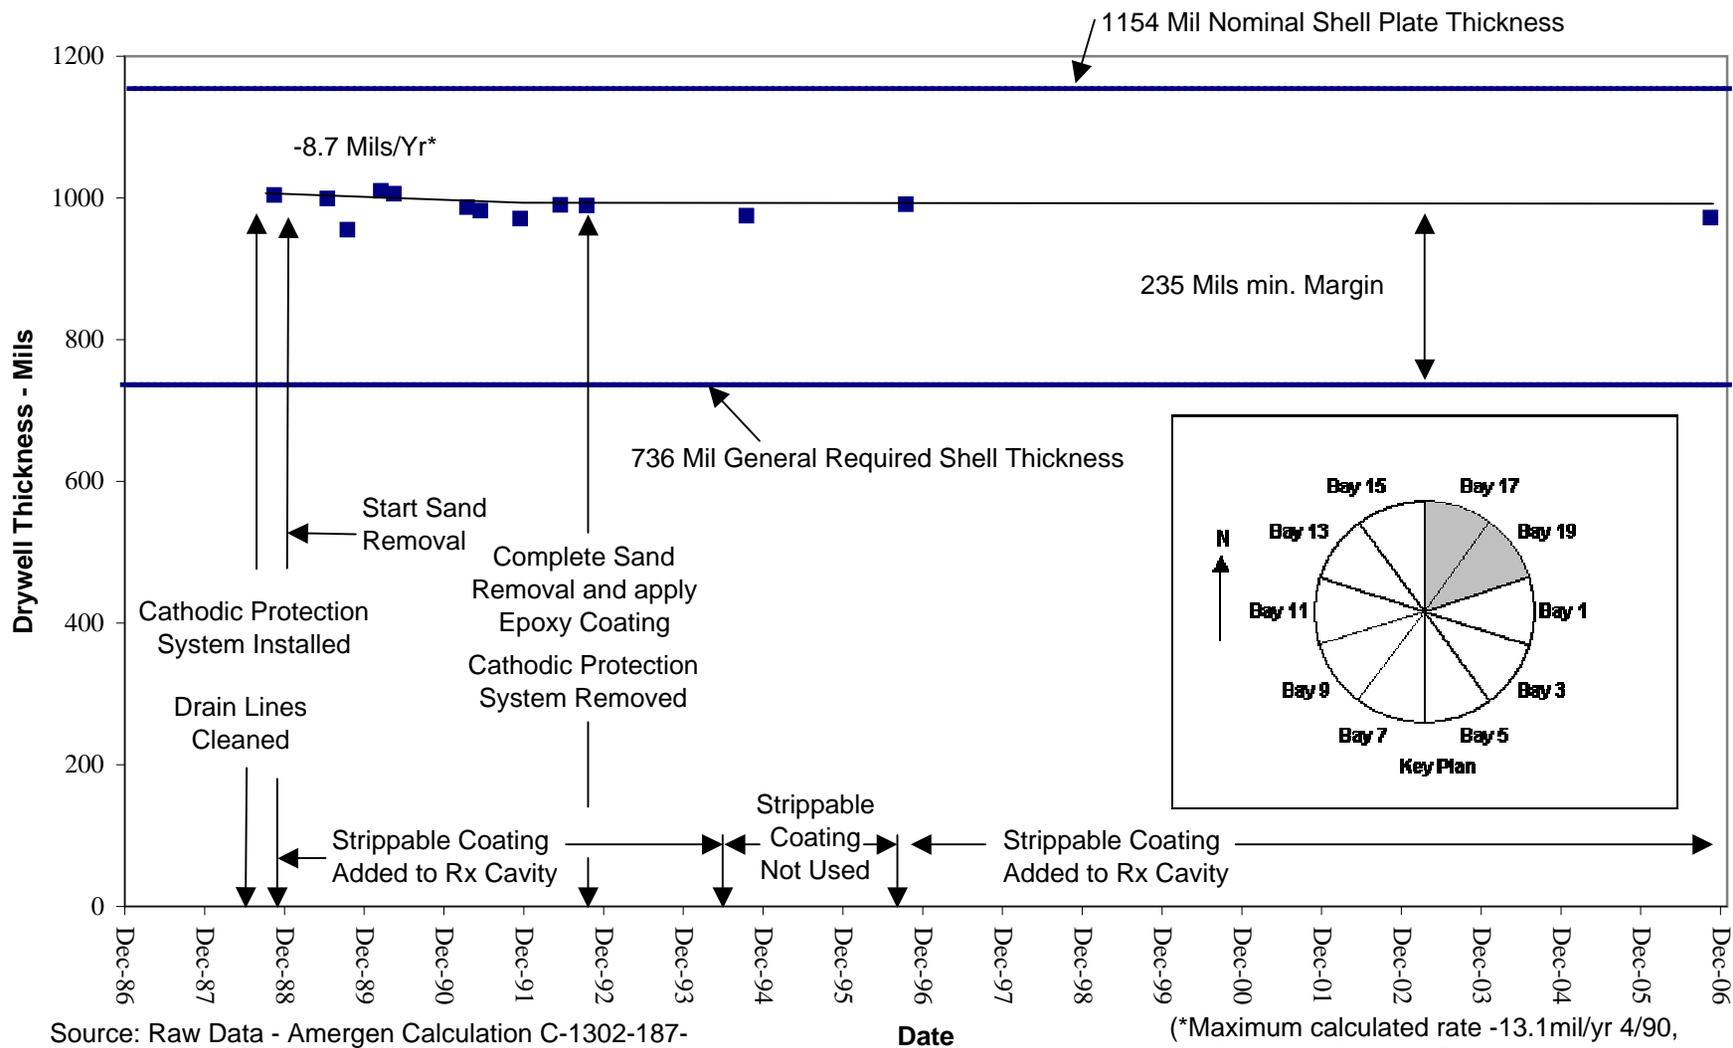
Figure 20. Sandbed Bays # 17/19 Frame Bottom

(*Maximum calculated rate -13.1mil/yr 4/90, C-1302-187-5300-011 Rev. 0)

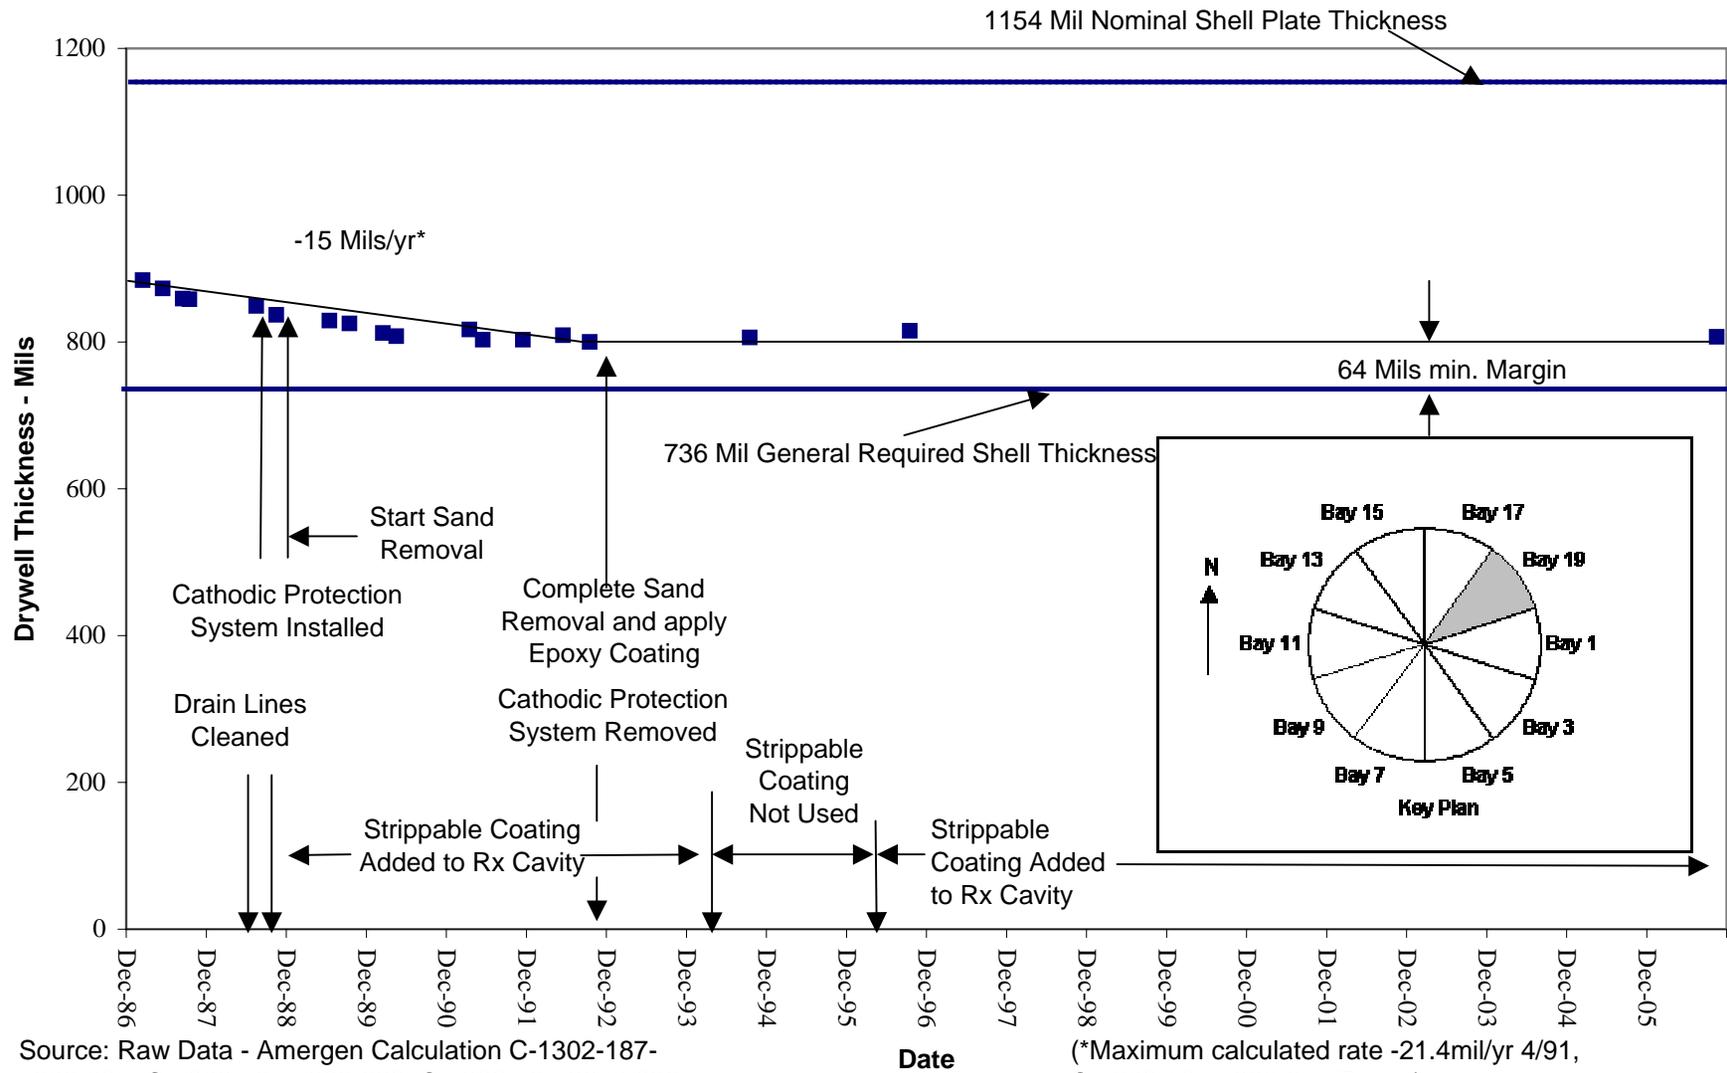
Figure 21 Sandbed Bay # 19A

(*Maximum calculated rate -21.4mil/yr 4/91, C-1302-187-5300-011 Rev. 1)

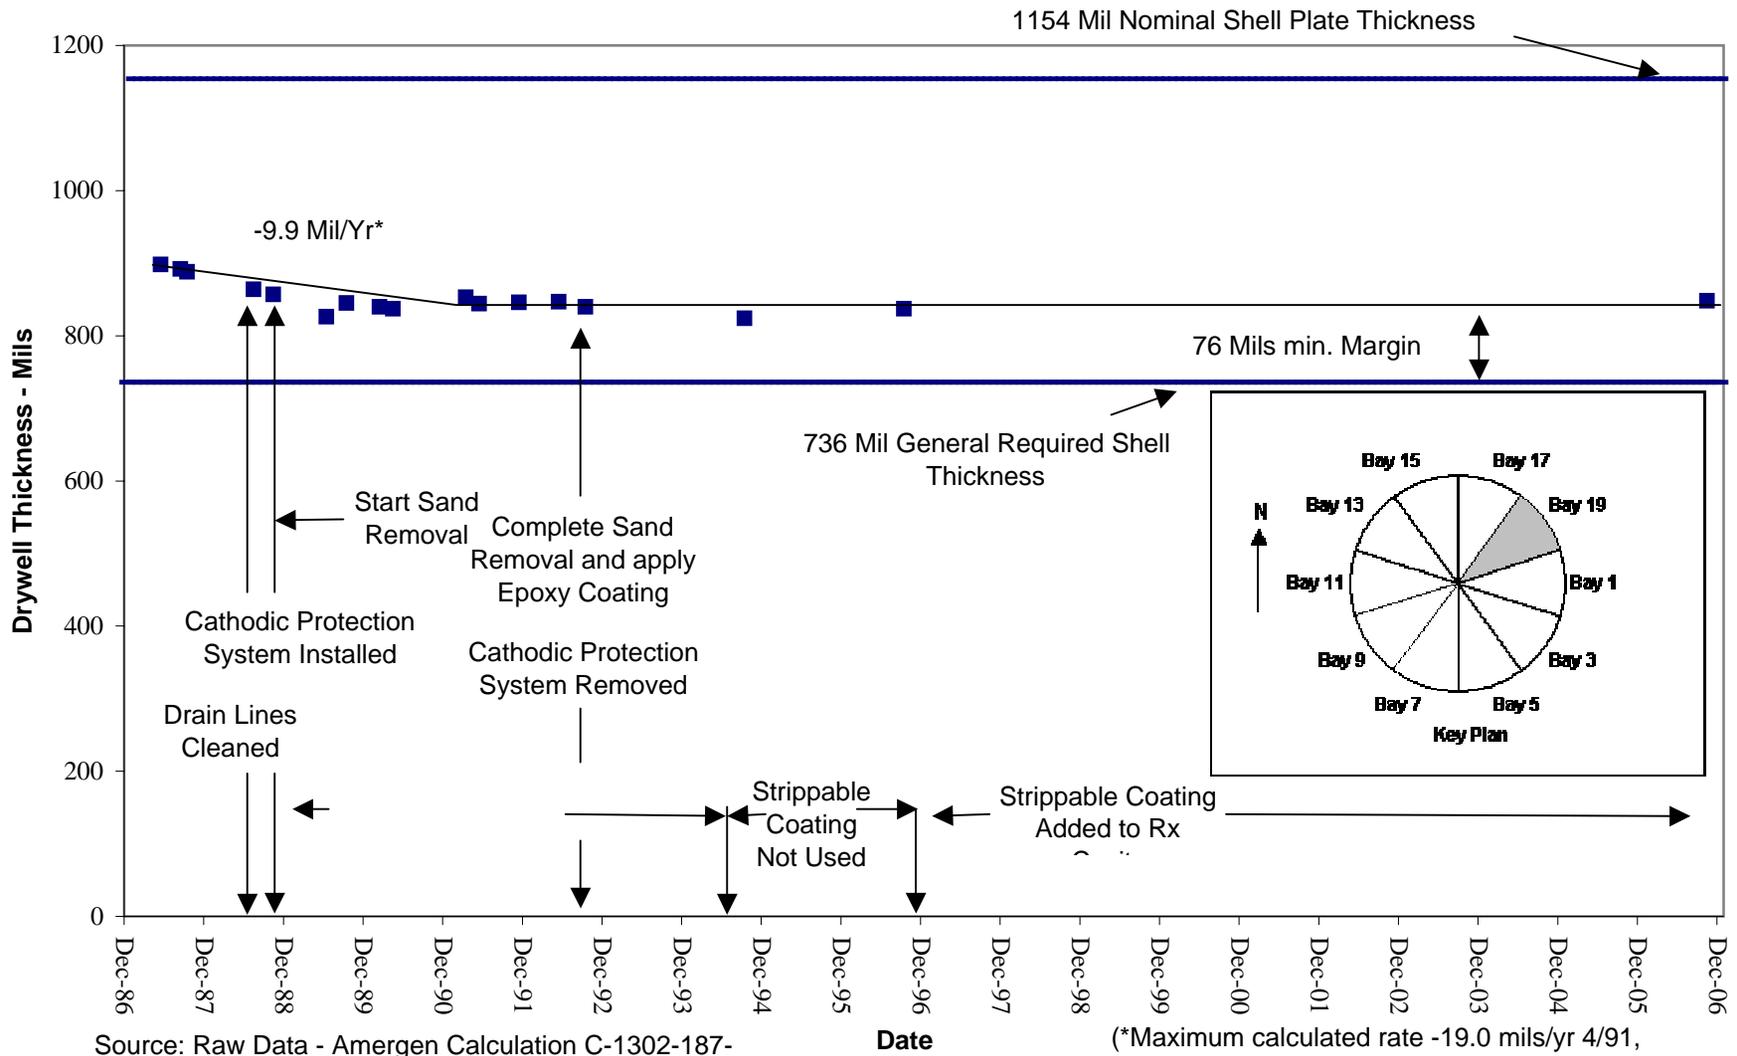
Figure 22. Sandbed Bay #19 B

(*Maximum calculated rate -19.0 mils/yr 4/91, C-1302-187-5300-011 Rev. 1)

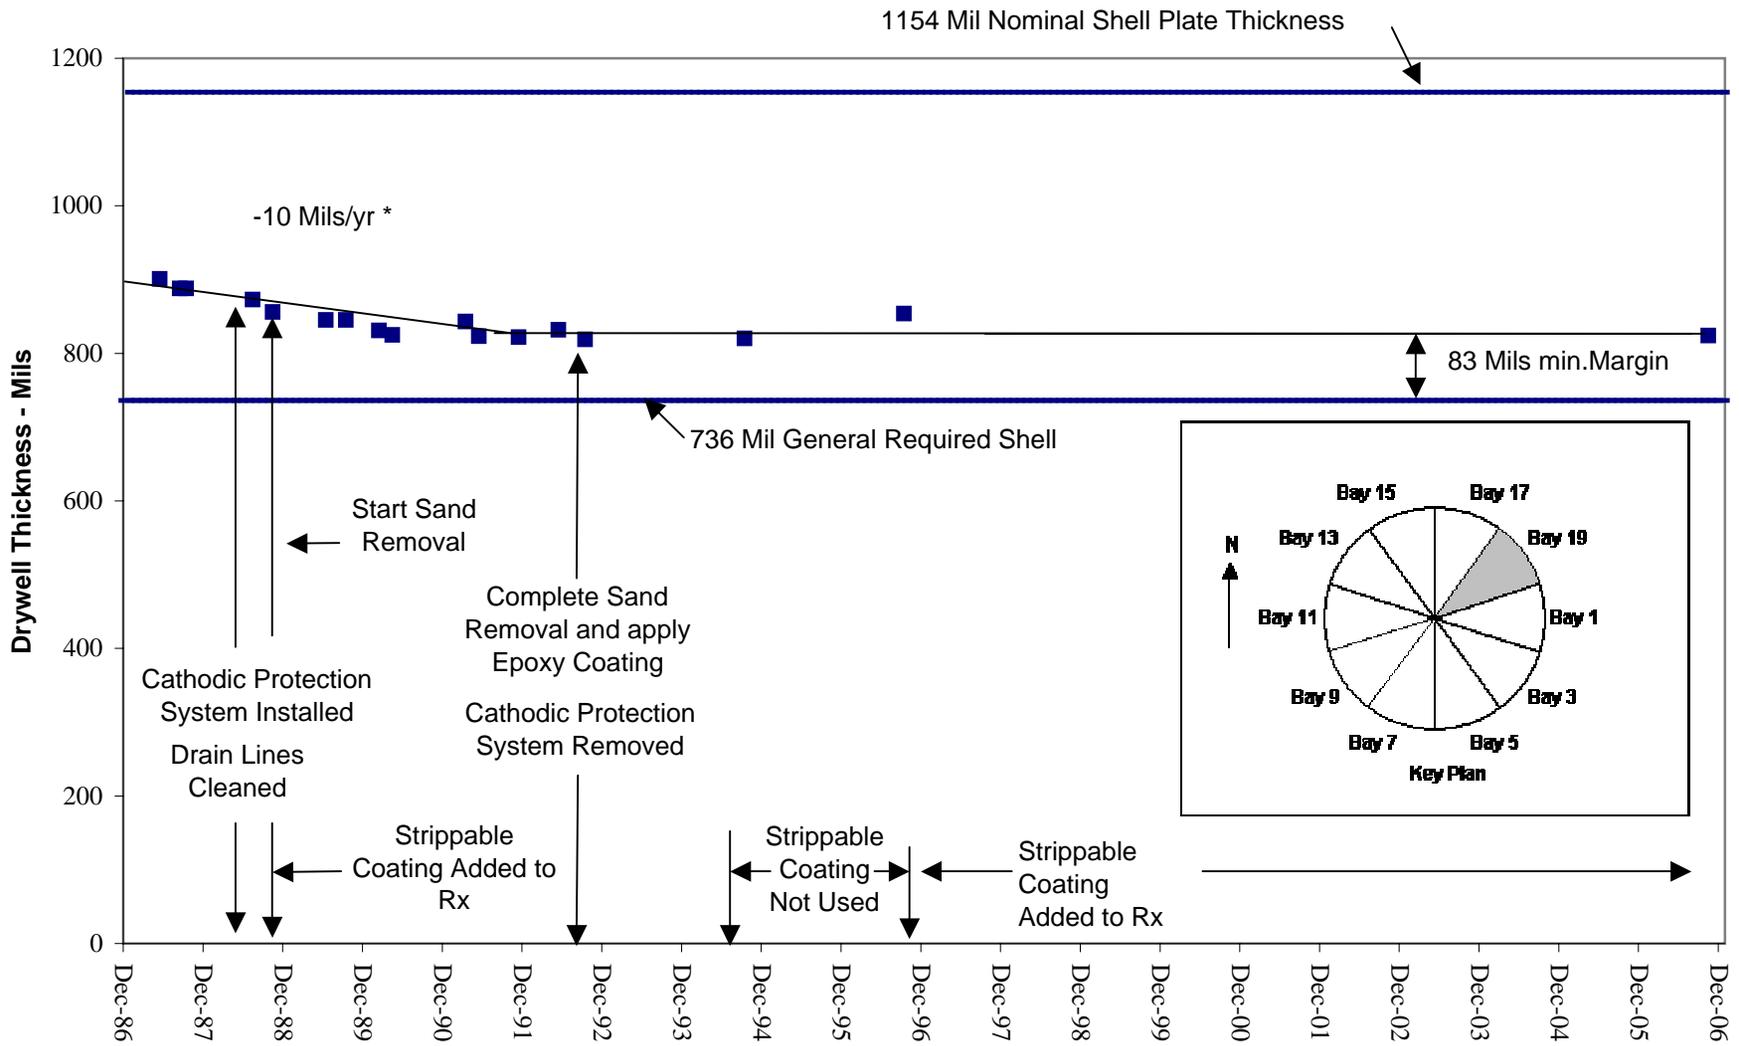
Figure 23. Sandbed Bay # 19C

Date (*Maximum calculated rate -24.3mils/yr 4/91, C-1302-187-5300-011 Rev.1)
