Natural Disasters and Safety Risks at Nuclear Power Stations
November 2004 by Paul Gunter

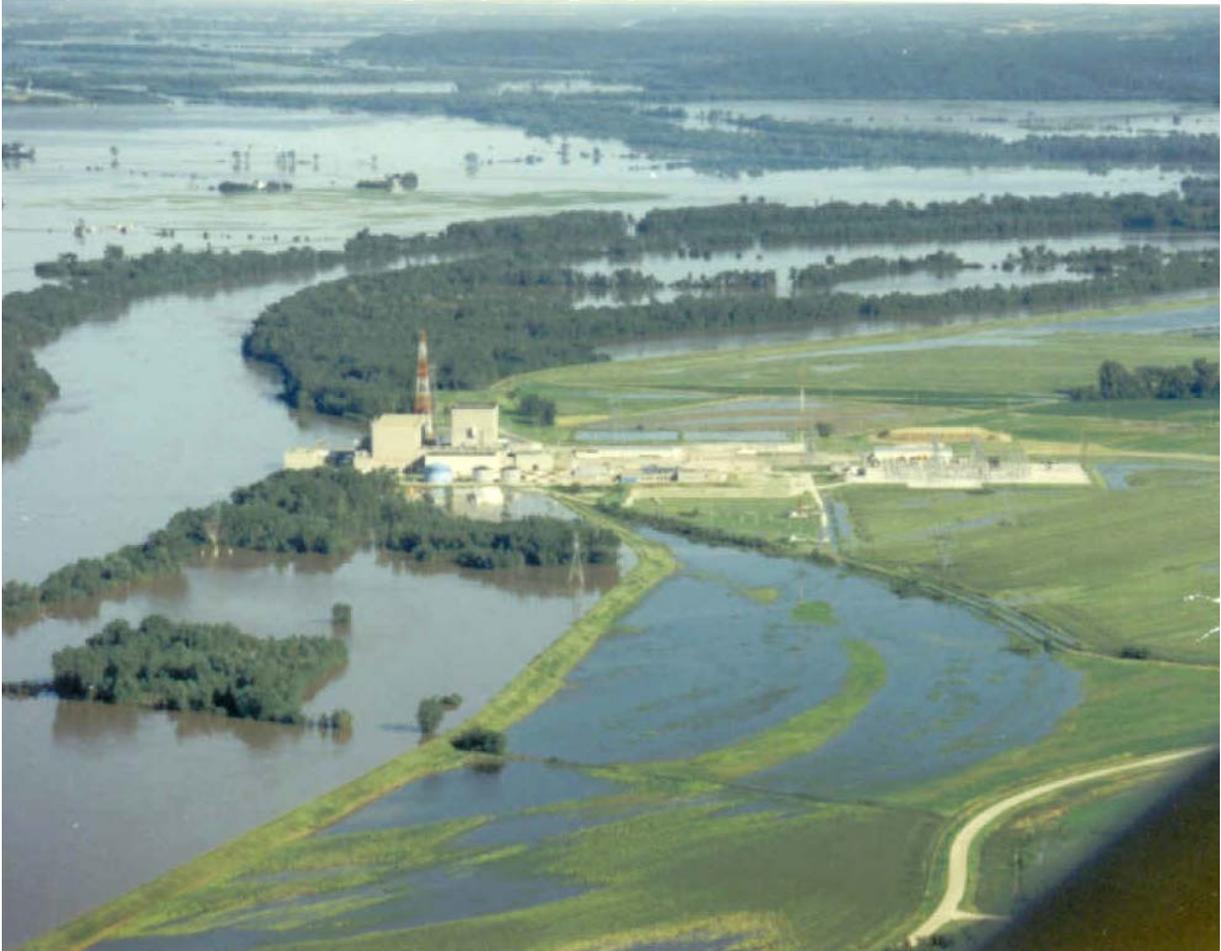
In mid-July 1993, the operator of the Cooper nuclear power station, built on a 100-year flood plain, encountered rapidly rising flood waters on the Missouri River near Brownville, Nebraska and was forced to shutdown the reactor as dikes and levees collapsed around the site closing many emergency escape routes in the region.

Global warming inundation? In fact, this photo shows the 1993 flood on the Missouri River as it recedes from Nebraska's Cooper nuclear power station.

Throughout the event the Nuclear Regulatory Commission (NRC) and station operators assured the public that the nuke was safely under control. On July 26th, the U.S. Army Corp of Engineers reported that Federal Levee 550 located upstream of the station collapsed acting “like a pressure valve for Cooper nuclear power plant.” An NRC Information Notice subsequently issued nearly a year later (NRC IN-94-27) indicated that below grade rooms in the reactor and turbine buildings had extensive leakage with rising water levels. The notice stated that “the floor drain system had backed up so that standing water from within areas known to be radiologically contaminated had migrated out into designated clean areas.”¹ The NRC inspectors noted that plant personnel “had not established measures to divert the water away from important components.” For example, water levels rising inside the reactor building impinged on electrical cables and equipment such as the Reactor Core Isolation Cooling (RCIC) pump room causing the circuitry to ground out. “This event demonstrates that flooding problems and degradation of equipment may be caused by water inleakage even though flood waters are not above grade elevations,” the information notice indicated. The RCIC system is critical to plant safety in the event of loss of offsite power and a condition known as “Station Blackout.”

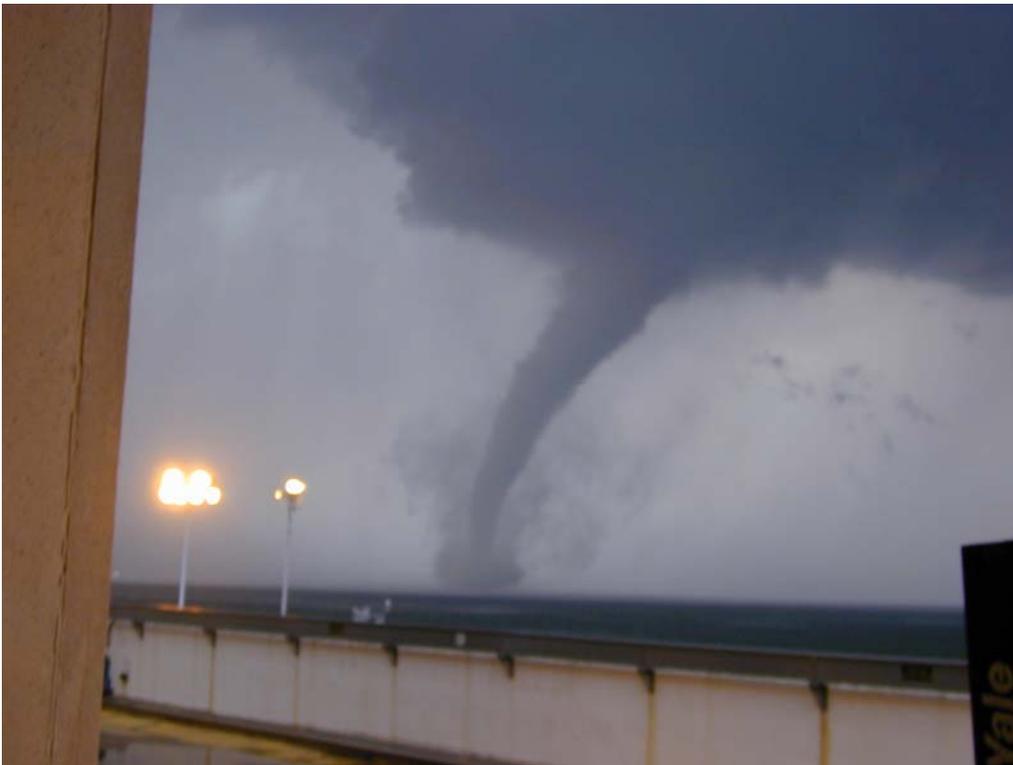
The tornado that leveled the town of La Plata, Maryland on April 27, 2002 is shown passing within one mile of the Calvert Cliffs nuclear generating station located on the shores of the Chesapeake Bay in Lusby, Maryland.

On April 27, 2002 the Calvert Cliffs nuclear power station on Maryland’s Chesapeake Bay was narrowly missed by a “severe” tornado with 260 mph winds. Originally rated as an F5 tornado (261-318 mph winds) the storm was later downgraded to an F4. According to NRC documents the F4 and F5 rated tornadoes can produce winds and tornado missiles which can badly damage steel reinforced concrete structures.² It was assumed that an F2 to F5 rated tornado could also significantly damage support systems for onsite irradiated fuel storage ponds such as the offsite power supply, emergency onsite power supplies, cooling pumps and make-up water supply. The low frequency of such violent storms is used to minimize the perception of the radiological risk to public health by making a tornado strike at a nuclear facility an extremely remote possibility.
