# **Flawed Reactor Pressure Vessels in Belgian Nuclear Plants Doel-3 and Tihange-2**

## ***Some Comments***

Ilse Tweer

January 2013

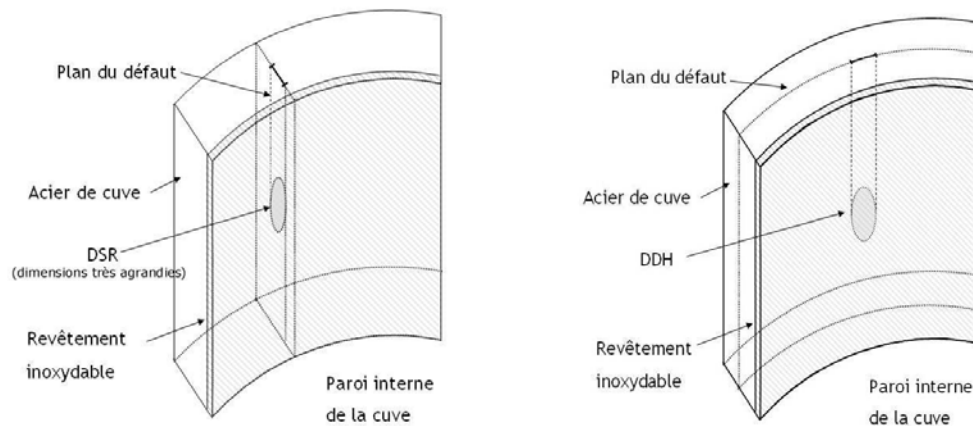
Figures 2a and 2b: Underclad cracks (a) and hydrogen-induced flaws (b)

While underclad cracks are directly under the stainless steel cladding oriented normal to the inside surface of the RPV wall, the observed flaws are parallel to the wall surface (see the following figures<sup>9</sup>; DSR<sup>10</sup> are underclad cracks, DDH<sup>11</sup> the hydrogen-induced flaws).
