Oyster Creek License Renewal Presentation to ACRS Subcommittee

January 18, 2007

Drywell Shell Corrosion Cause and Corrective Actions

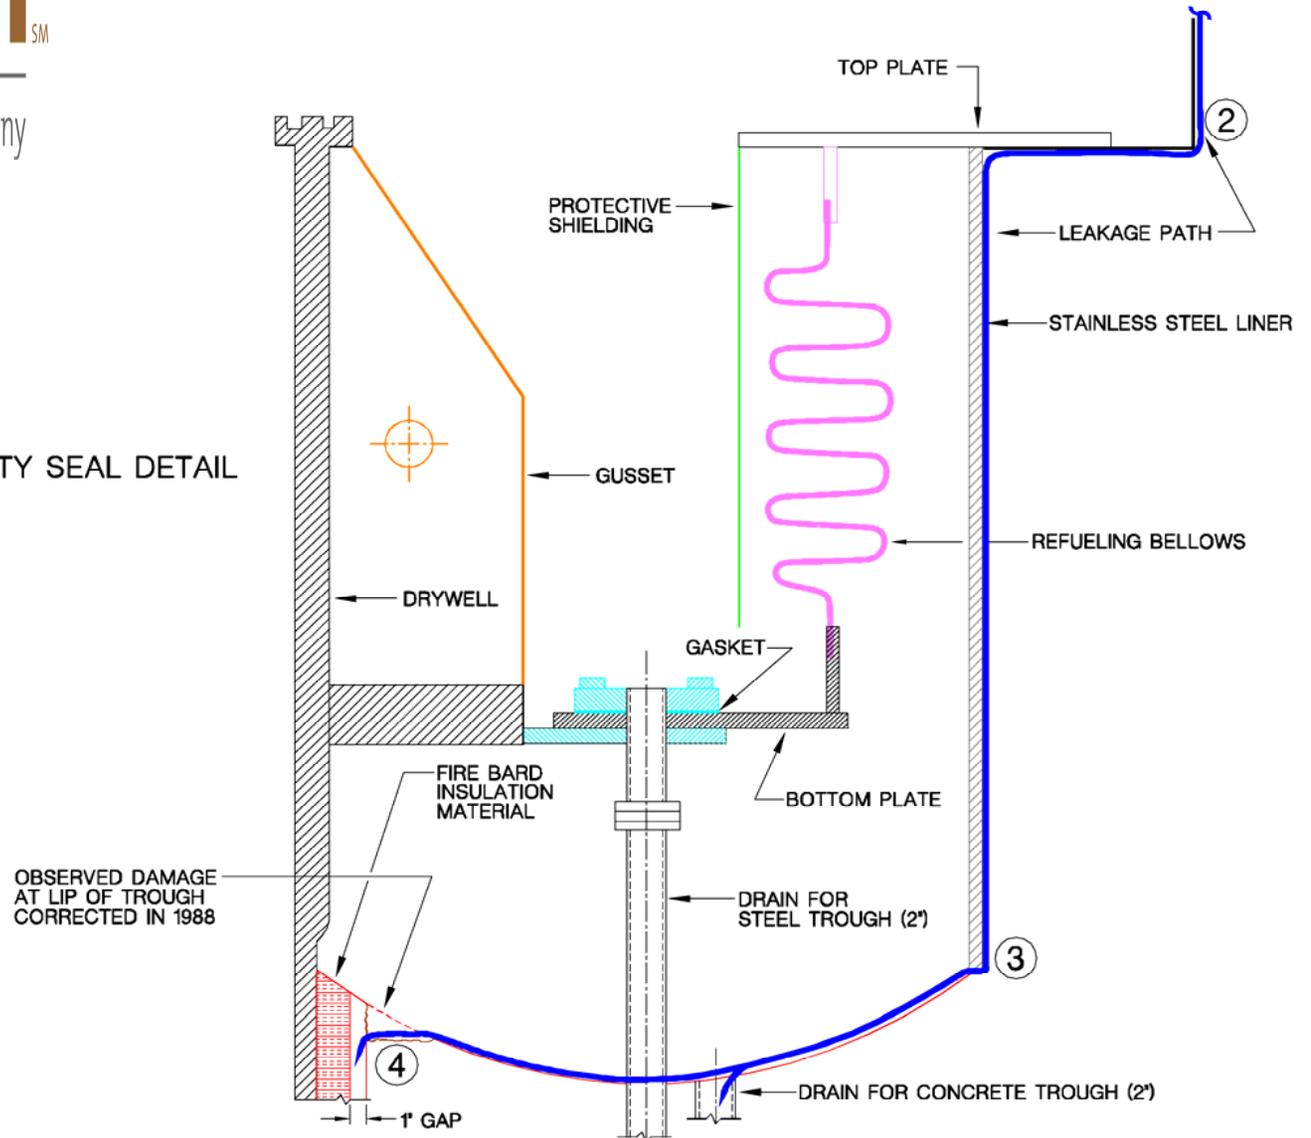
LOWER DRYWELL/SANDBED REGION DETAIL C

- Water accumulation in the sand bed region resulted in corrosion of the exterior surface of the drywell shell
- Corrective actions were completed in 1992
 - Prevented water intrusion into the sand bed region
 - Eliminated corrosive environment by removing the sand
 - Coated the drywell shell with epoxy in the sand bed region

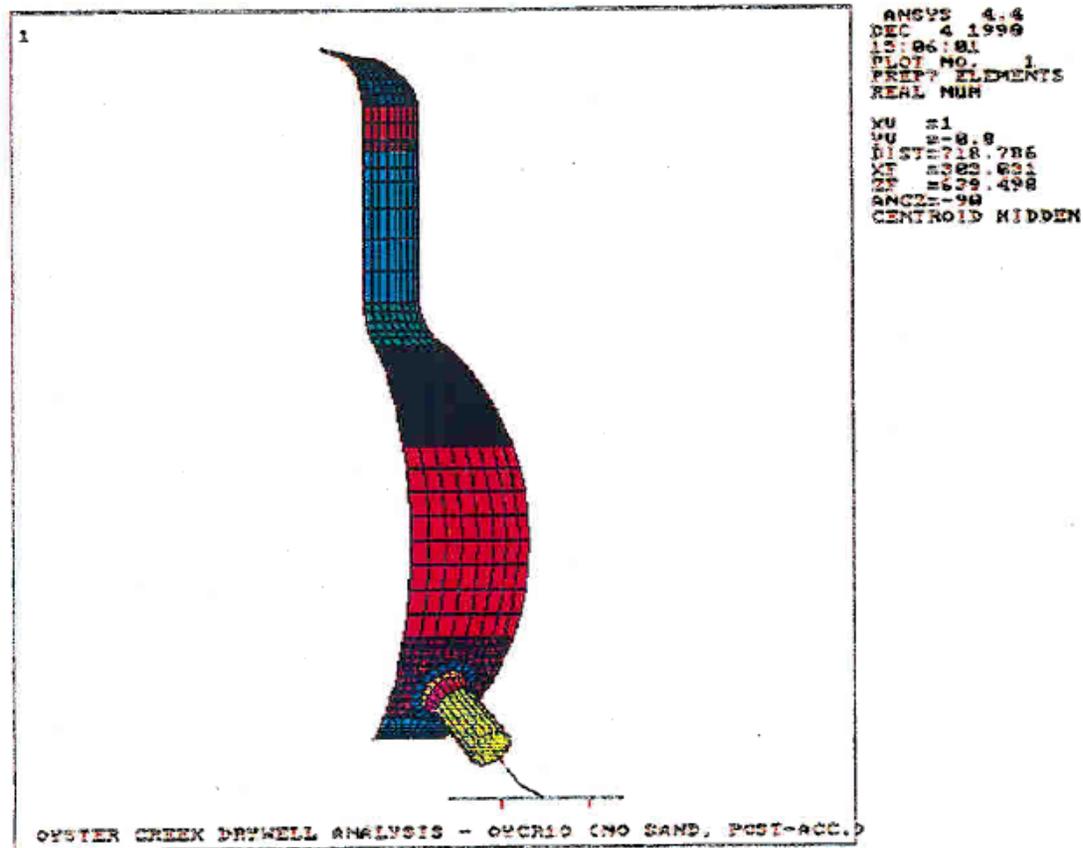
Pie Slice model

- Taking advantage of symmetry of the drywell with 10 vent lines, a 36 degree section was modeled
 - The model included the drywell shell from base of the sand bed region to the top of the elliptical head and the vent and vent header
 - Drywell shell thickness in the sand bed region: 736 mils uniform

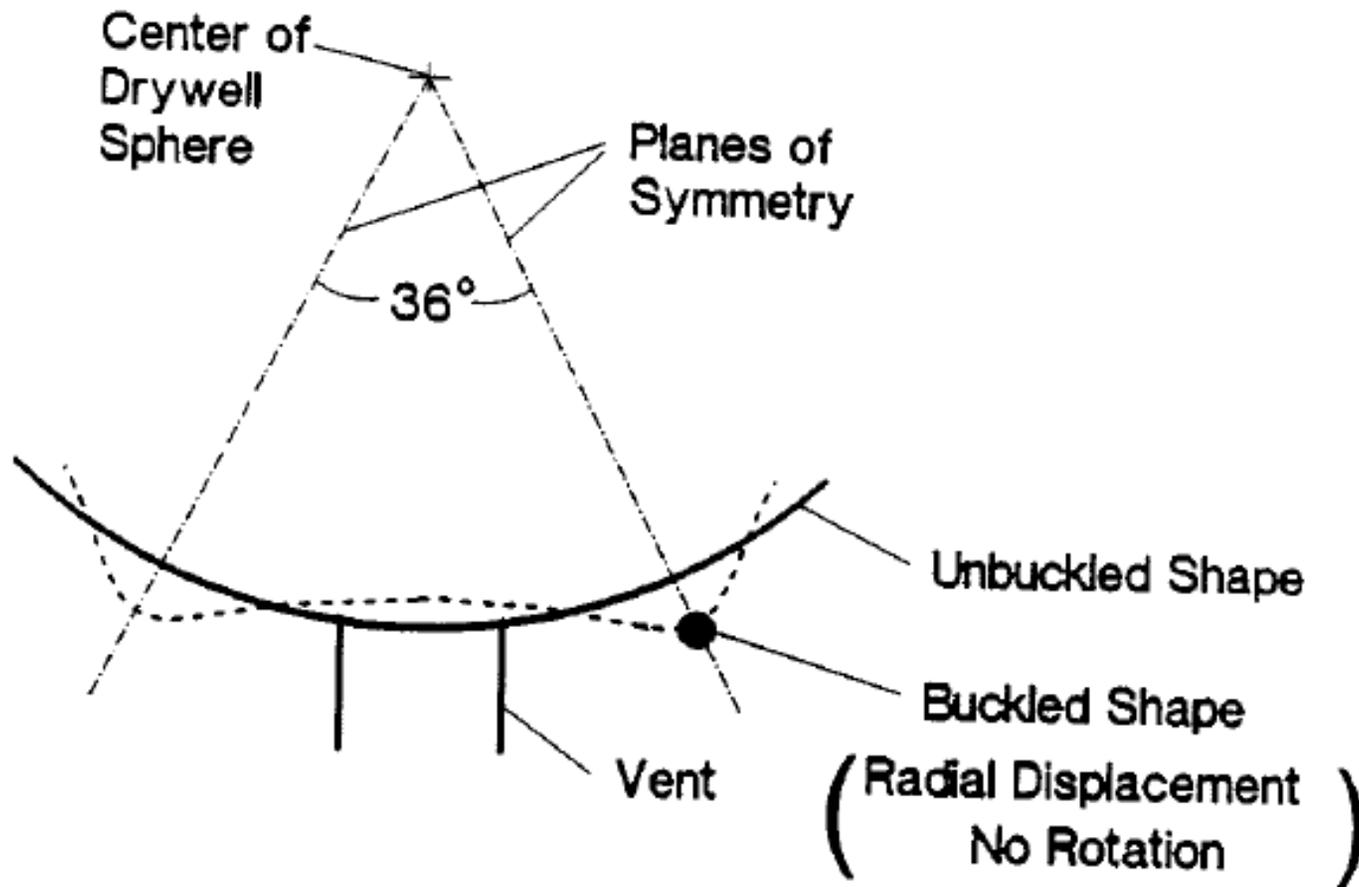
Symmetric Buckling of Drywell

- FS is factor of safety (equal to 2.0 for refueling condition and 1.67 for post accident condition)
- Boundary conditions for buckling analysis
 - Symmetric at both edges (sym-sym)
 - Symmetric at one edge and asymmetric at the other edge (sym-asym)
 - Asymmetric at both the edges (asym-asym)
 - This captures all possible buckling mode shapes
- A uniform drywell shell thickness in the sand bed region of 736 mils was used in the buckling analysis

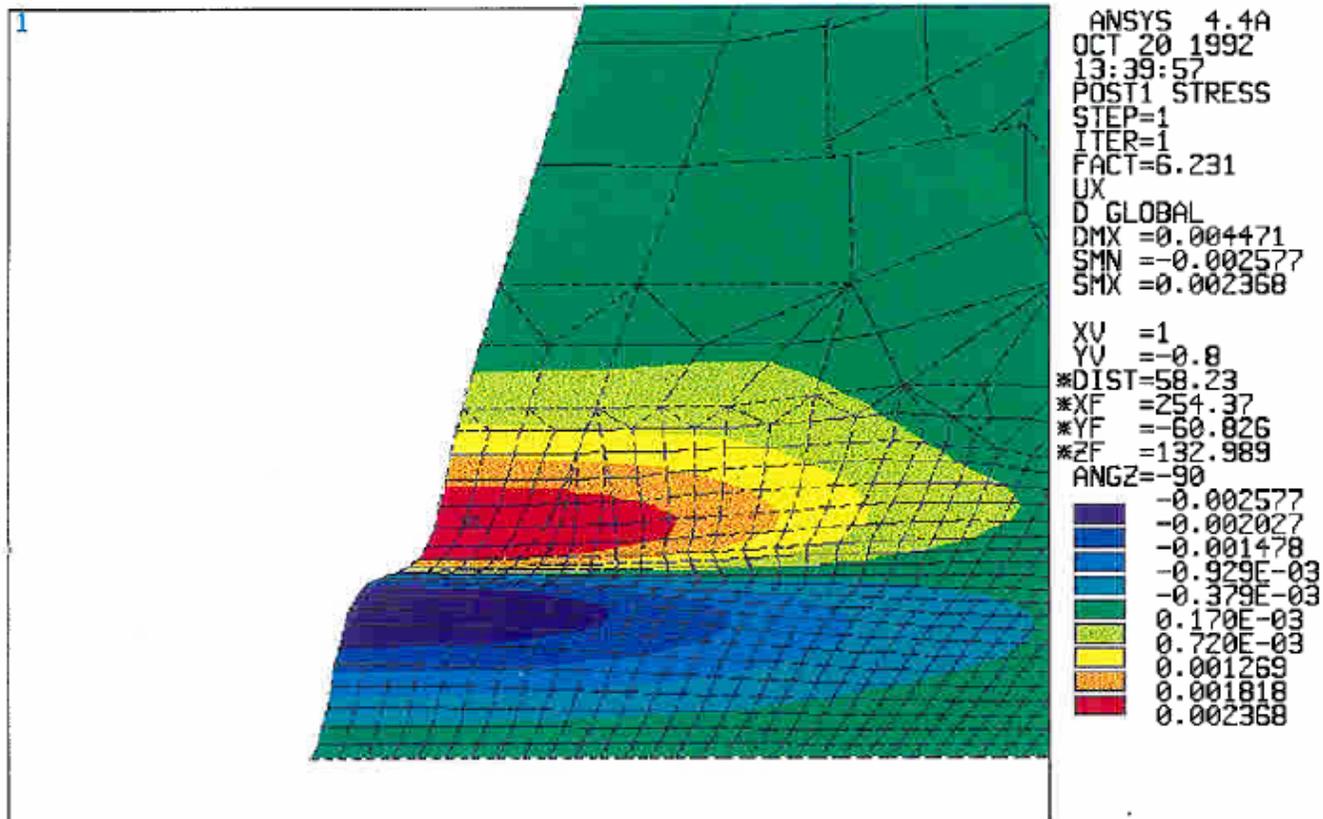
Figure 3-19 Sym-Asym Buckling Mode Shape - Refueling Case

- Limiting load combination is the refueling condition
- Loads during refueling condition are
 - Gravity loads including weight of refueling water
 - External pressure of 2 psig
 - Seismic inertia and deflection loads for unflooded condition

OYSTER CREEK DRYWELL - ASYM - SYM , NO SAND, REFUELING

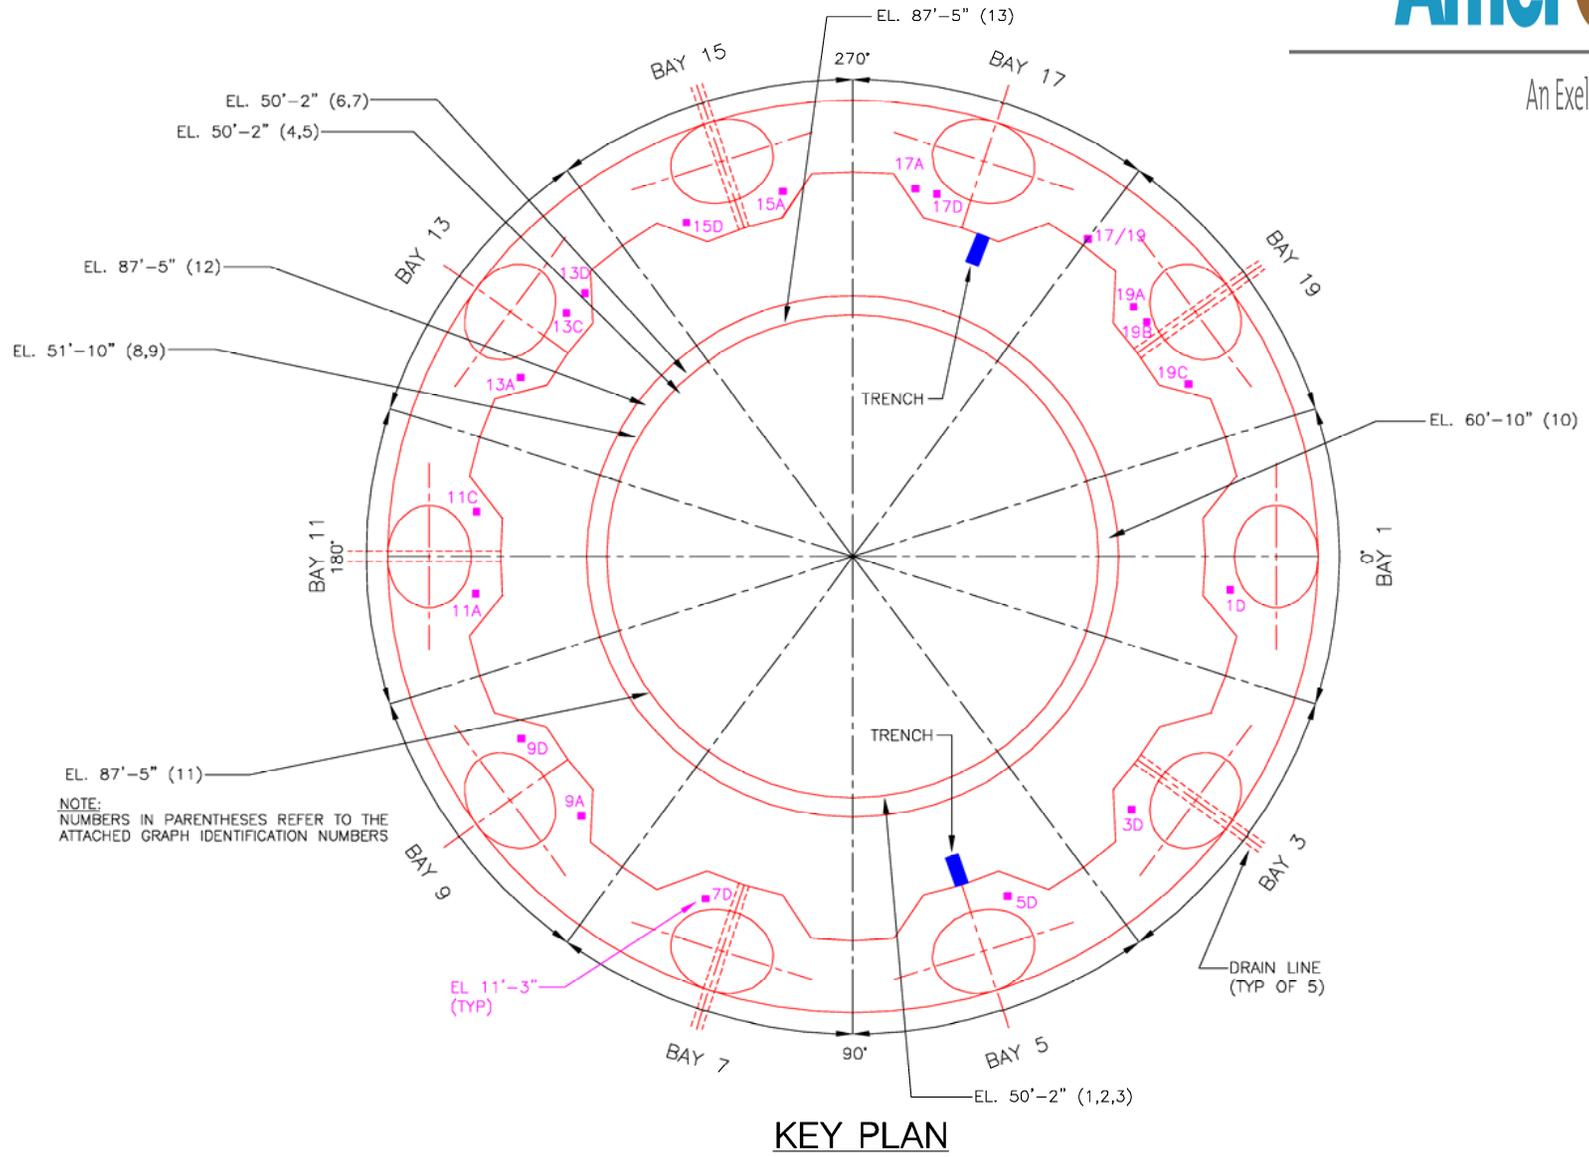
VIEW FROM INSIDE DRYWELL

- 1983 to 1986 corrosion data 360° at elev. 11'3"
 - When thin locations were identified, UT measurements were taken horizontally and vertically to locate the thinnest locations
 - UT grid measurements were taken at the thinnest locations
 - 19 locations were selected for corrosion monitoring based on over 500 initial data points measured
 - At least one grid is located in each of the 10 bays

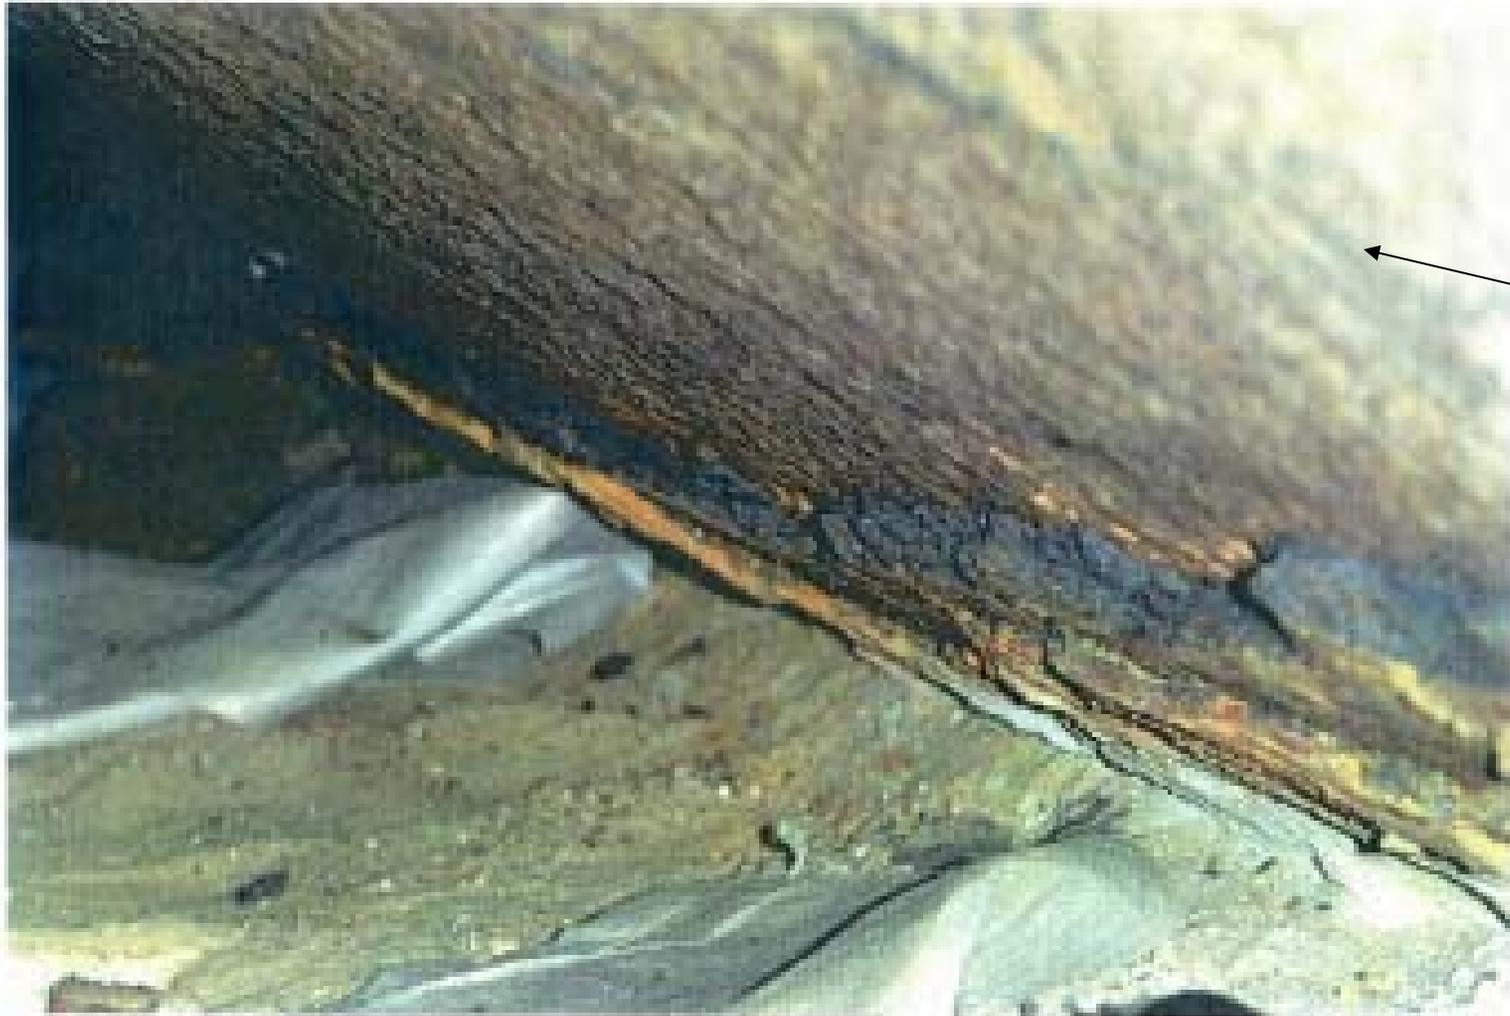
Sand Bed Region 1992

Corrosion product on drywell vessel

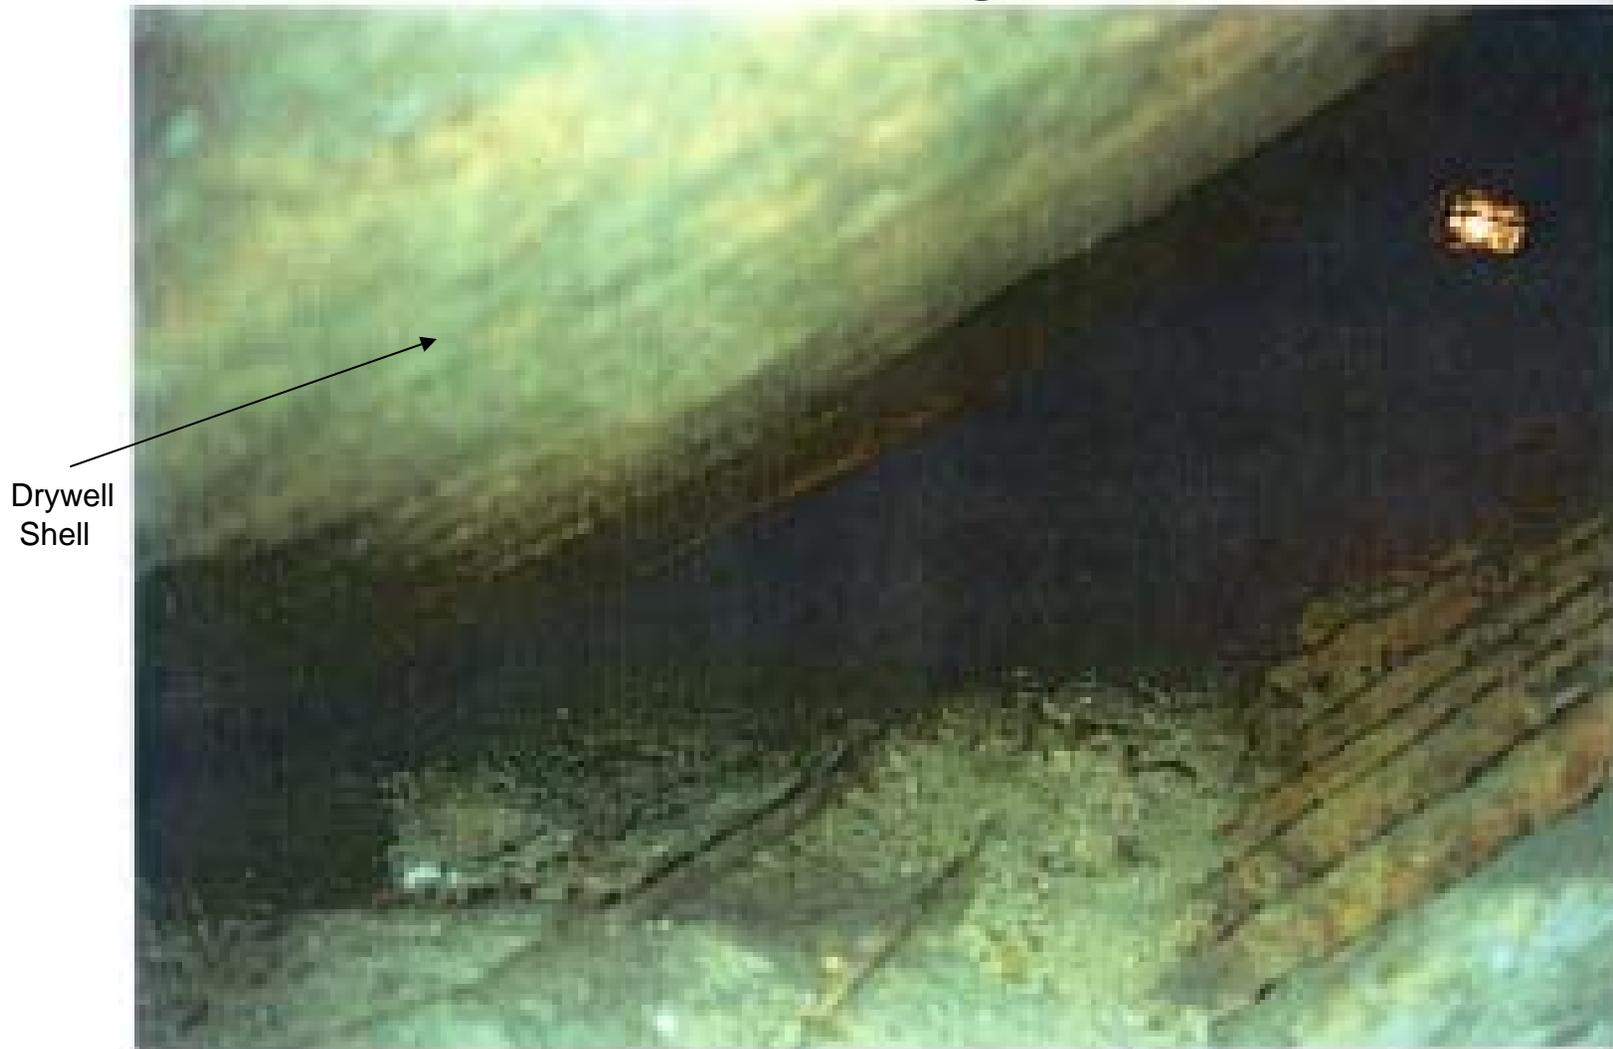
Sand Bed Region 1992

As found condition of floor bed

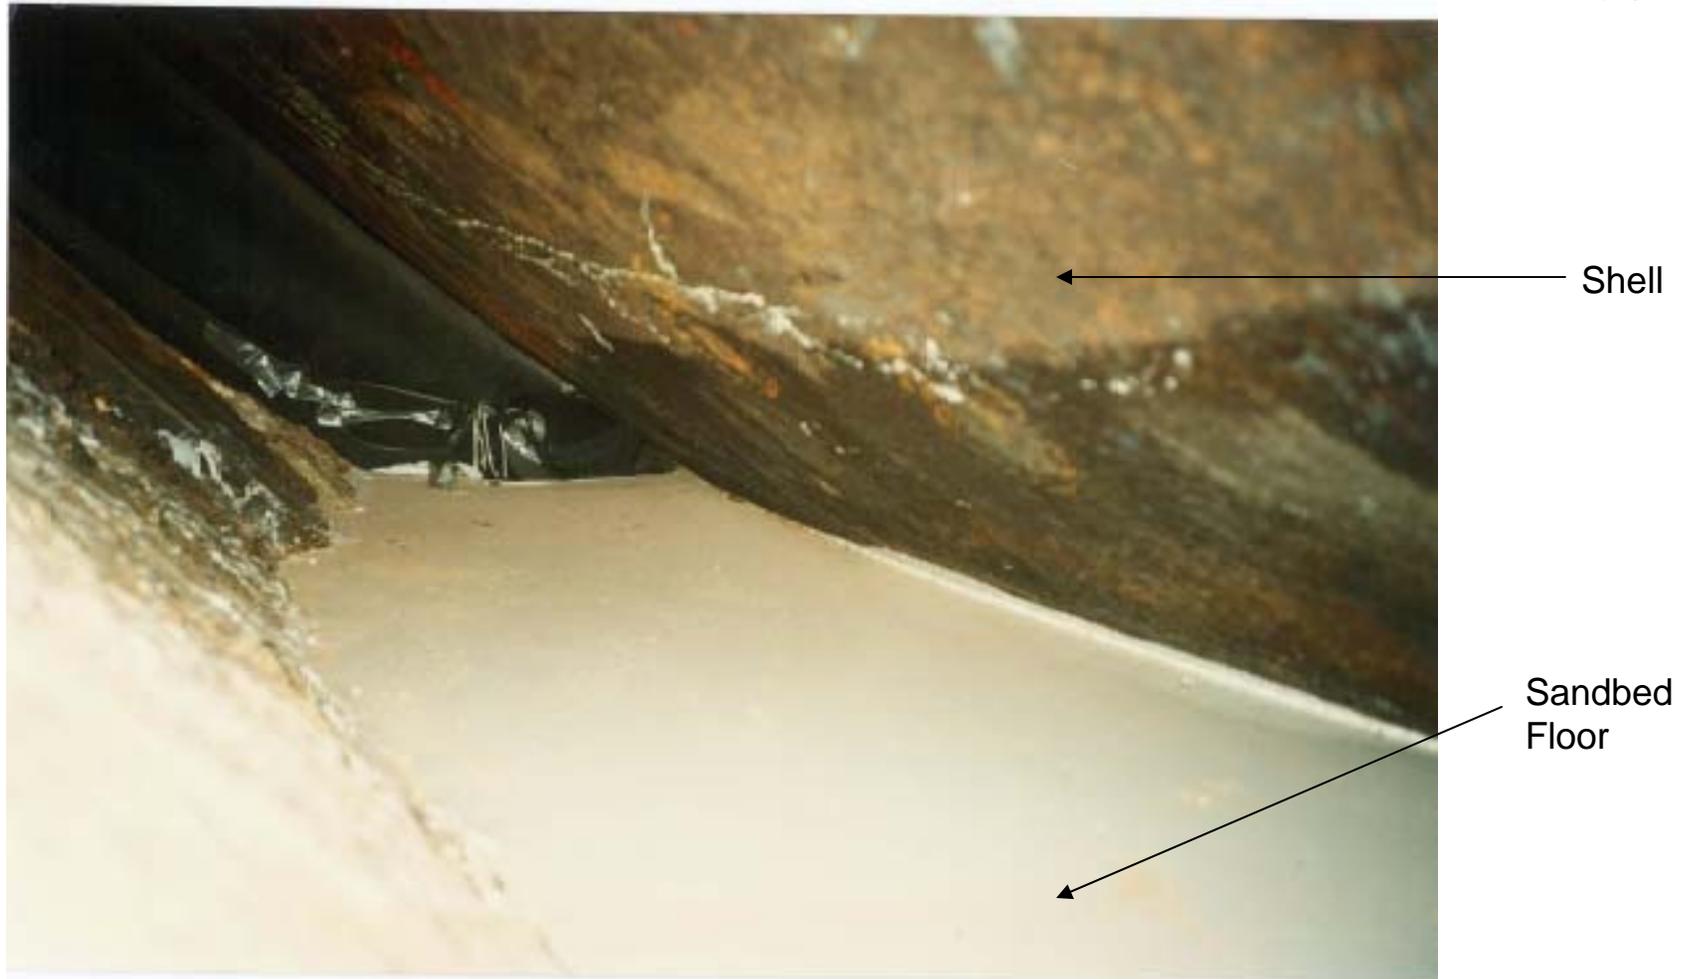
Bay 5 before shell coating

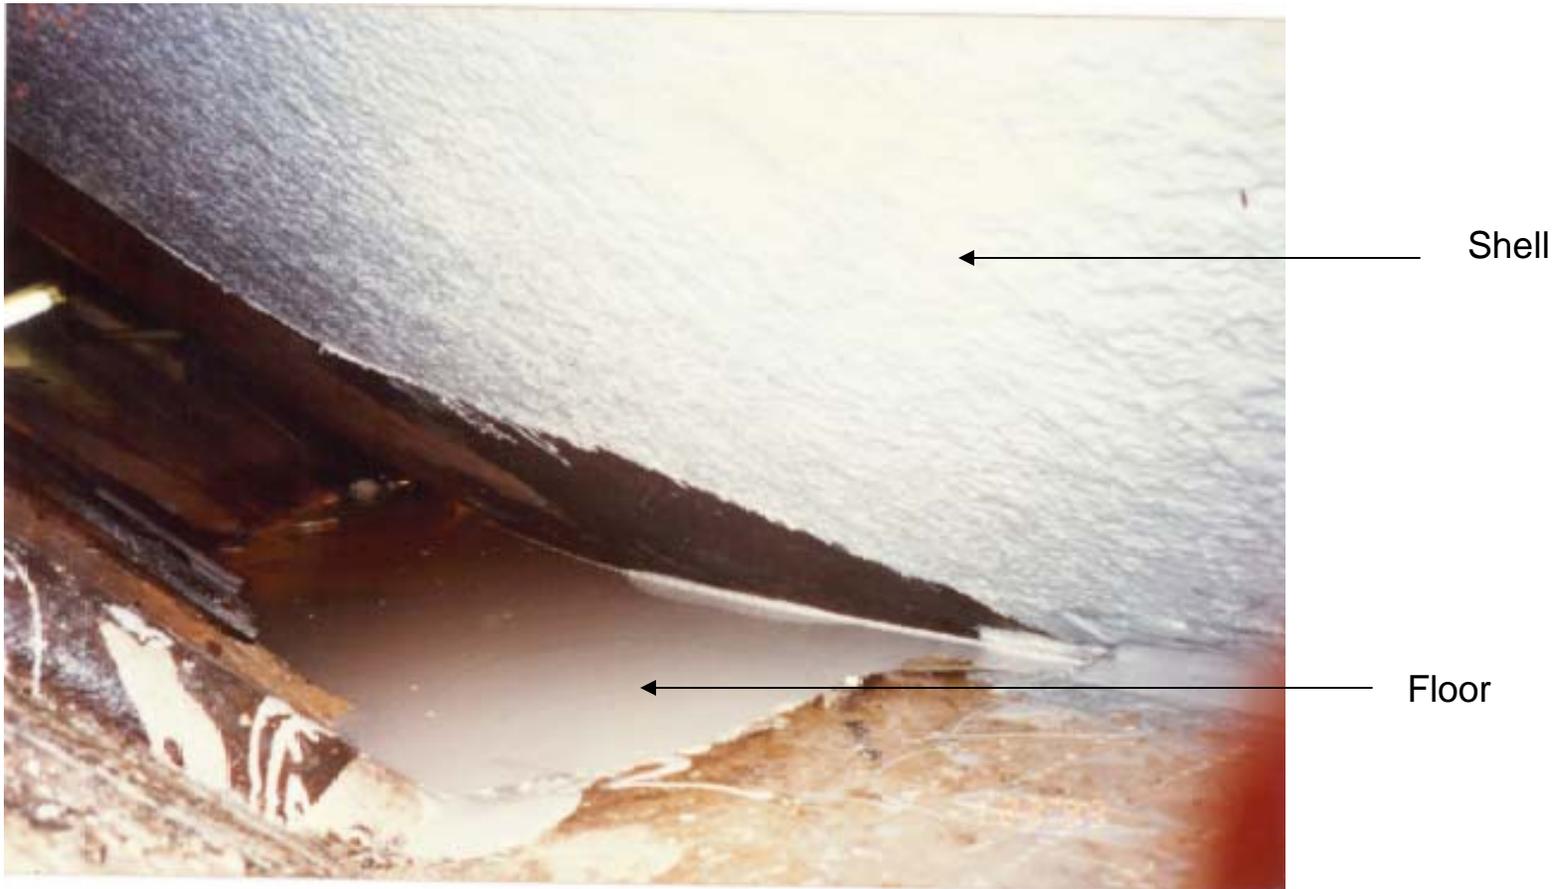
Shell and floor undergoing coating and repairs

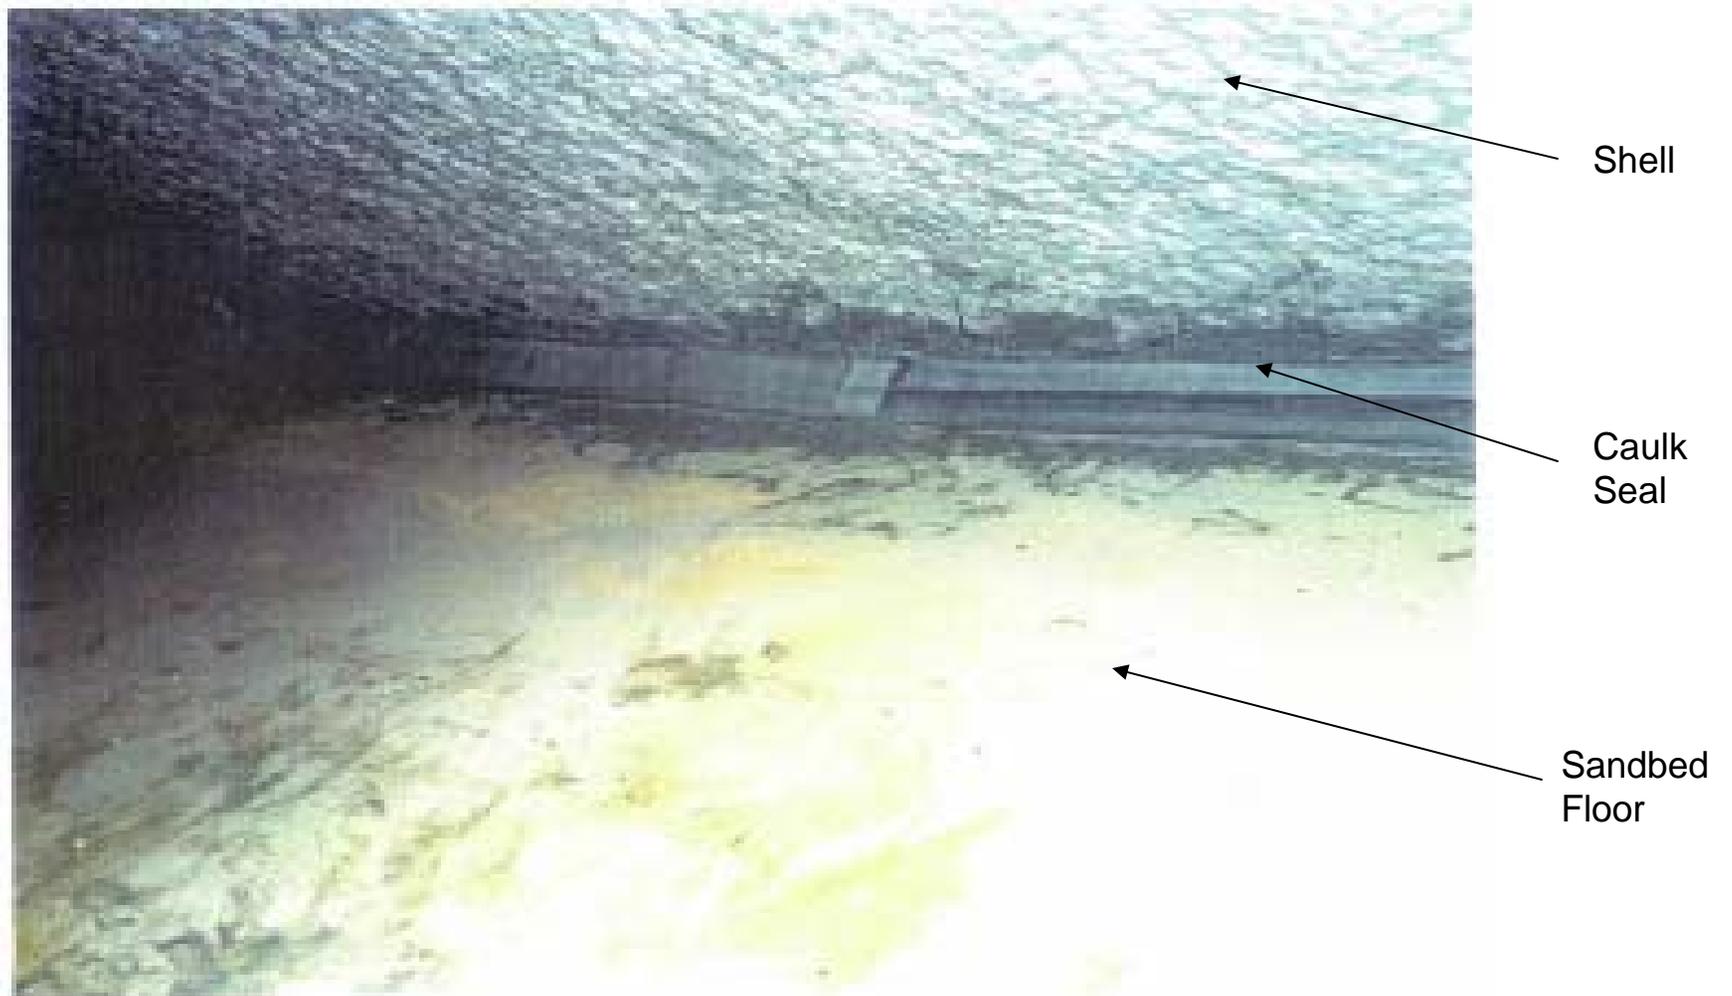
Finished floor, vessel with two top coats – caulking material applied

- DEVOE Epoxy coating system (3 part)
 - Designed for application on corroded surfaces
 - One coat DEVOE 167 Rust Penetrating Sealer
 - Penetrates rusty surfaces
 - Reinforces rusty steel substrates
 - Ensures adhesion of Devran 184 epoxy coating

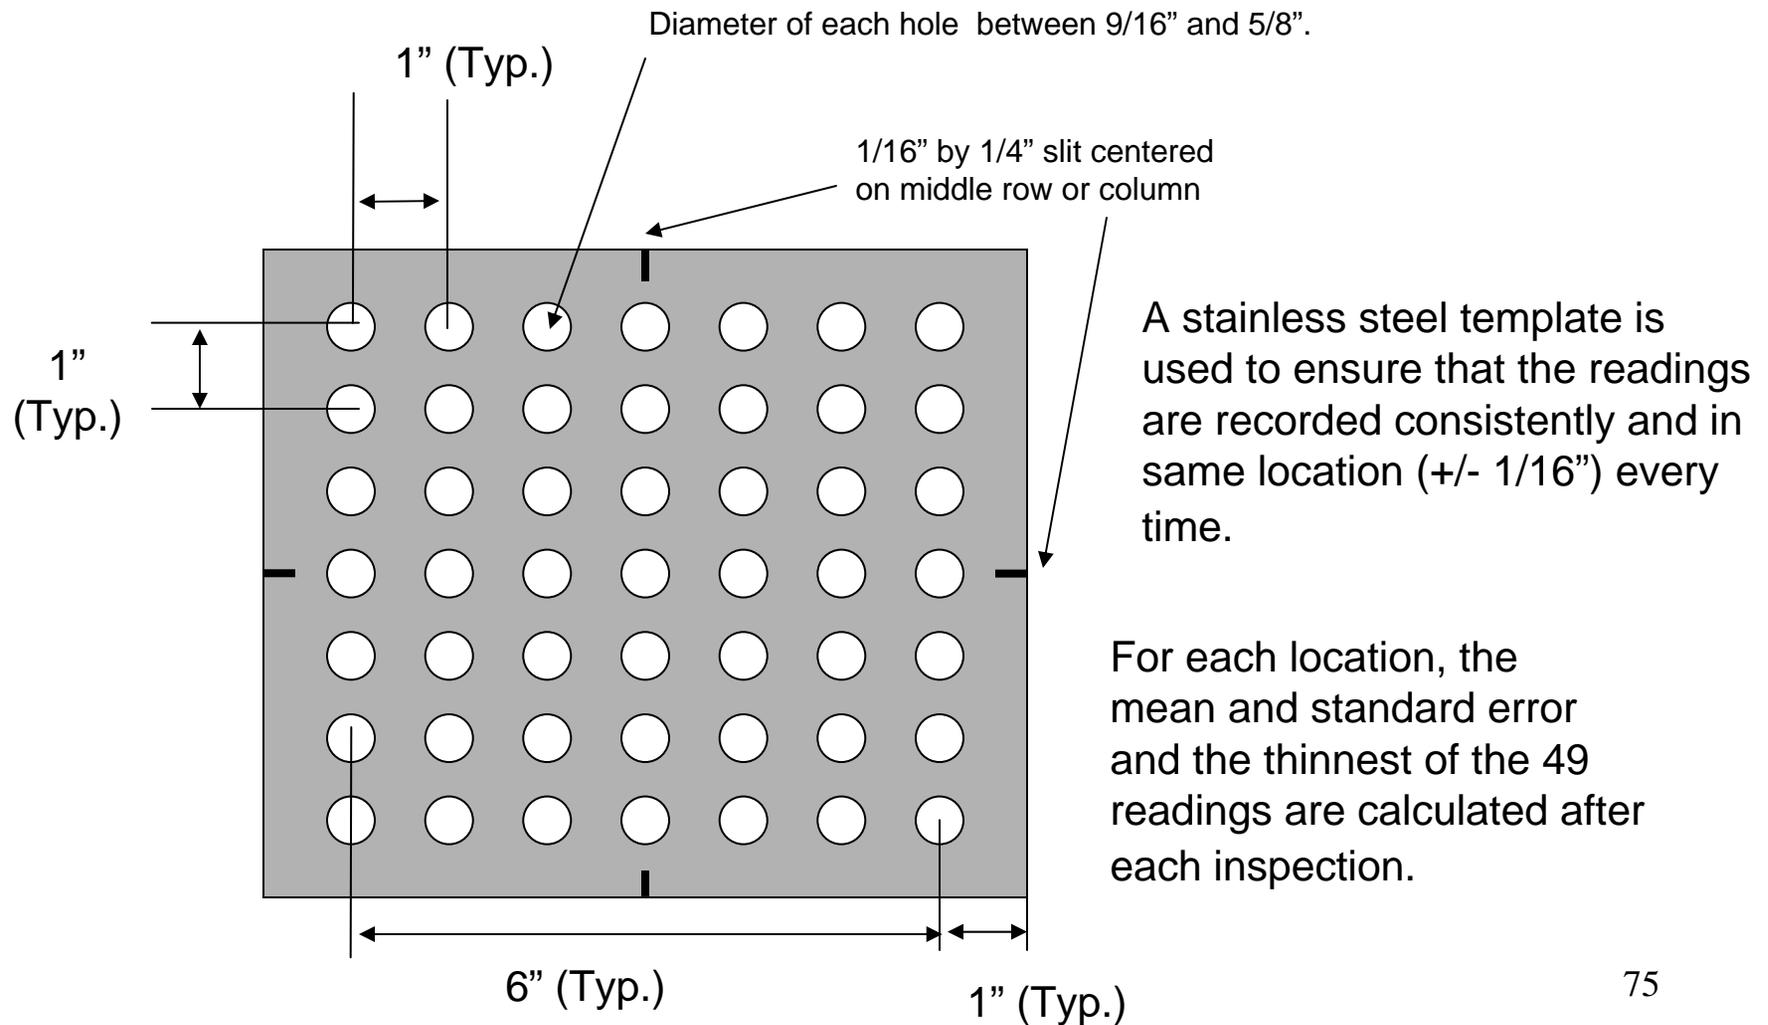
49 UT readings are recorded over a 6" by 6" area.

- Measurement locations are marked on the inside of the drywell shell
- Use a stainless steel template with 49 holes to align the UT probe
- UT probe placed perpendicular to the surface to consistently obtain lowest reading
- A protective grease is applied to the 6"x6" grid during operation, and removed to take UT measurements

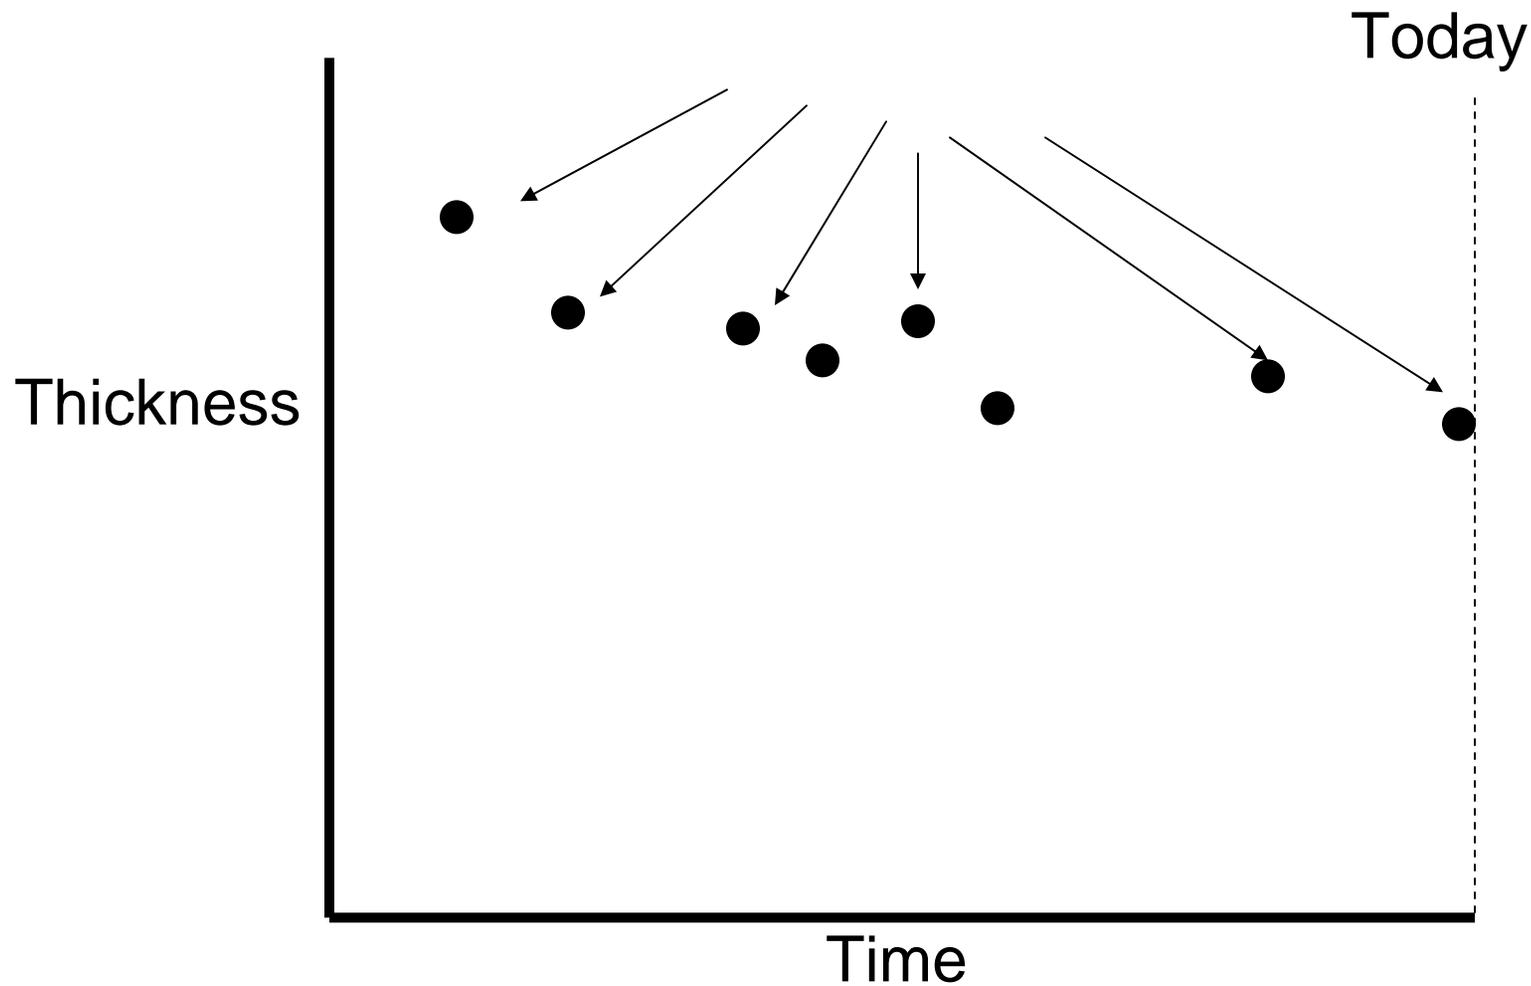
For each location the means and thinnest points are trended over time

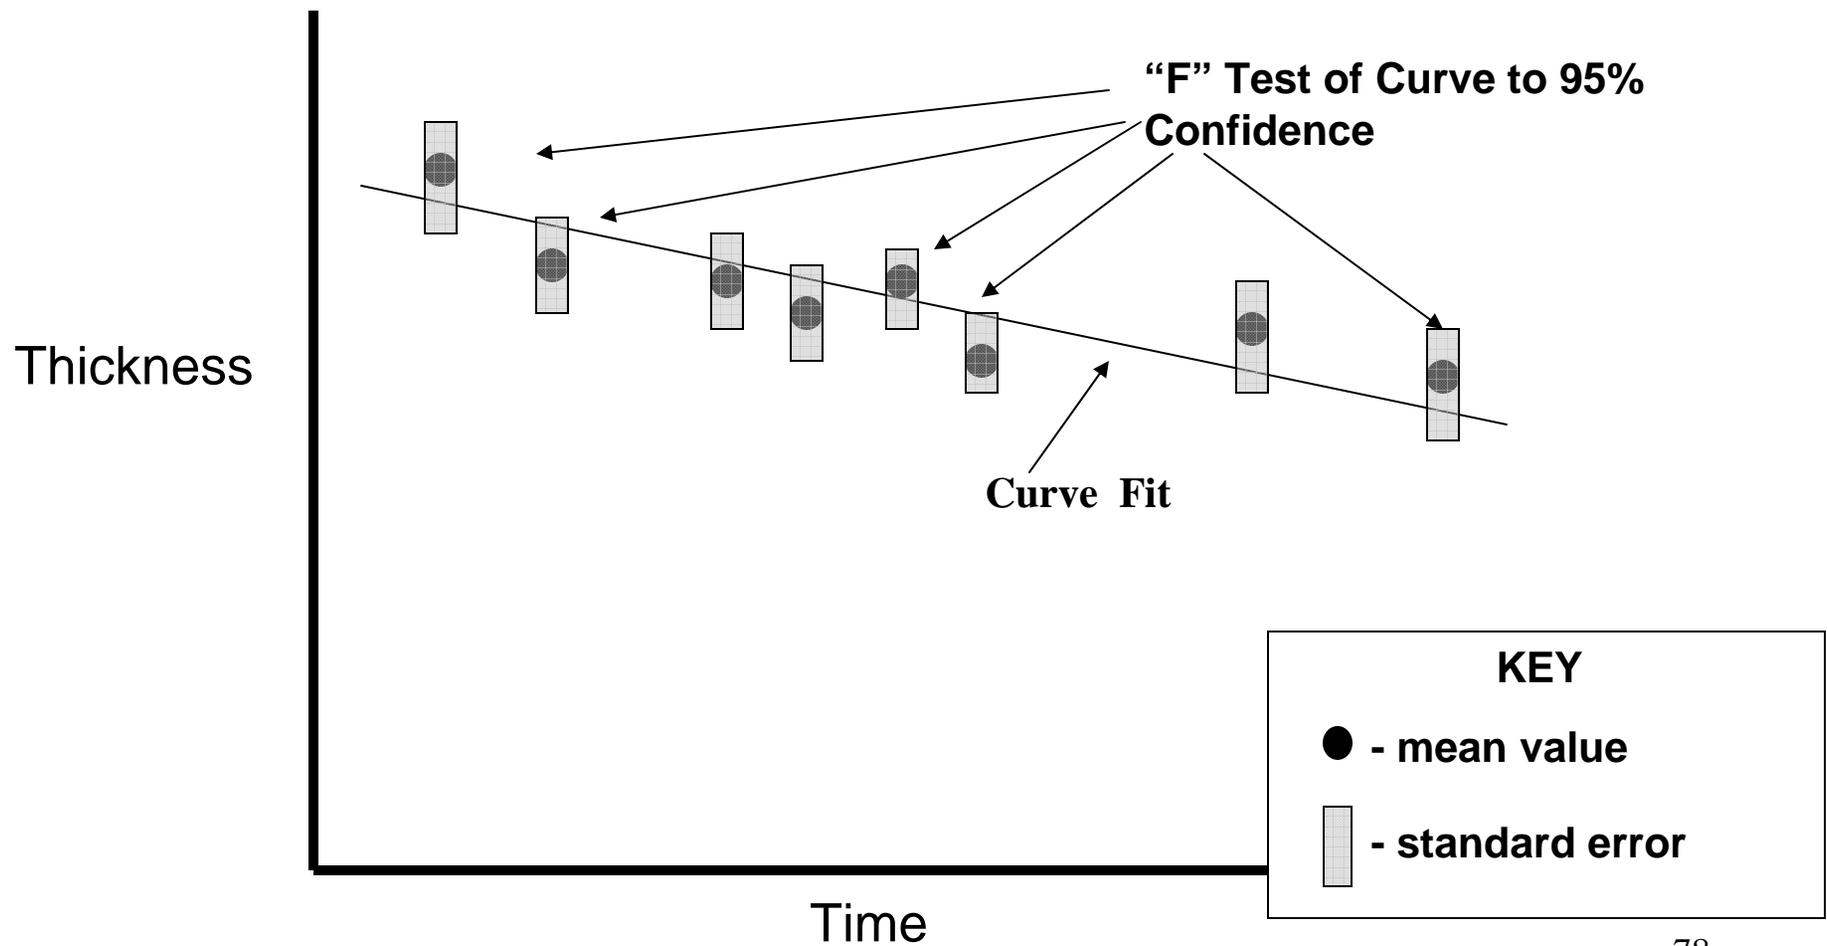
1) A curve fit based on the regression model is then developed.

2) The Corrosion “F” Test is performed to determine if the data meet the curve fit with 95% confidence.

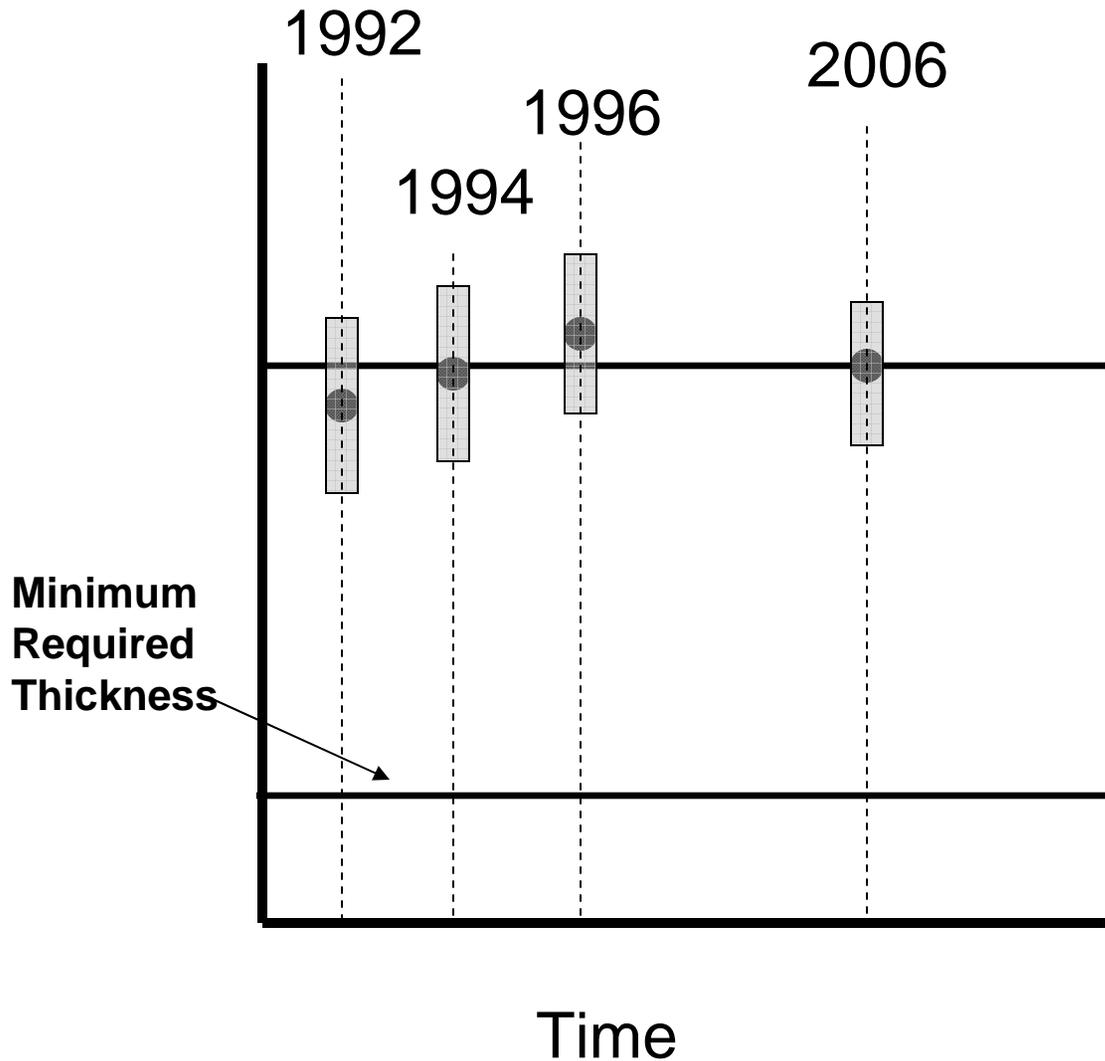
2006 Sand Bed Data Summary

In the case of the 2006 sand bed inspections, there are only 4 inspections per location with most standard errors between +/- 8 and +/-16 mils

There are not enough inspections to satisfy the Corrosion Test F test with 95% confidence.

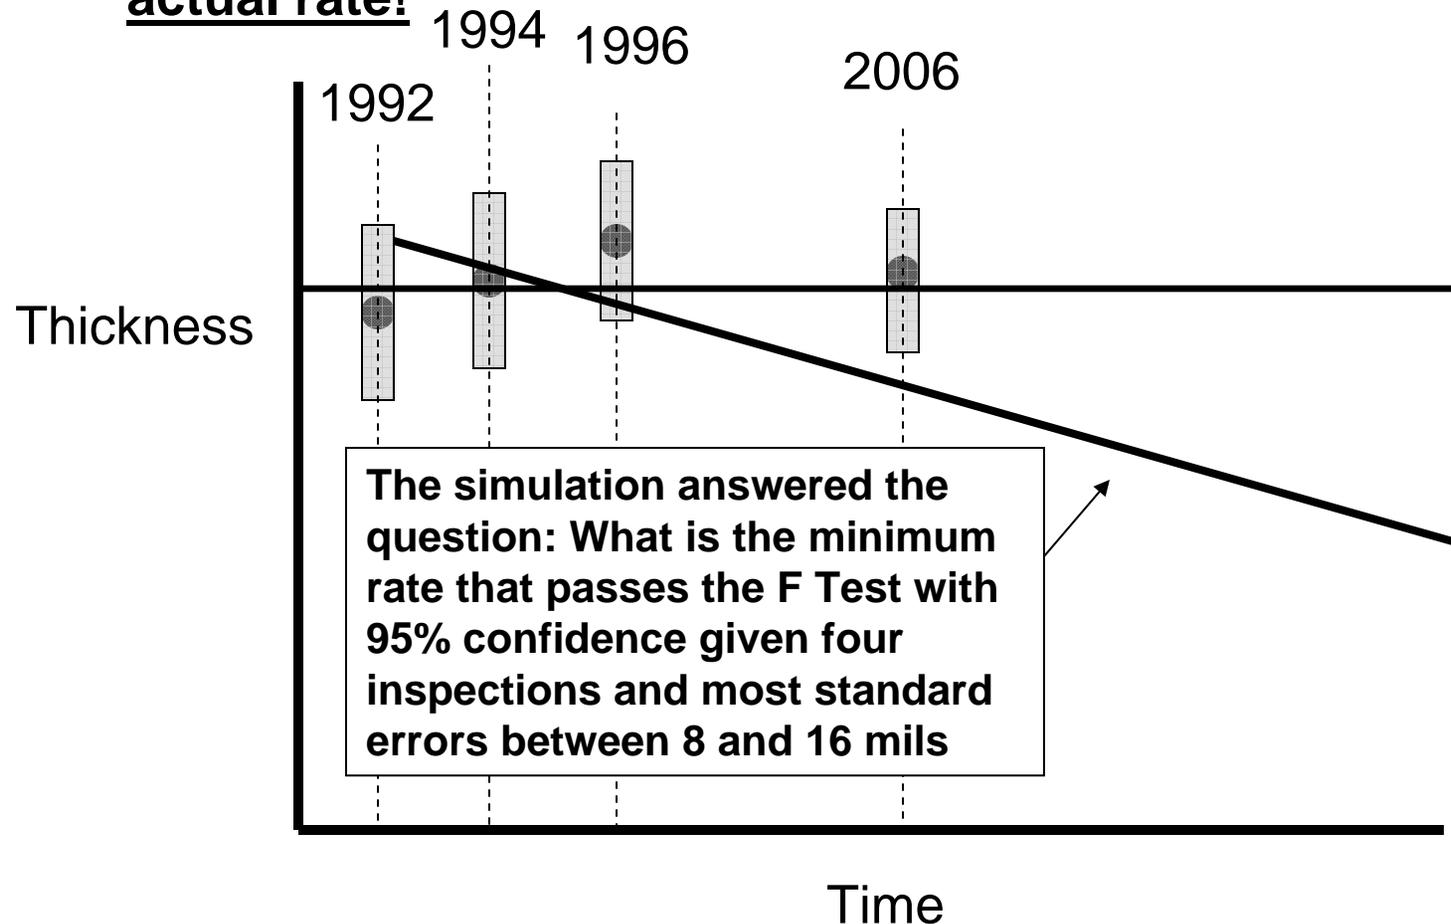
Given only 4 inspections and the standard errors, simulation was required to determine the minimum observable rate with 95% confidence. This is not an actual rate!
