Oyster Creek License Renewal Presentation to ACRS Subcommittee

January 18, 2007

Drywell Shell Corrosion Cause and Corrective Actions

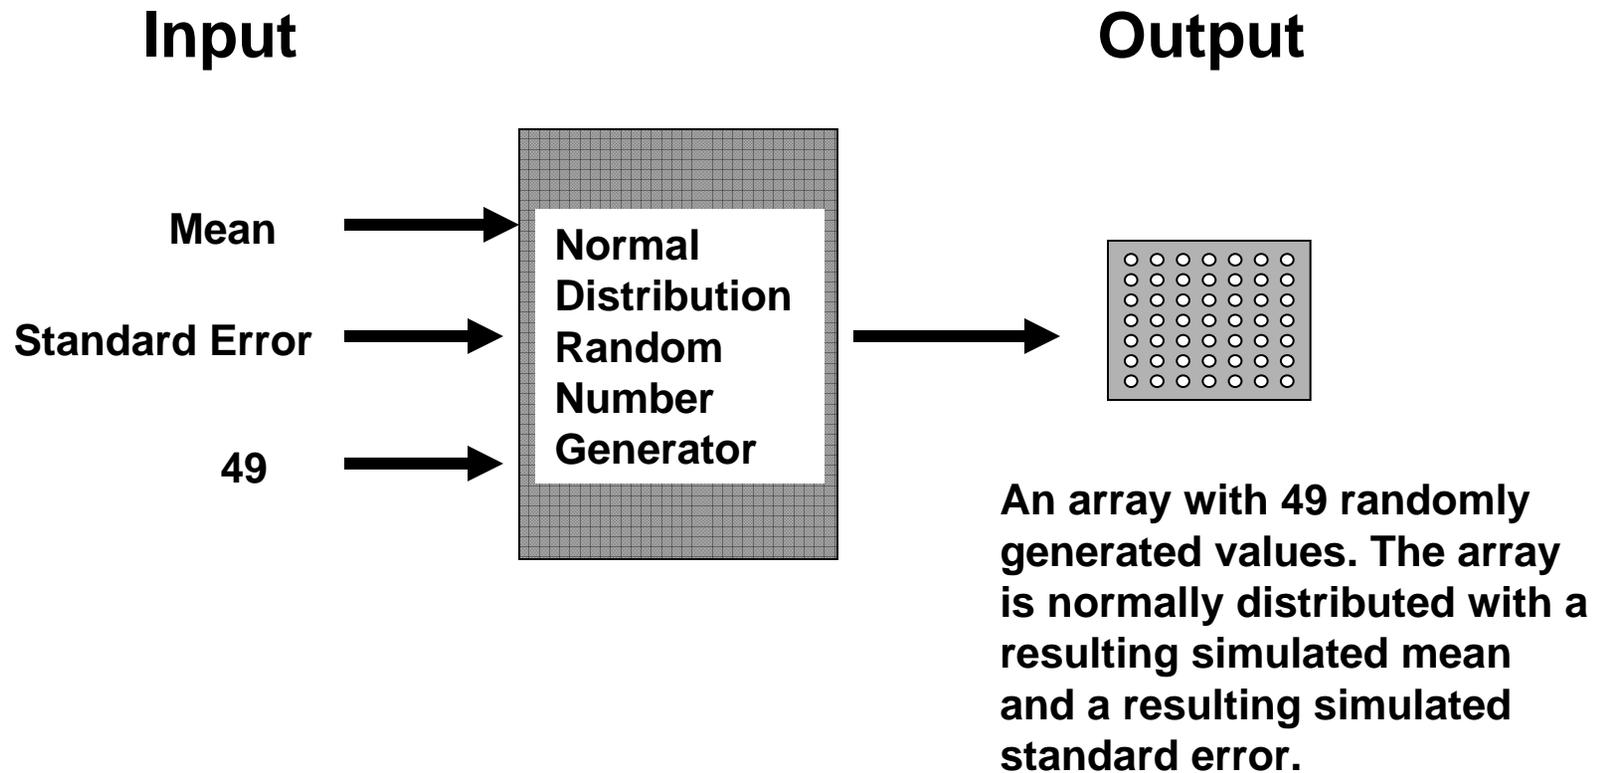
The simulation used a random number generator based on the normal distribution

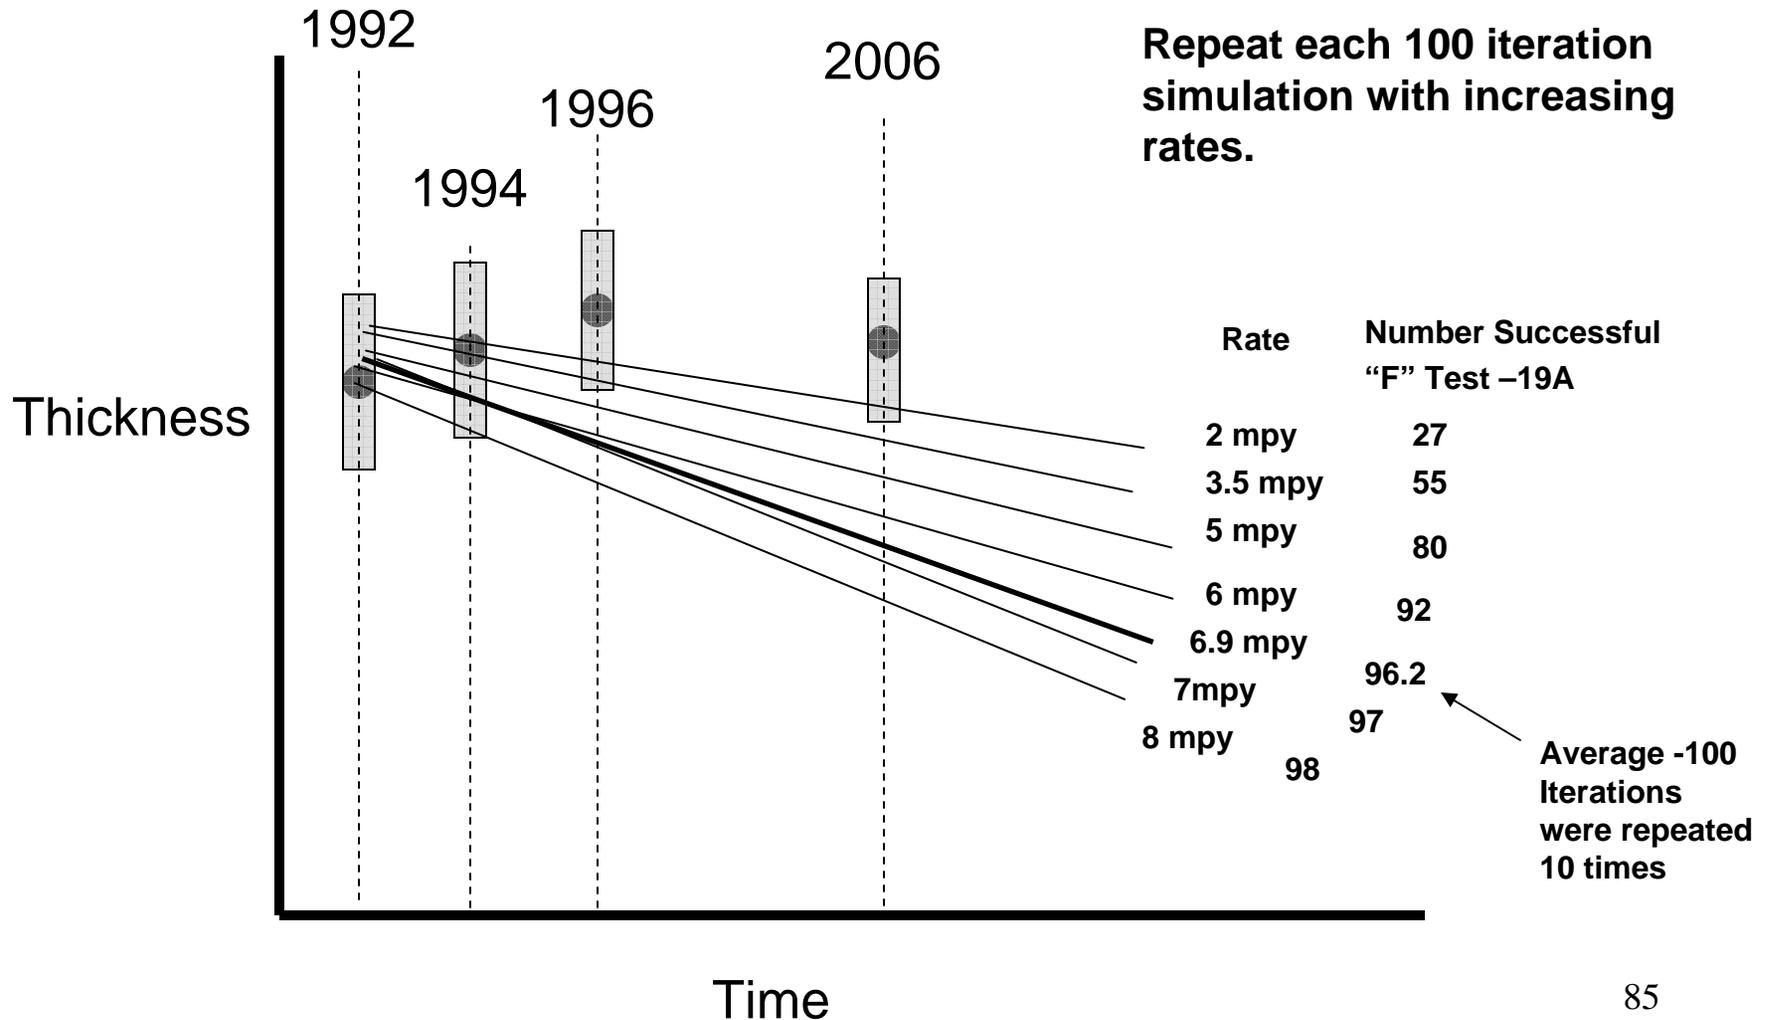
The minimum rate which consistently passes the Corrosion “F” Tests 95 out of 100 times is the Minimum Observable Corrosion Rate.

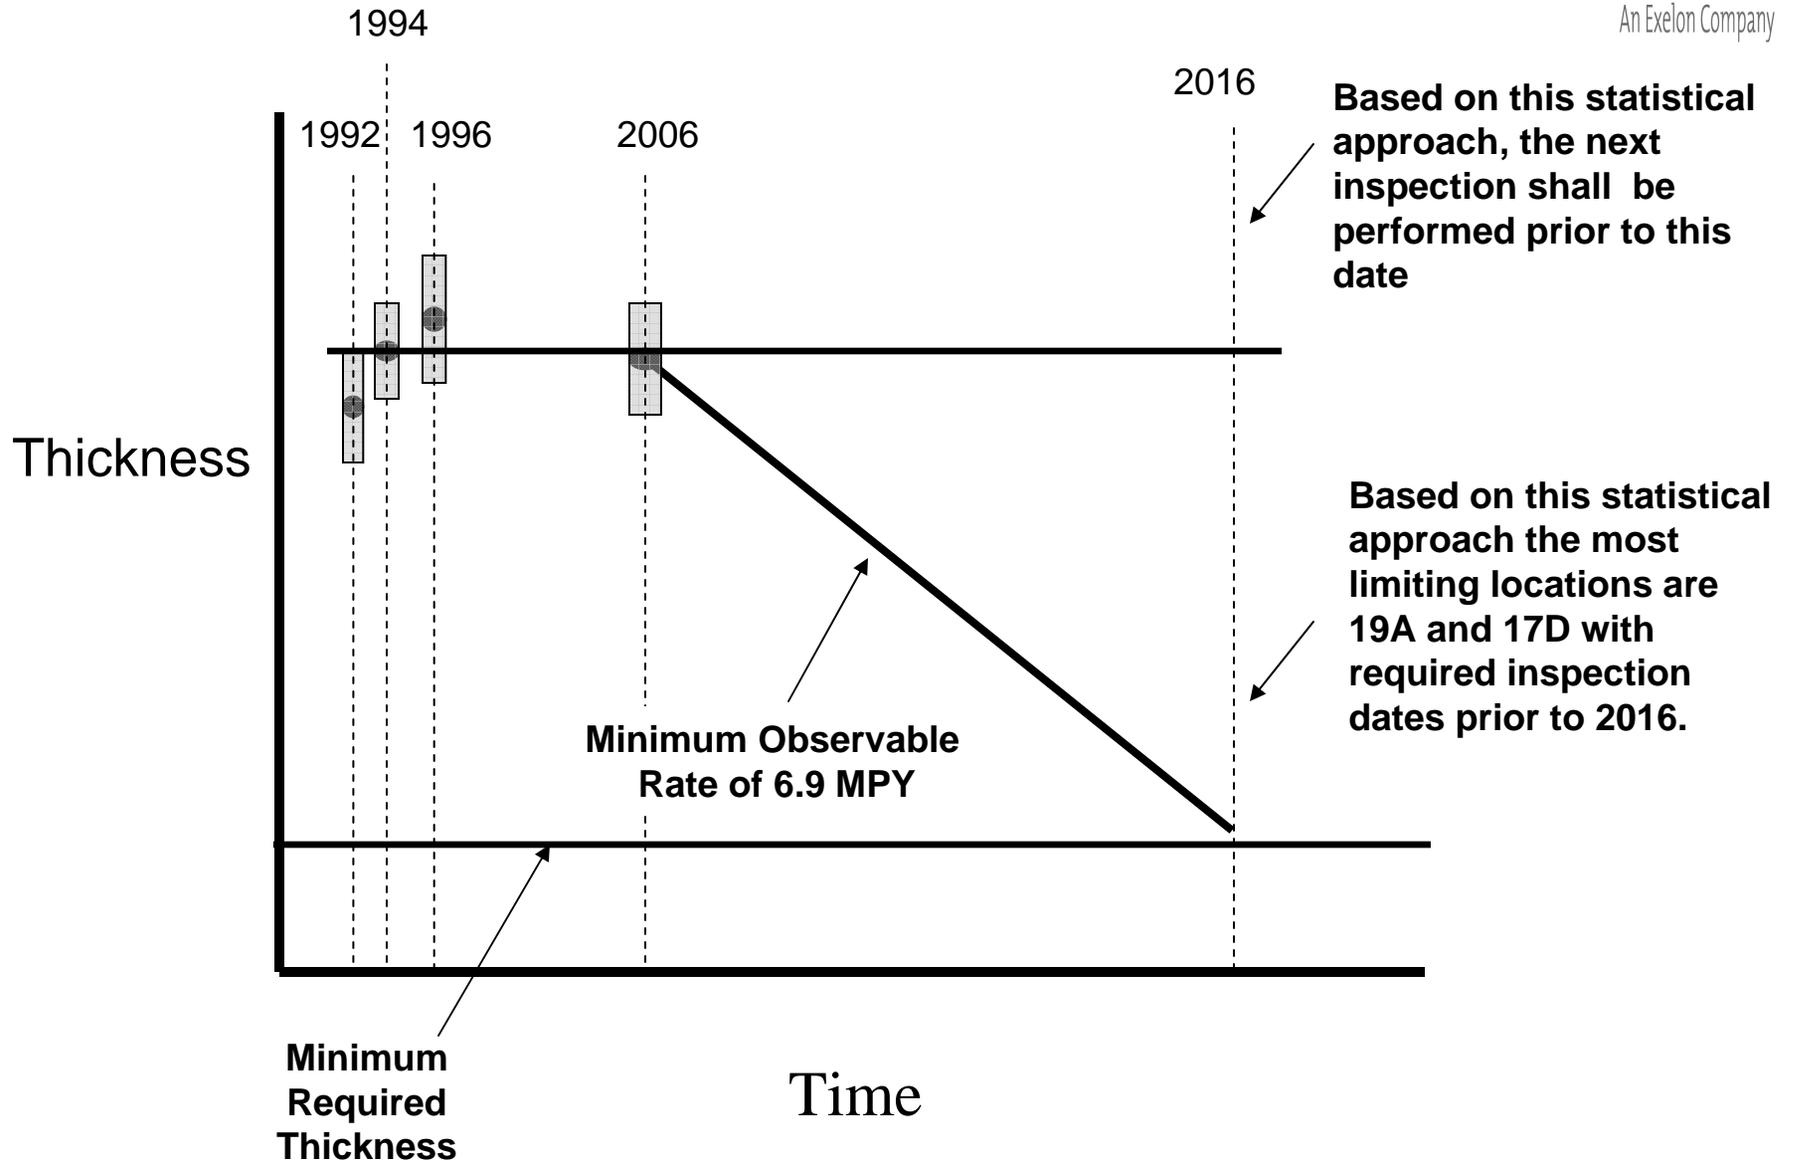
Next Required Inspection Based on the Minimum Observable Rate

- The most limiting locations are 19A and 17D, with required inspections prior to 2016
- Therefore, the next inspection scheduled for 2010 is appropriate
- Analysis after future inspections will be used to determine the appropriate inspection frequency

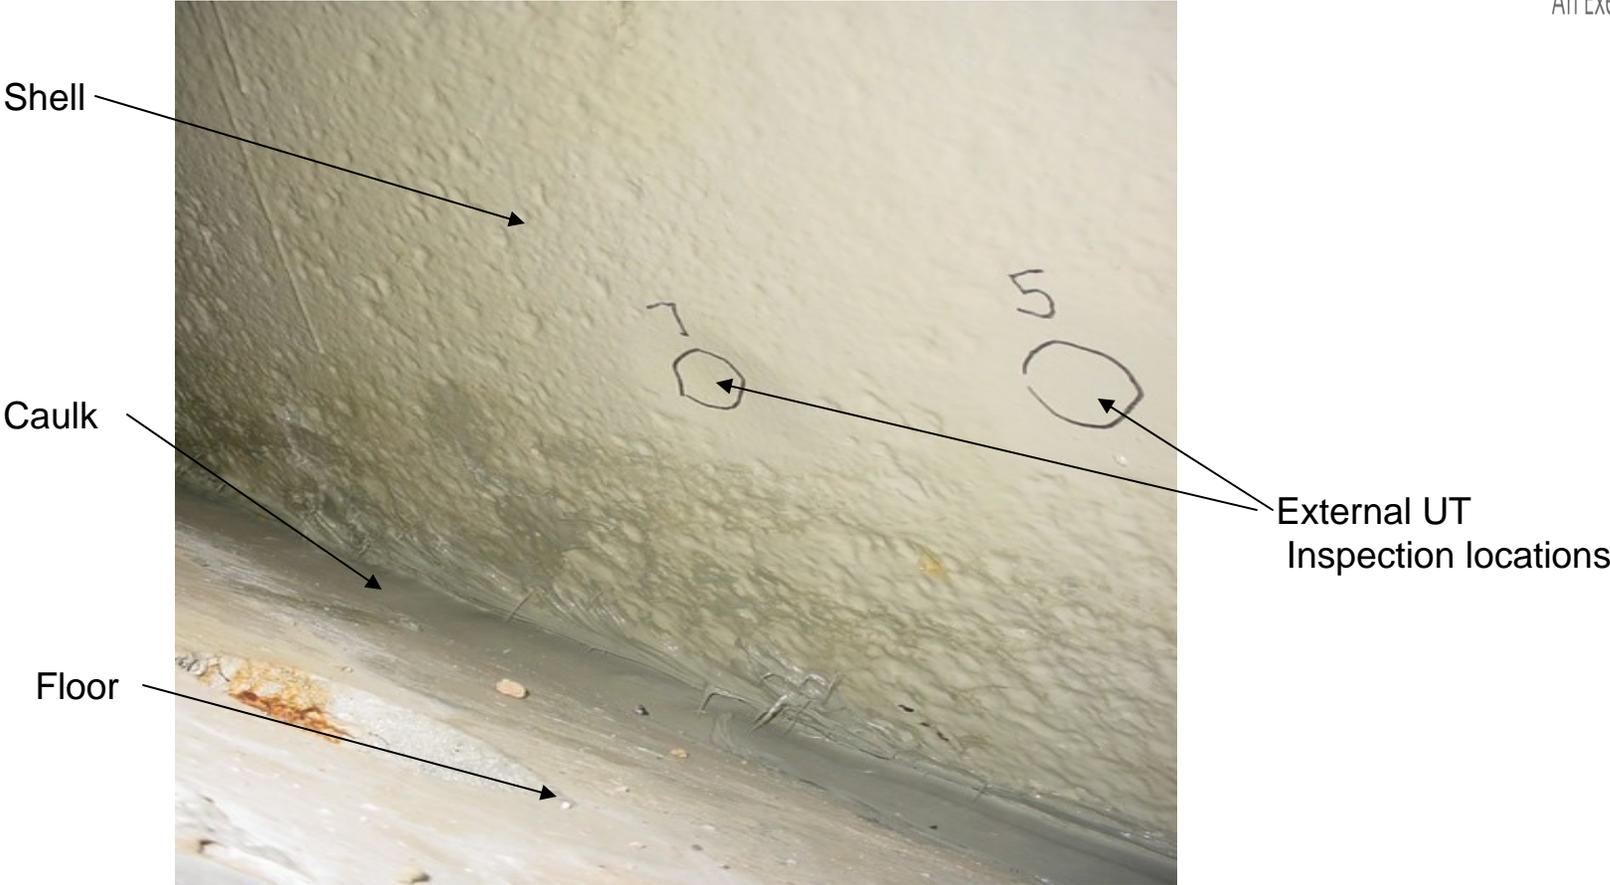
Bay 7 – Drywell shell, caulking, sand bed floor

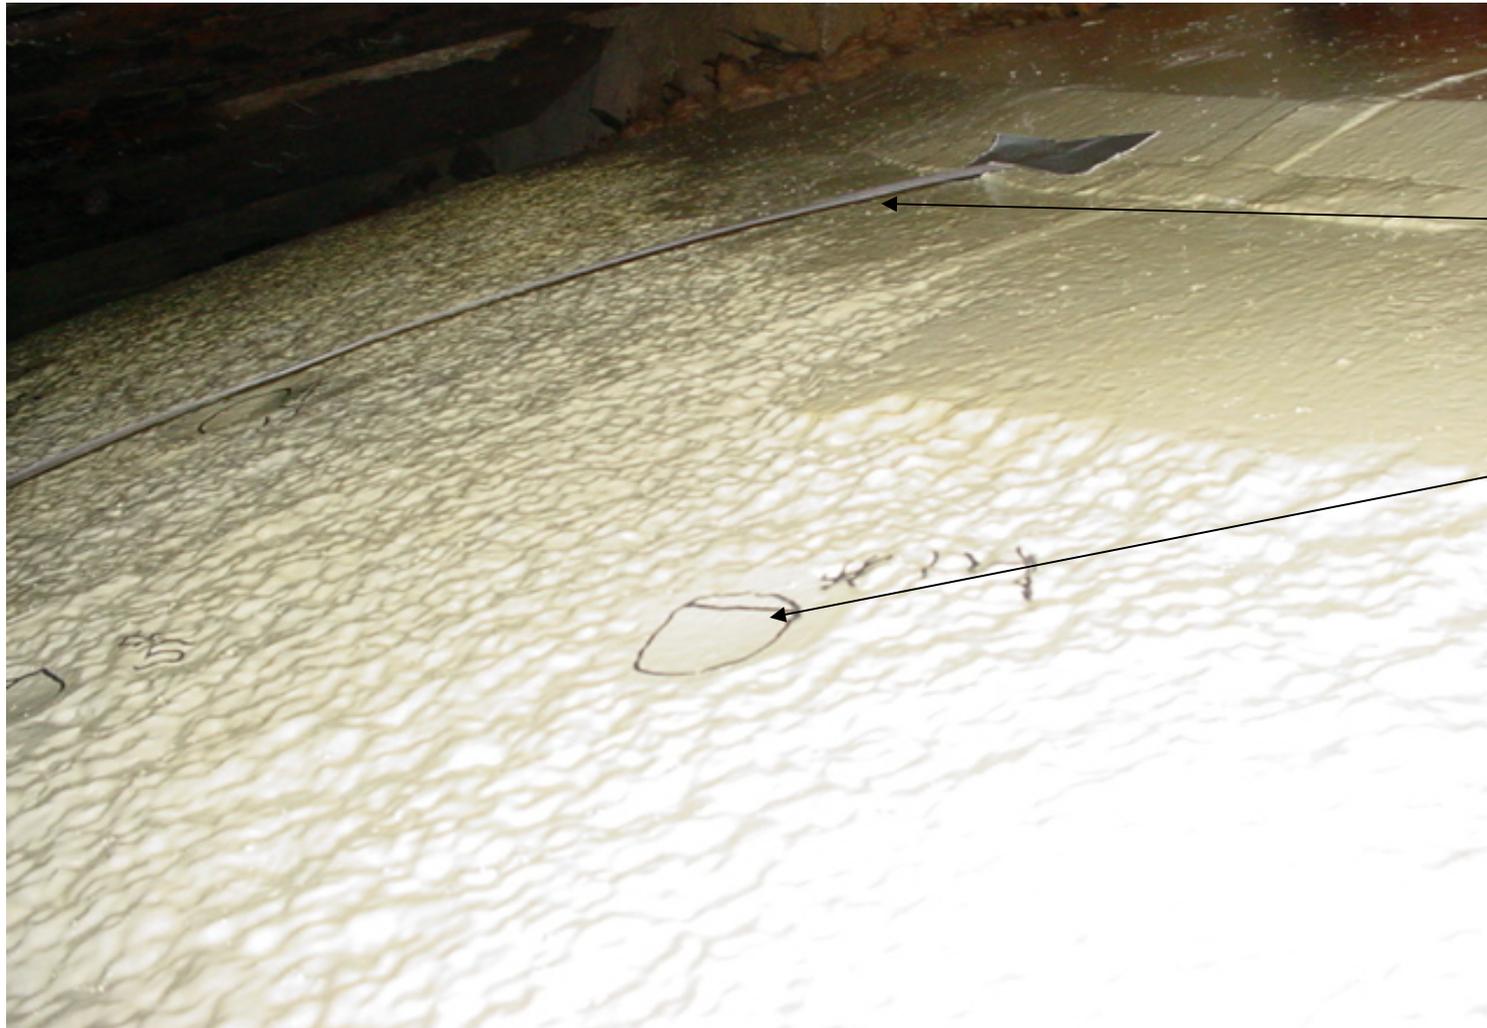
Reference for locating inspection points

External UT Inspection location

Bay 13 Drywell shell

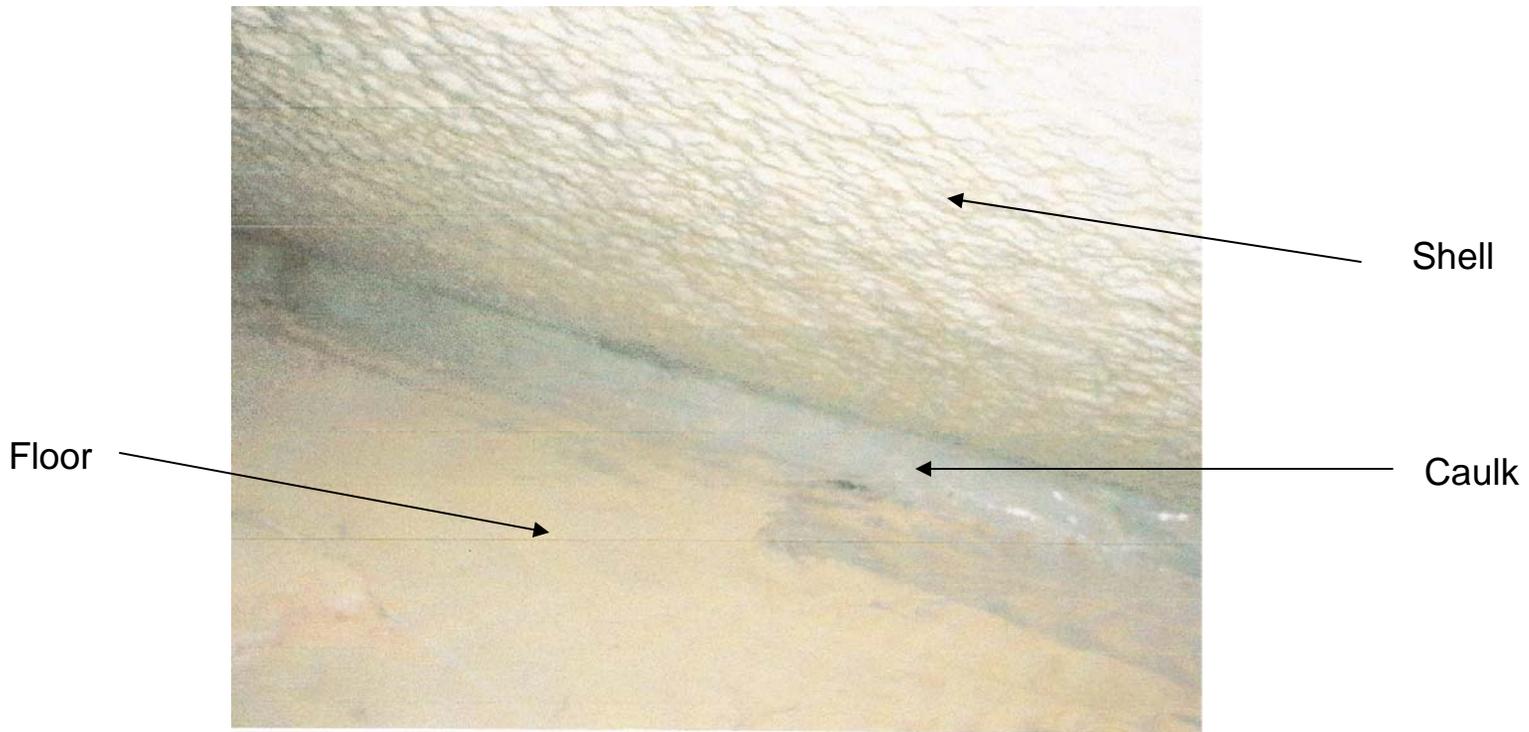
Bay 19 caulking

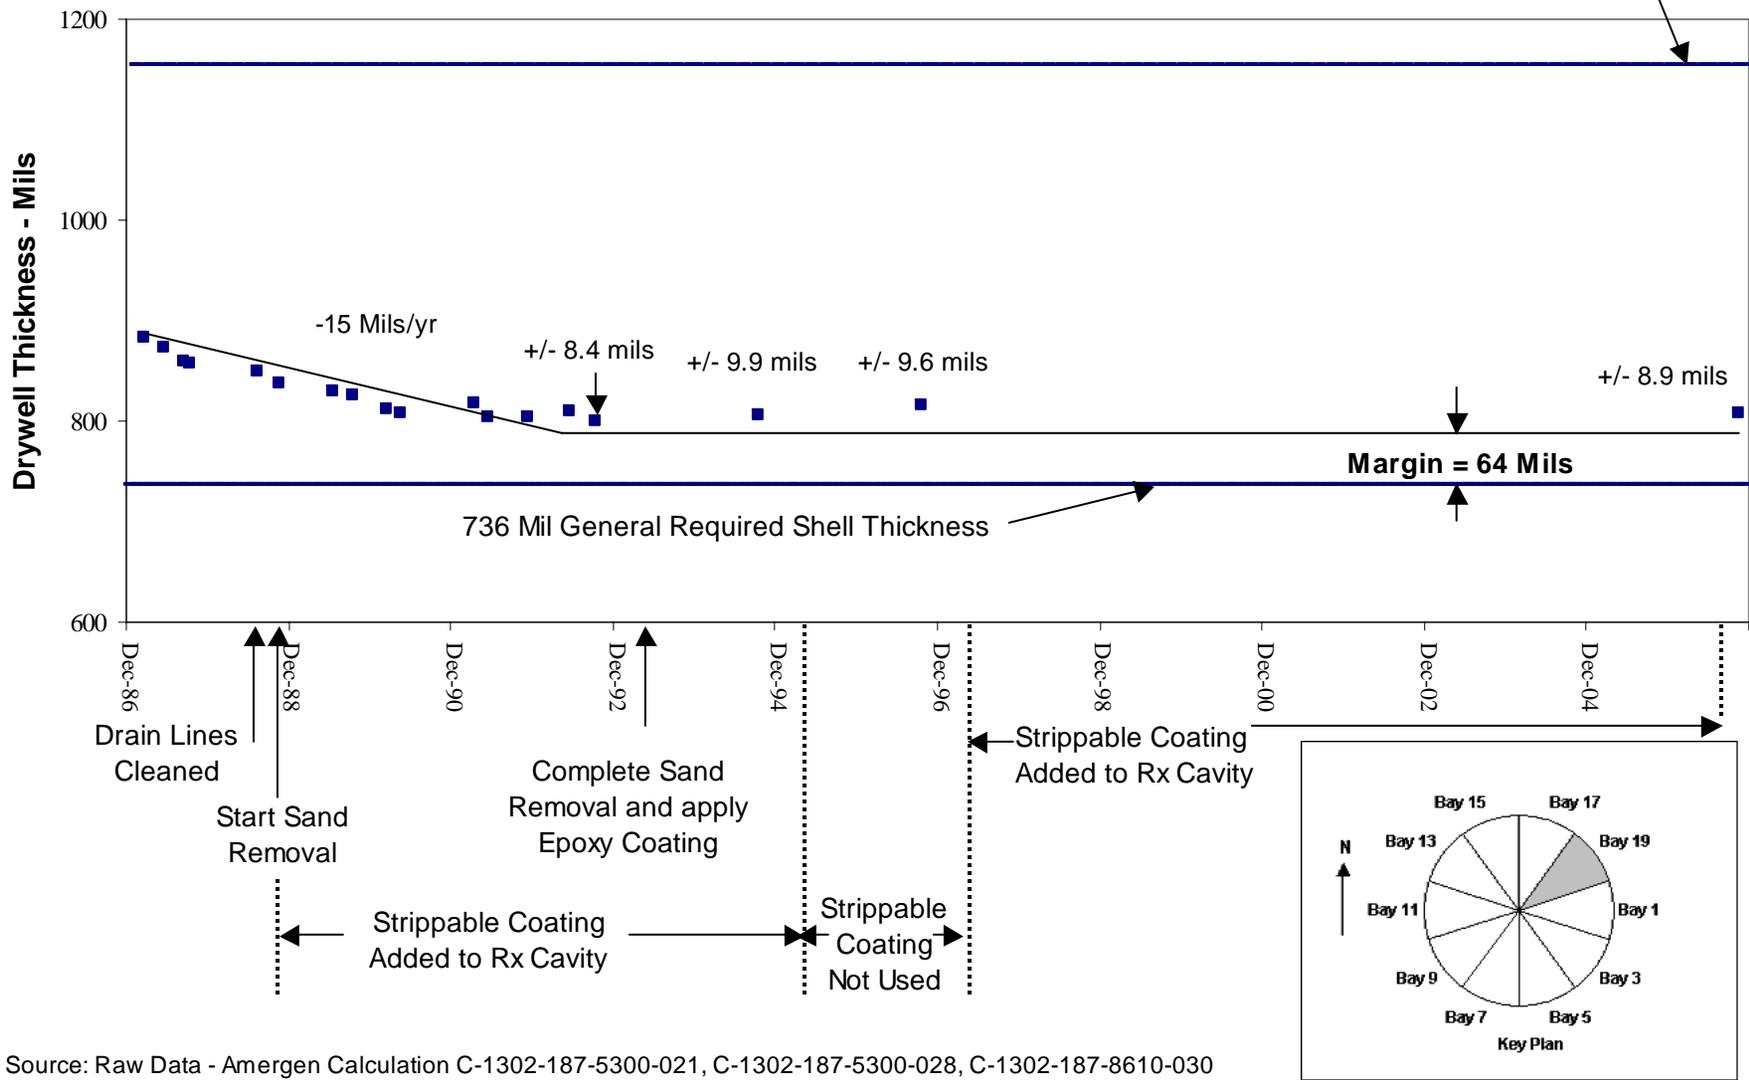
Figure 21 Sandbed Bay # 19A

1154 Mil Nominal Shell Plate Thickness

Source: Raw Data - Amergen Calculation C-1302-187-5300-021, C-1302-187-5300-028, C-1302-187-8610-030

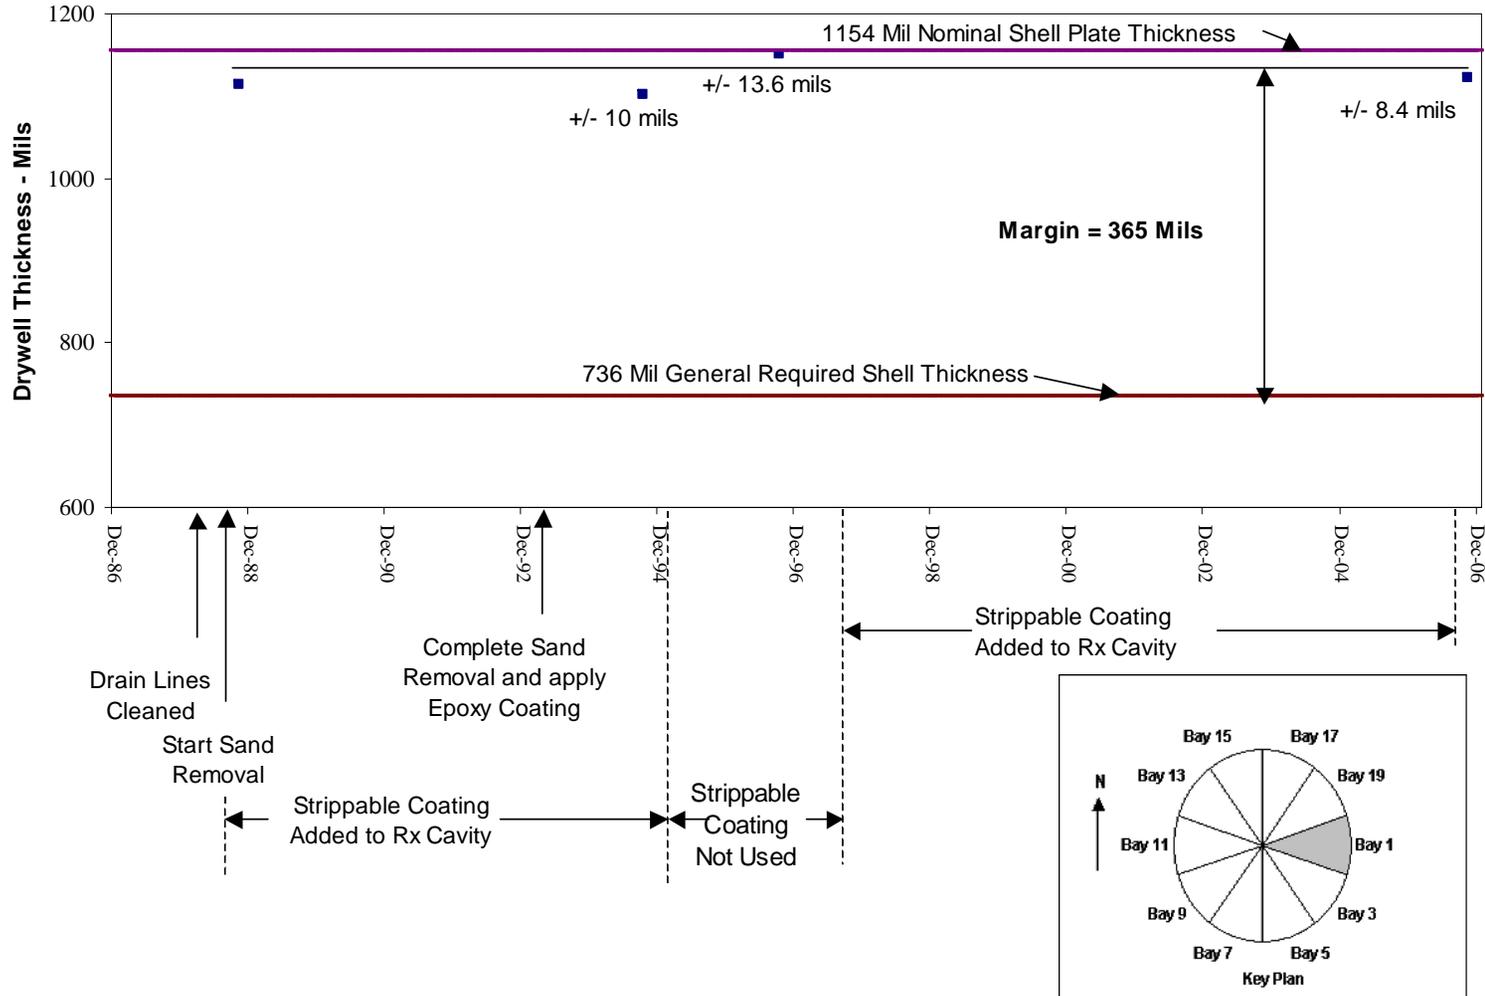
Figure 1. Sandbed Bay # 1D

Source: Raw Data - AmerGen Calculation C-1302-187-5300-021, C-1302-187-5300-028, C-1302-187-8610-

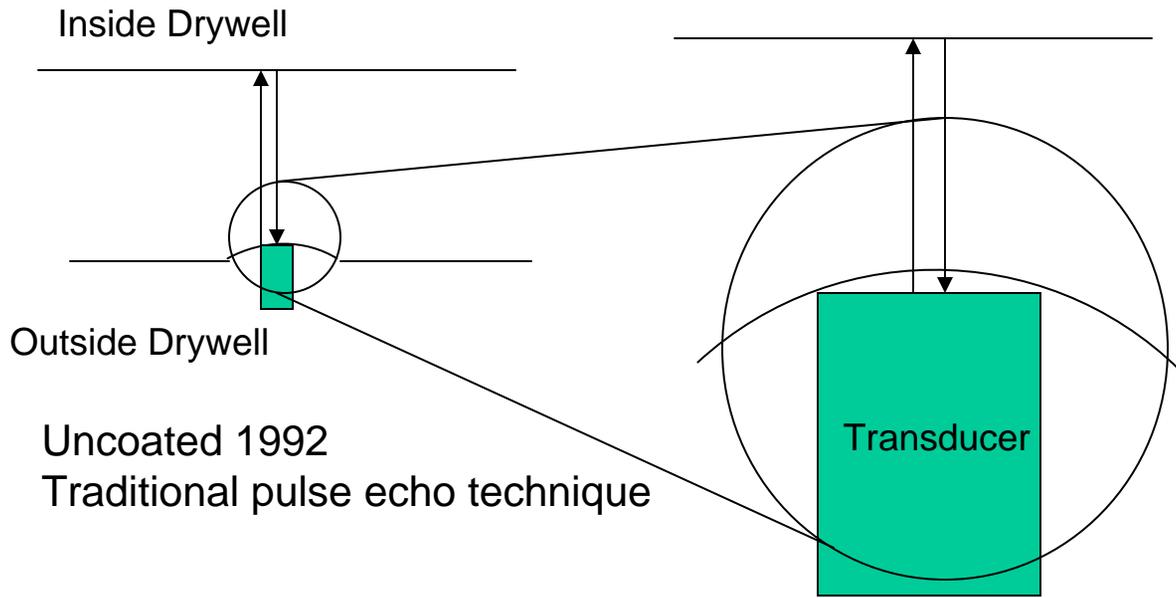
Uncoated 1992
Traditional pulse echo technique

Concave Curvature Effects
1992 vs. 2006 External
UT Data (106) Sand
Bed Readings

- 106 individual UT measurements were taken externally in the sand bed region
- It was verified that all 106 measurements meet the local thickness requirements (both buckling and membrane stresses)
- The 2006 measurements are not directly comparable to the 1992 results because of differences in measurement techniques

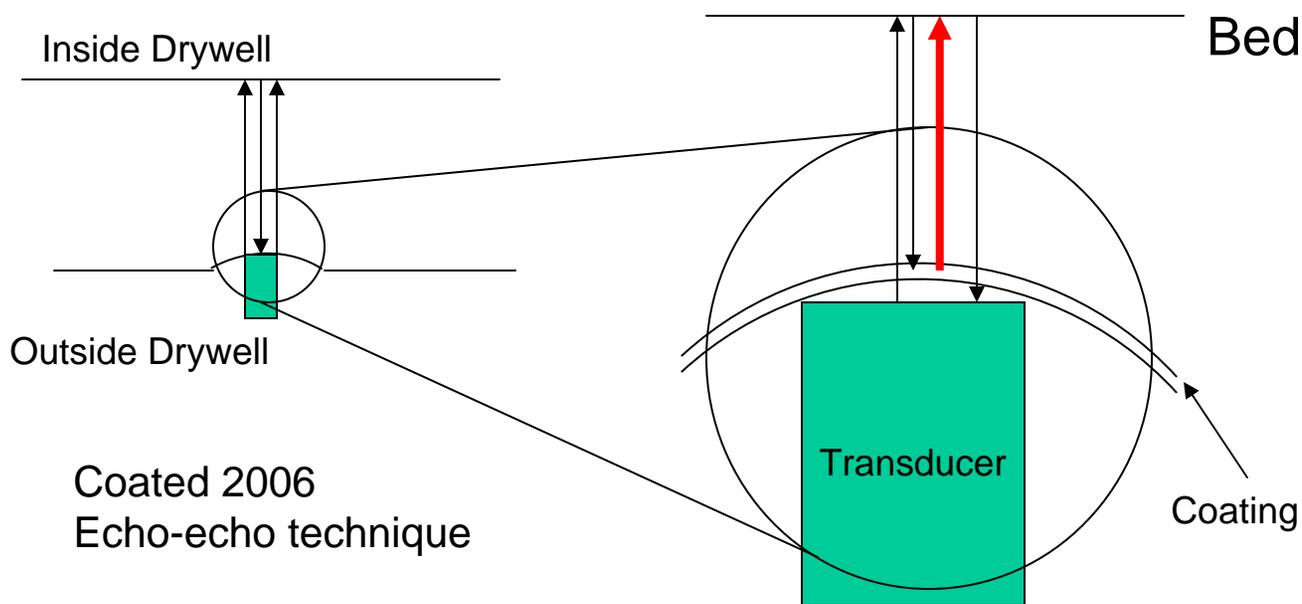
Coated 2006
Echo-echo technique

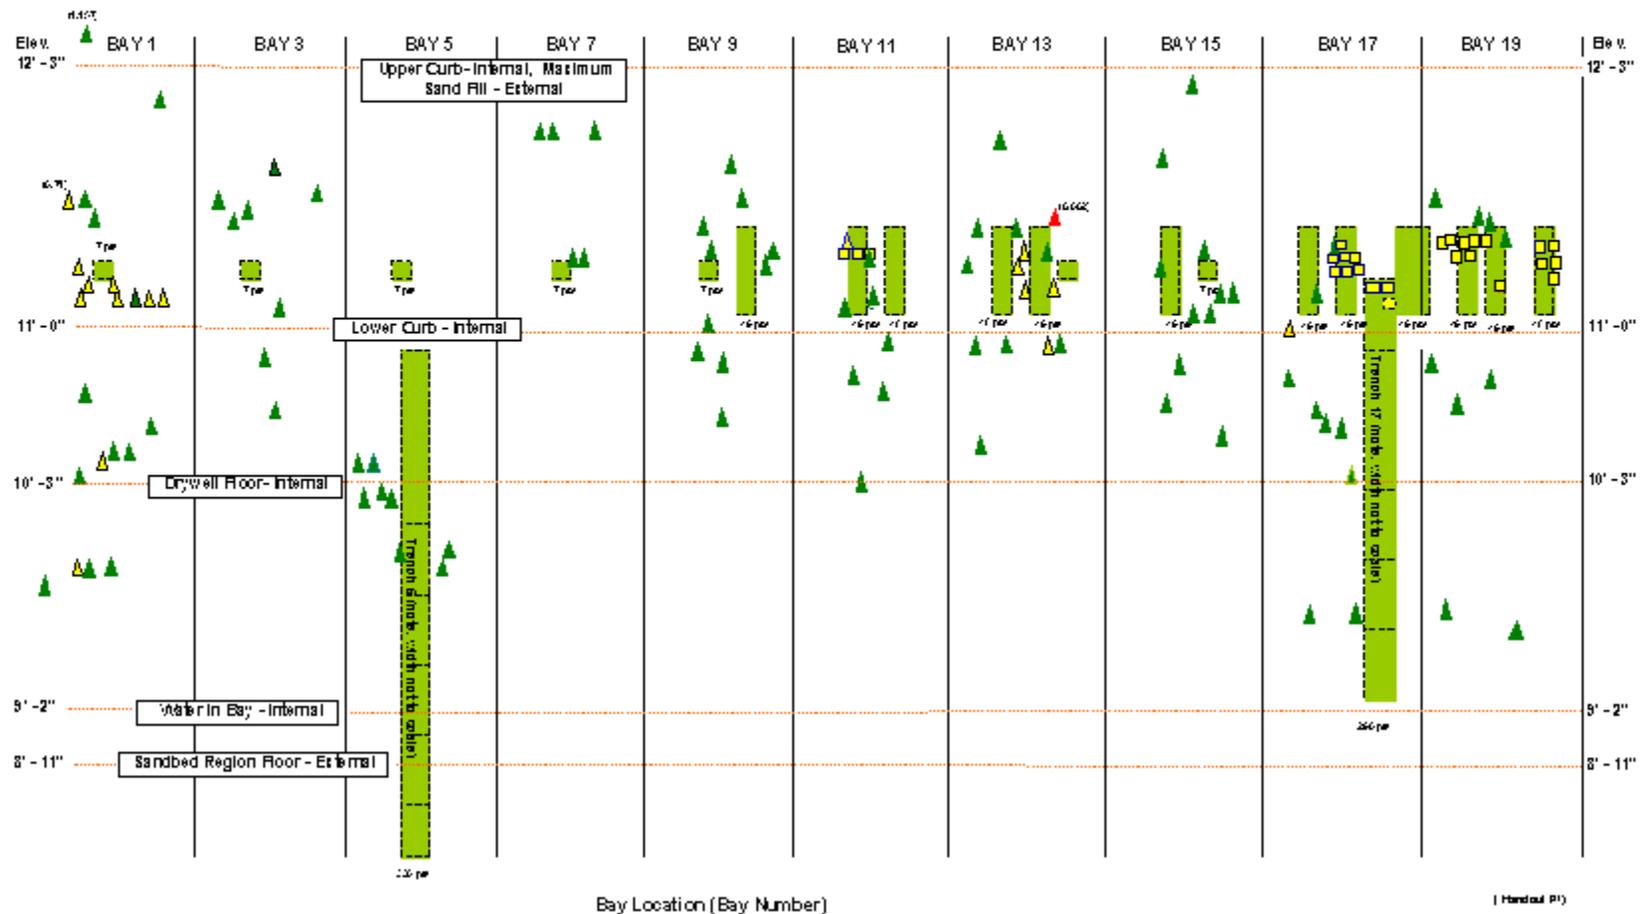
Location / Type of UT Measurement

- △ External Point UT Measurements
- Internal Grid UT Measurements
- Internal Point UT Measurements

For illustration of measurement locations in each bay. Vertical dimensions to scale showing approximate measurement locations. Horizontal dimensions not to scale for the individual bays.

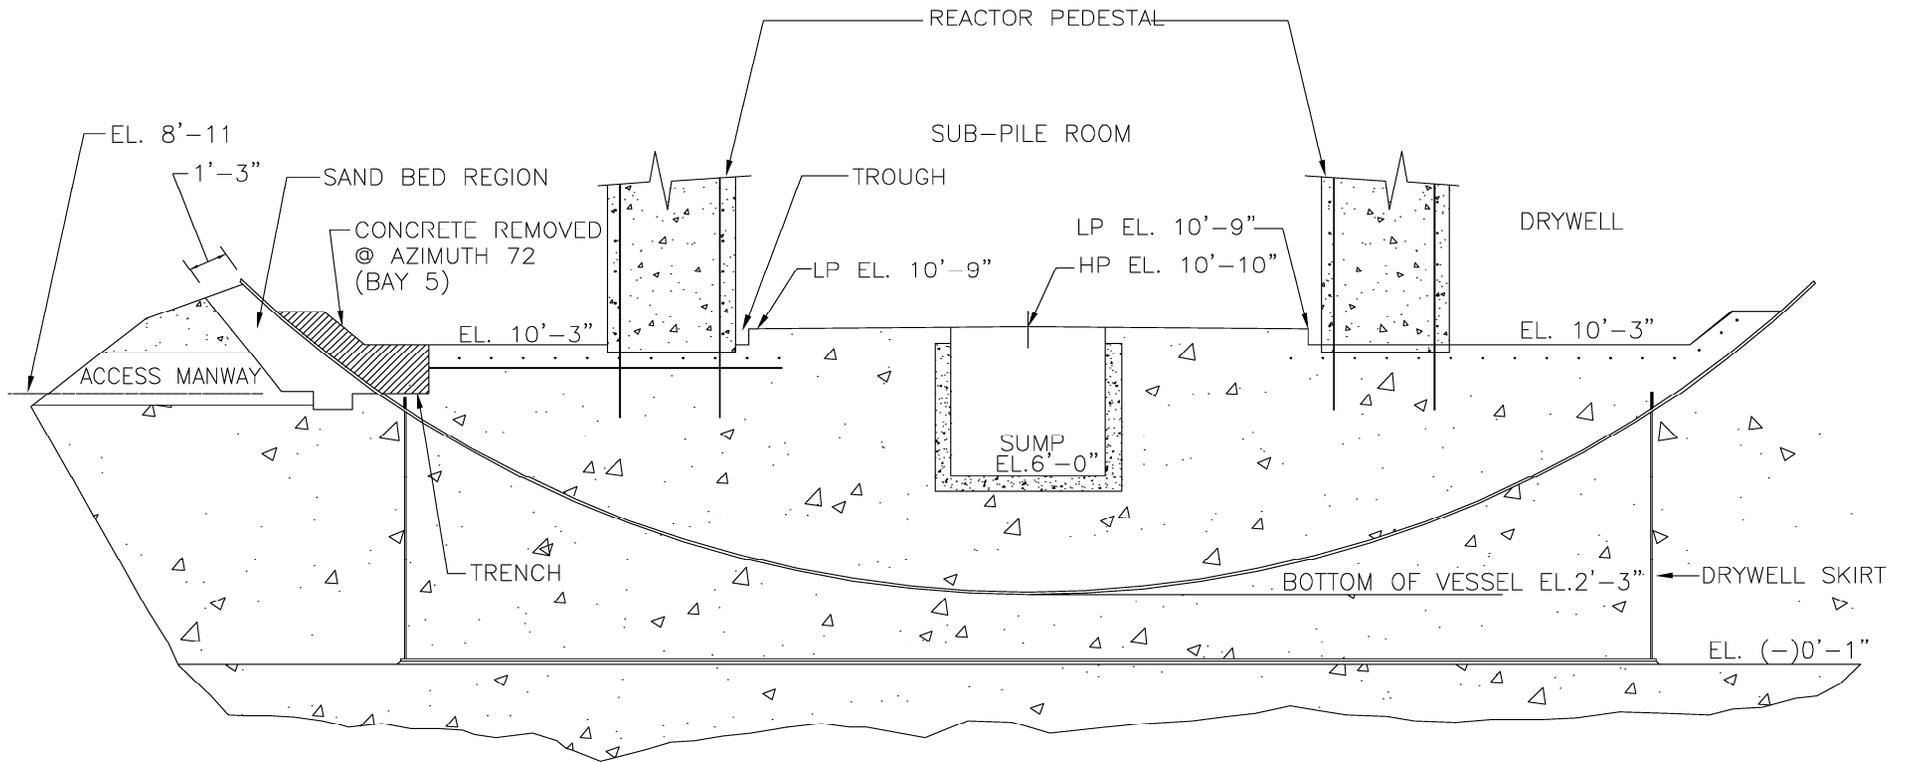
LOWER DRYWELL- SANDBED, TRENCH & SUMP

ELEVATION LOOKING WEST

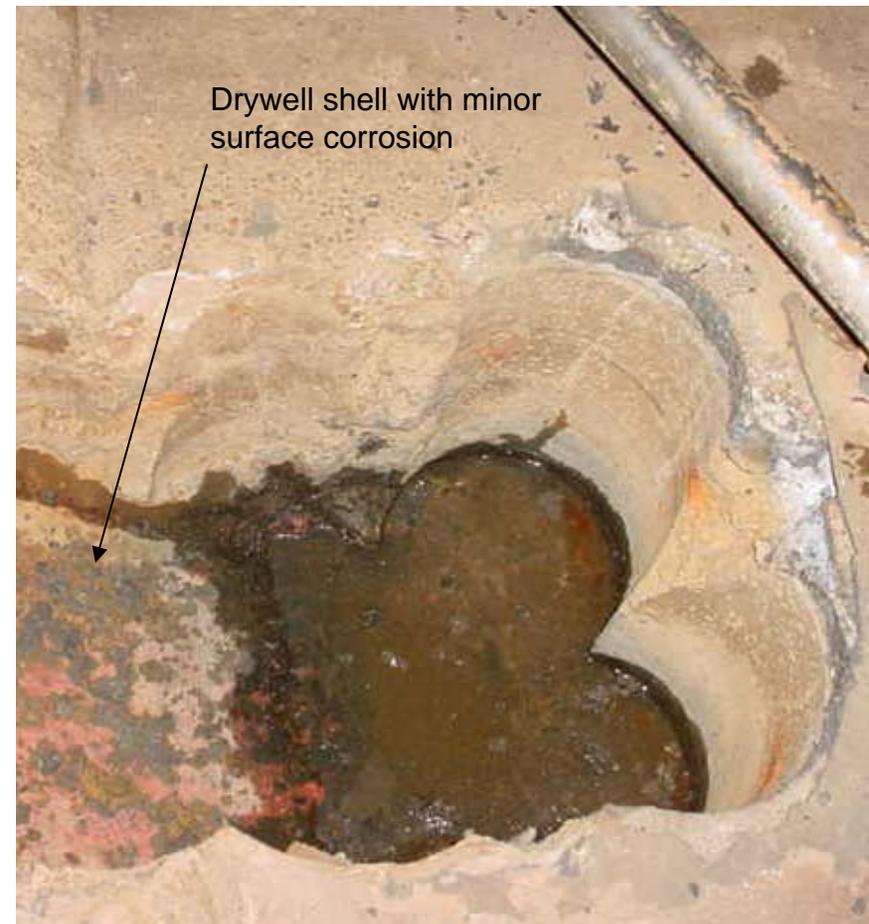
- Trench #5 water's high Ca indicates that the water slowly migrated through the alkaline concrete
- Any subsequent water ingress into the concrete floor will also become high pH concrete pore water

- Chemistry of the drywell Trench #5 water (from equipment leakage) shows high pH, low Cl⁻, low SO₄⁼ and high Ca:
 - pH 8.4 to 10.2 (despite CO₂) (> GALL/EPRI limit)
 - Cl⁻: 13.6 – 14.6 ppm (<< 500 ppm GALL/EPRI limit)
 - SO₄⁼: 228 - 230 ppm (<<1500 ppm GALL/EPRI limit)
 - Ca: 83.5 – 96.6 ppm (No GALL/EPRI limit)
- Water is characterized as good quality “concrete pore water” that mitigates steel corrosion
- Trench #5 water complies with GALL/EPRI embedded steel guidelines

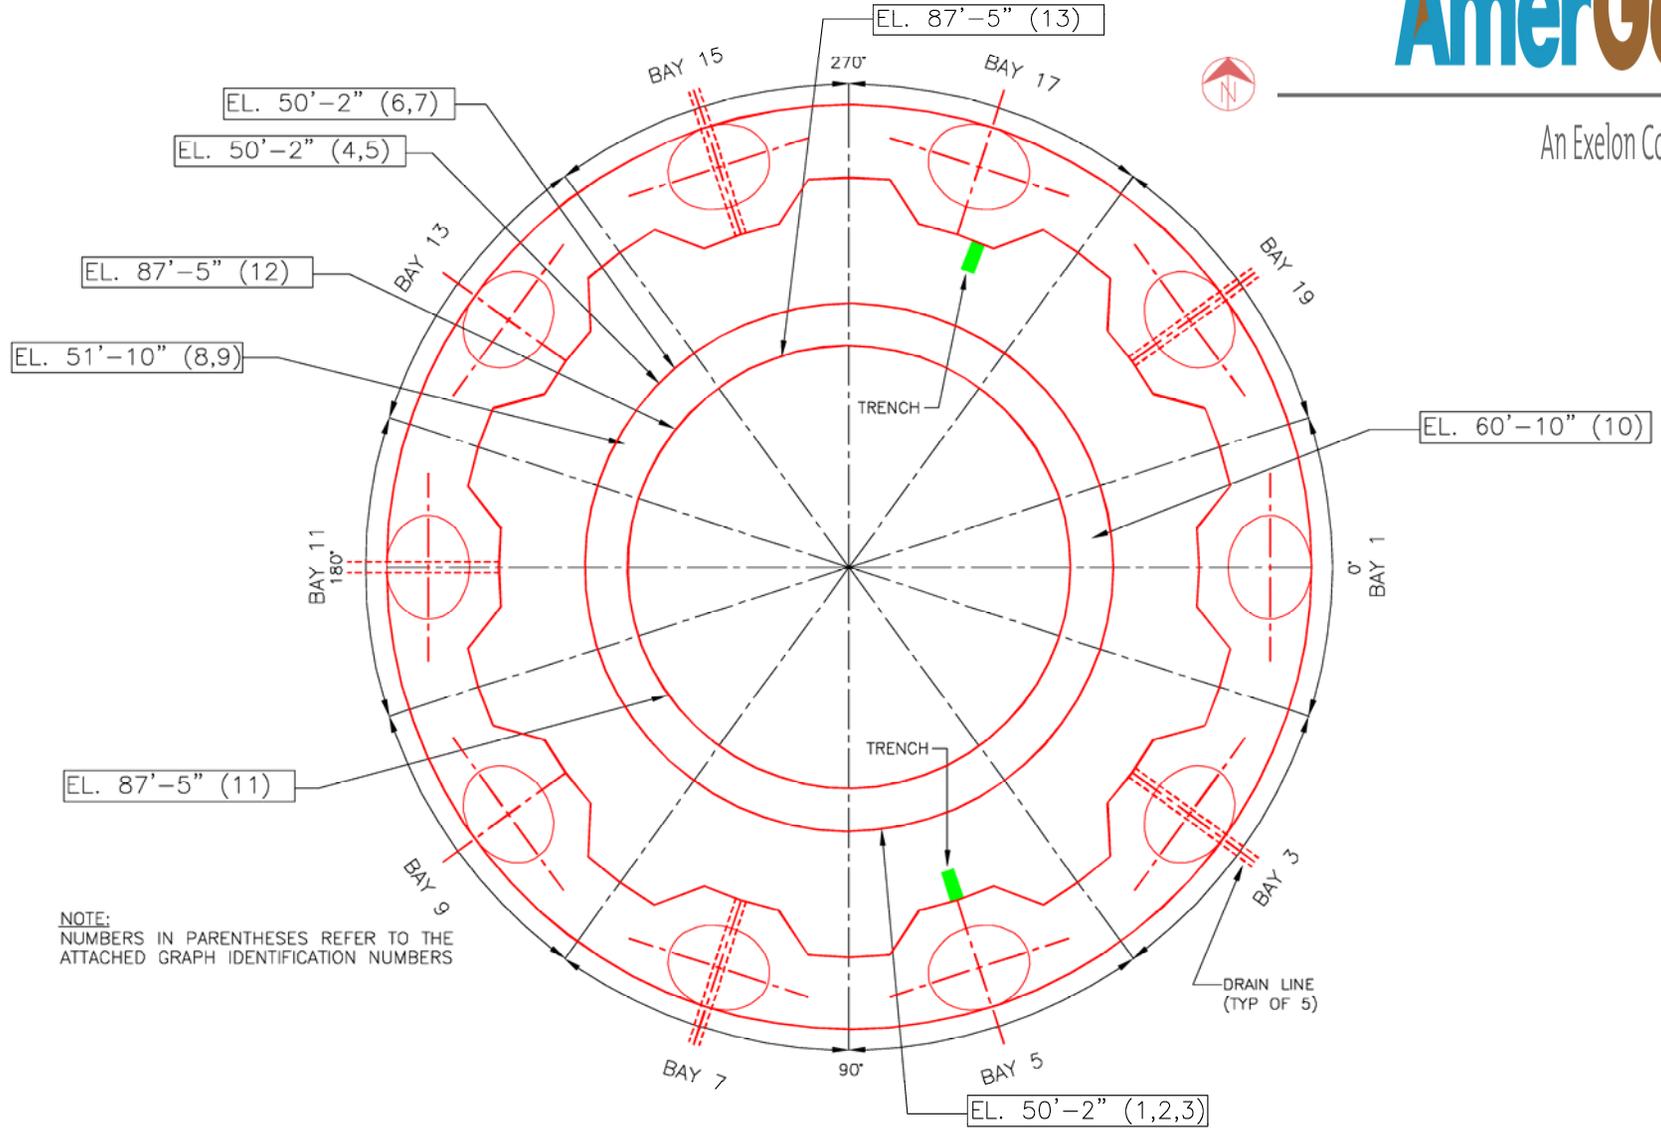
- Starting in 1983, over 1,000 UT measurements were taken to locate areas of corrosion on the exterior surface of the drywell shell
- 13 grid locations have been selected for monitoring
- These locations are measured every other refueling outage

NOTE:
NUMBERS IN PARENTHESES REFER TO THE
ATTACHED GRAPH IDENTIFICATION NUMBERS

- 12 of the 13 locations show no statistically observable corrosion
- The location with the minimum margin (137 mils) has no ongoing corrosion
- 1 location shows a corrosion rate of 0.66 mils/year
 - Projected thickness in 2029 is 720 mils, compared to a minimum required thickness of 541 mils
