Oyster Creek Nuclear Generating Station

Unresolved Problems With Drywell Corrosion

January 18, 2007

Richard Webster, Rutgers Environmental Law Clinic
on behalf of the Coalition to Stop the Relicensing of
Oyster Creek

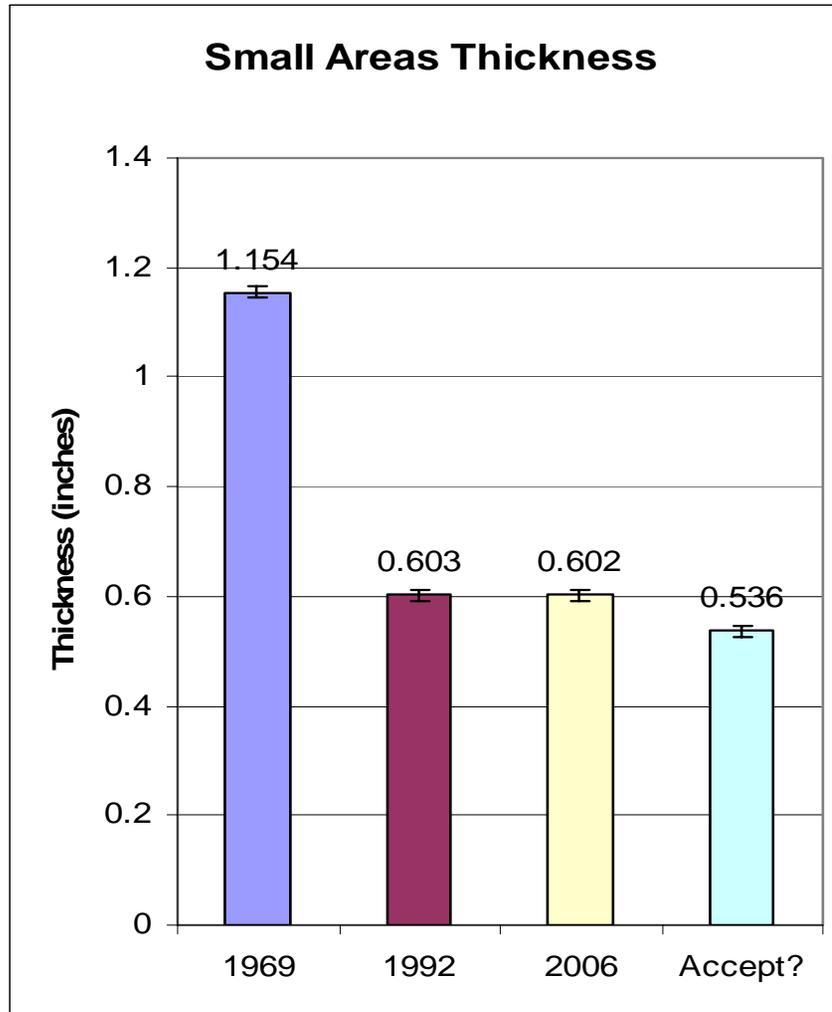
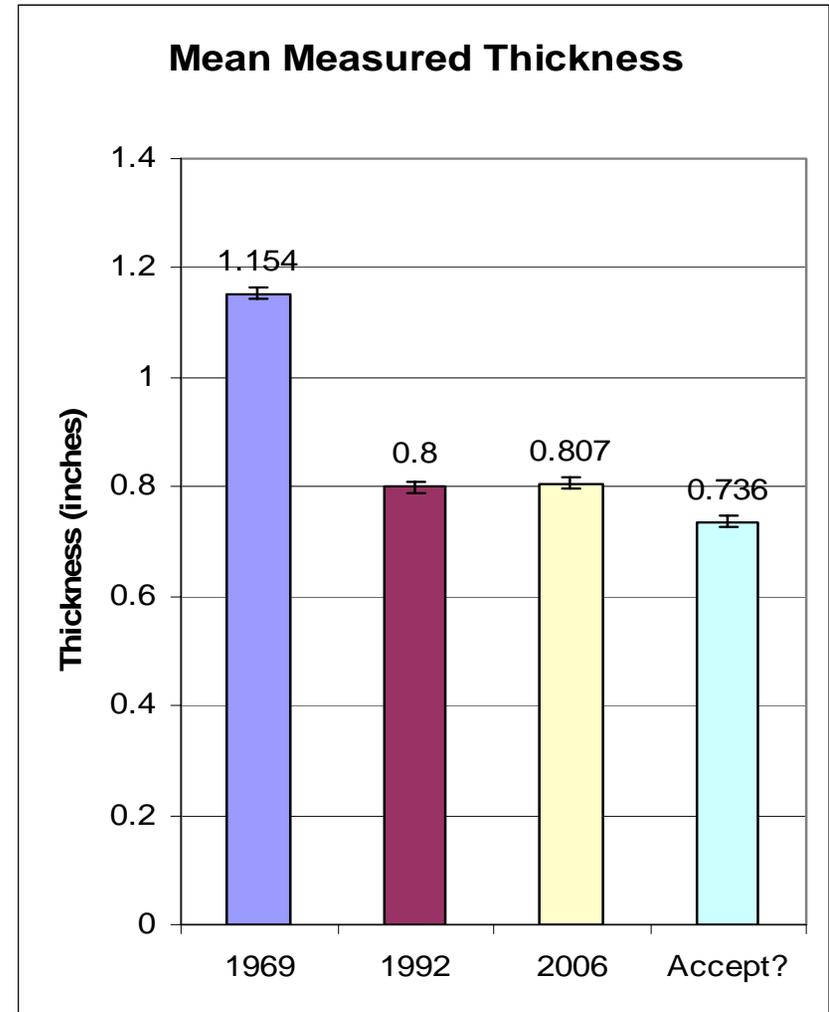
Claimed Safety Margins Based on 6 By 6 Grids

- Sandia Model shows a uniform symmetric sandbed at thickness 0.844 inches exactly conforms to code requirements
- Corrosion in Bays 1, 9, 11 and 13 is widespread, are many points thinner than 0.844 inches
- 4 Grids in Bays 11, 17, and 19 show average thinner than 0.844 inches
- In Bay 13, best estimate is that area with average thickness thinner than 0.736 inches is around 4 sq. ft.
- Area thinner than 0.736 inches has probably expanded since 1992
- High degree of uncertainty about the nature of the corroded surface
