**CORRO-CONSULTA**

**MEMORANDUM**

**Subject: Update of Current Knowledge Regarding the State of Integrity of OCNGS Drywell Liner and Comments Pertaining to Aging Management Thereof**

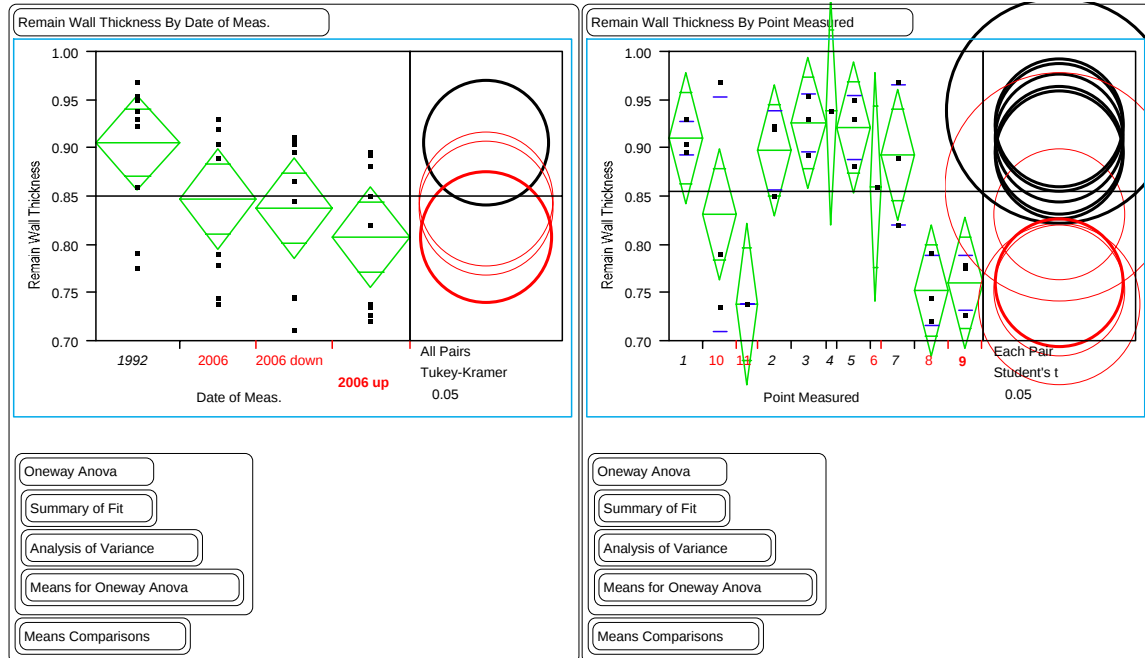
**Figure 10: External UT measurements in Bay 19**

Again one finds that the “up” measurements are significantly lower from the 1992 measurements.
