Corro-Consulta

MEMORANDUM

July 26, 2006

Subject: Oyster Creek, Drywell Liner
Embedded Region Issues

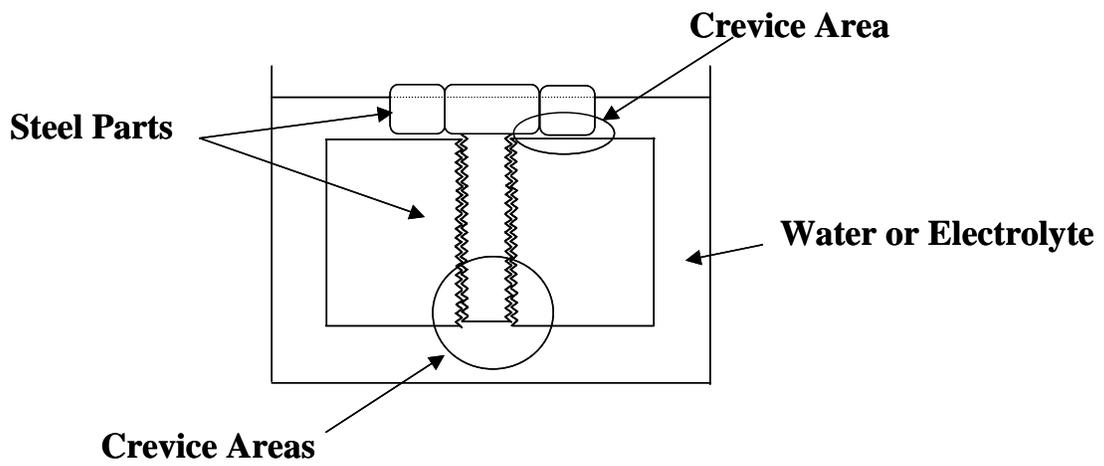
Figure A I-1

Formation of Crevice underneath Screw-head

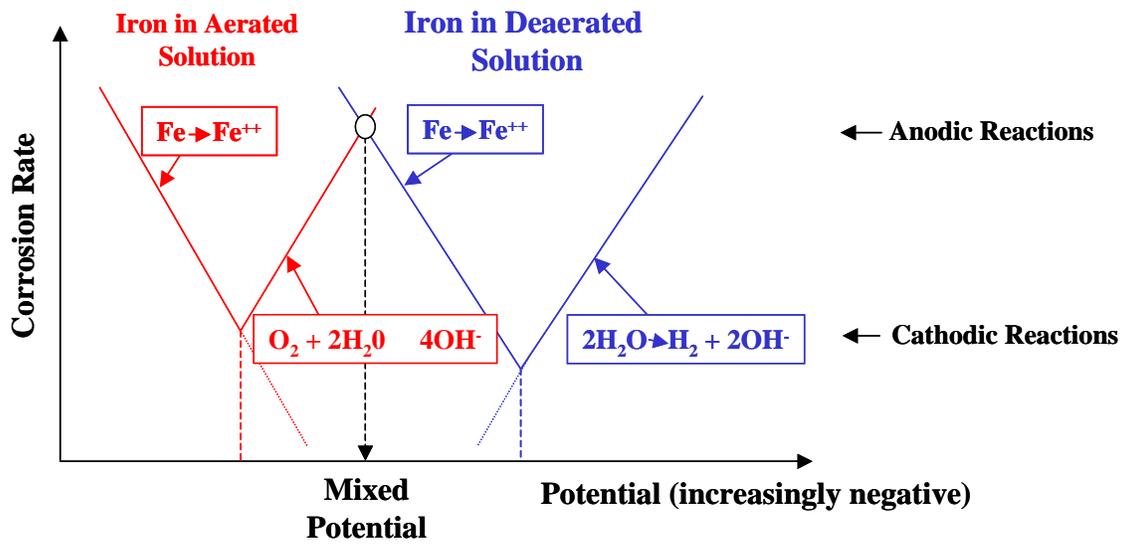
Figure AI-2

Such situations can be theoretically discussed by means of polarization diagrams presented in the form of an Evans diagram as in Fig. A I-2. The diagram describes separately the polarization behaviors of the two parts of the iron piece as if they were disconnected and then defines a mixed potential as well as the resulting anodic and cathodic corrosion rates at the mixed potential.

The steel immersed in aerated solution will assume a fairly positive potential (depending on pH perhaps about + 200 mV vs. SCE). The cathodic reaction will be the reduction of oxygen to hydroxyl ions while the anodic reaction is the oxidation of iron to iron ions. The current potential relationships describe the rate of the respective reactions when the potential is moved (for instance by external means) in the negative or positive direction. At the point where anodic and cathodic reactions (currents) are equal is the corrosion potential and the associated corrosion current (corrosion rate). For the part of the steel immersed in the deaerated solution the potential is more negative (depending on pH perhaps on the order of -400 mV vs. SEC). The anodic reaction is the same while in the absence of oxygen water is reduced to hydrogen and hydroxyl ions.

In reality, however, the two pieces of metal are in electrical contact and are furthermore wetted by the same solution (i.e. in electrolytic contact as well). Under these conditions the metal must assume one potential and one potential only, namely the mixed potential. As can be seen from Fig. A I-2 this is only possible if the cathodic reaction rate of the aerated side increases which then forces the anodic reaction of the deaerated side to increase as well. To a certain extent this result may be counter intuitive in that now the area that is starved in oxygen is corroding while the oxygen rich side is, as is often said as well, cathodically protected by the corroding side.

Evans Diagram for Coupling of Iron in Aerated Solution With Iron in Deaerated Solution
