# **Oyster Creek License Renewal Presentation to ACRS**

February 1, 2007

# Summary of Drywell Corrosion

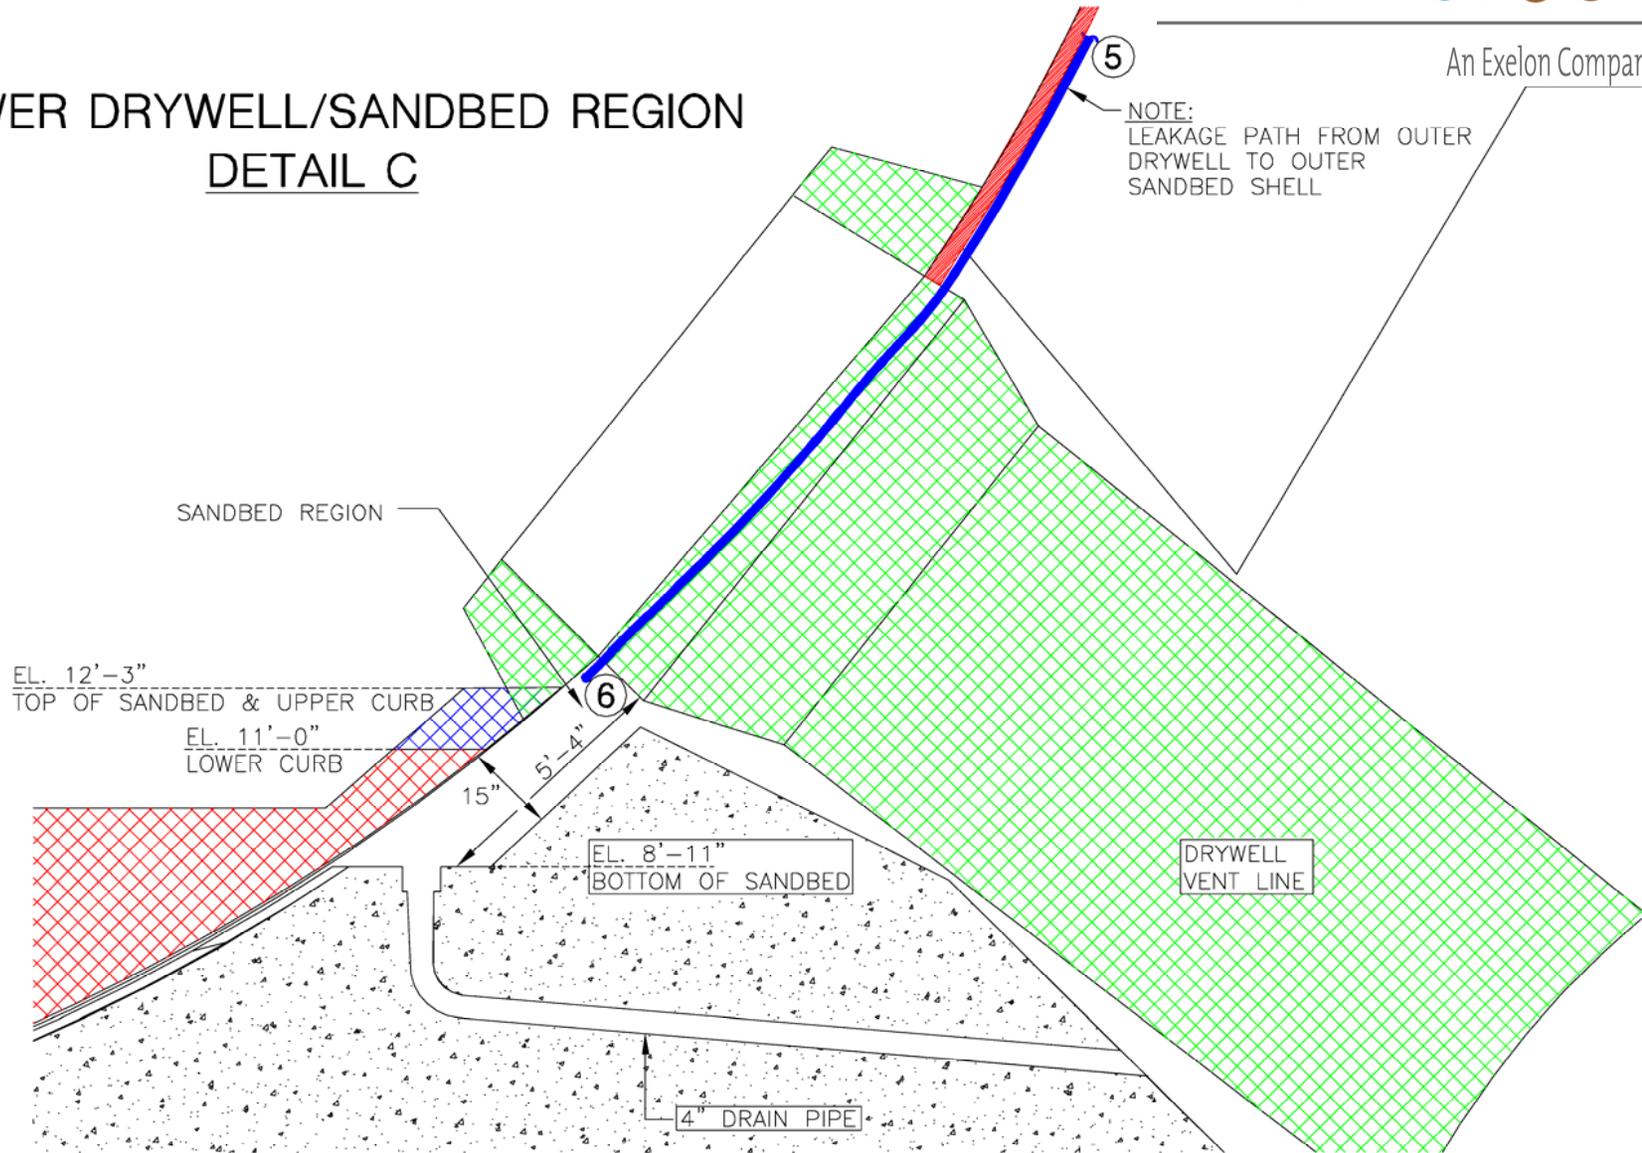
## LOWER DRYWELL/SANDBED REGION DETAIL C

- Leakage from the reactor cavity liner accumulated in the sand bed region, corroding the exterior surface of the drywell shell
- Corrective actions
  - Water has been prevented from entering the sand bed region
  - The sand was removed and the exterior of the drywell shell coated with an epoxy coating
  - Analysis performed to determine code required thickness of the drywell shell

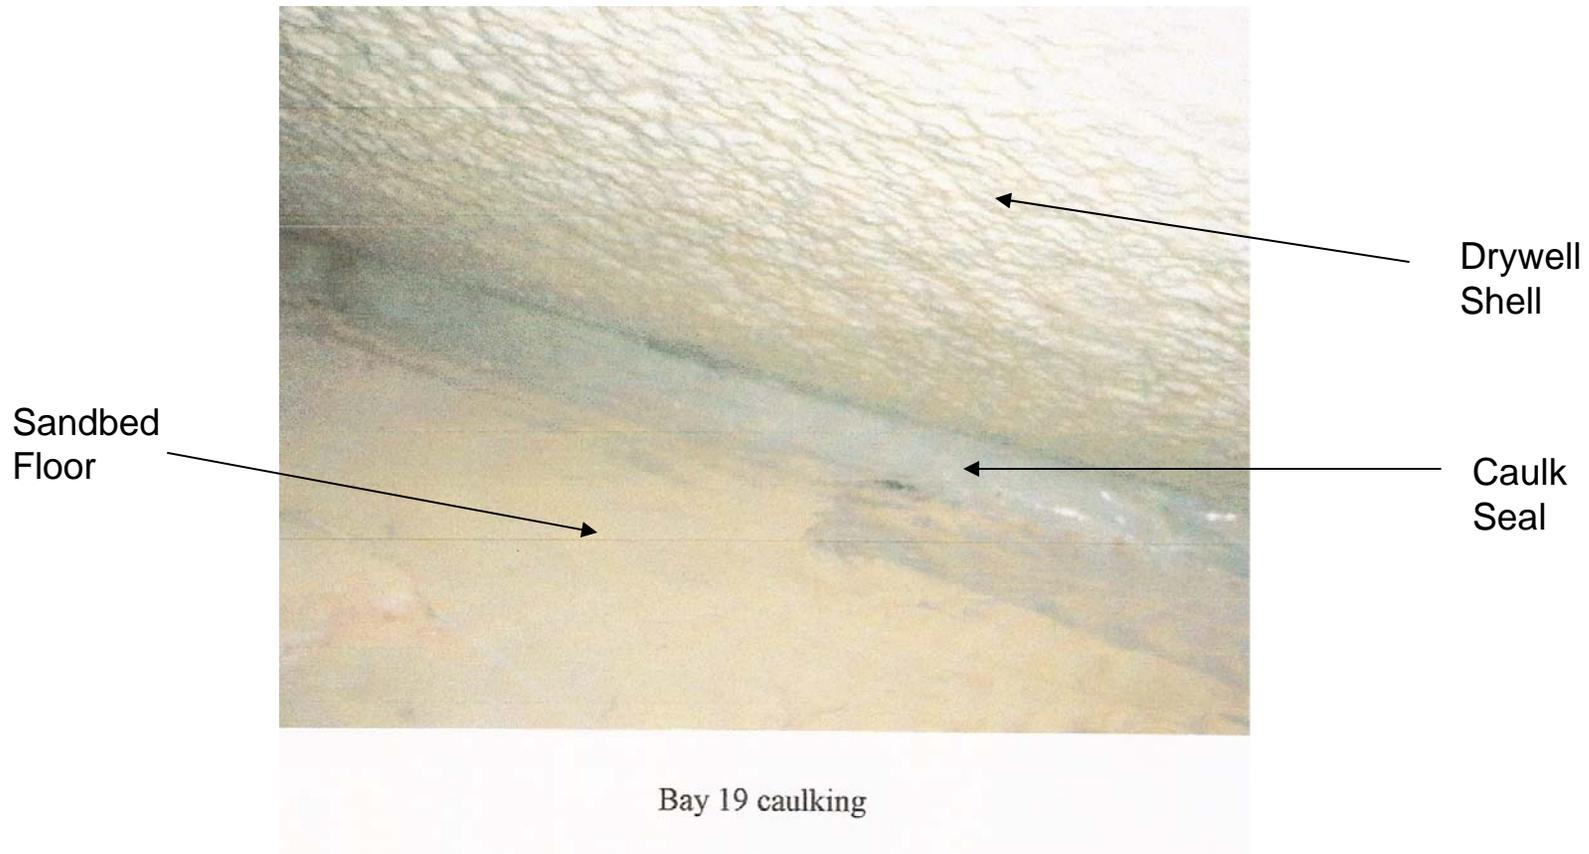
# Sand Bed Region 2006

- 2006 Refueling outage monitoring results
  - Low leakage from reactor cavity liner
    - Approximately 1 gpm
  - No water in the sand bed region
  - Epoxy coating 100% visual inspection in all bays
    - In good condition
  - UT grid measurements in sand bed region from inside the drywell
    - No corrosion
  - Local UT measurements in sand bed from outside
    - The drywell shell exceeds required thickness
  - UT grid measurements in upper elevations
    - No corrosion except 1 location shows 0.66 mils/yr

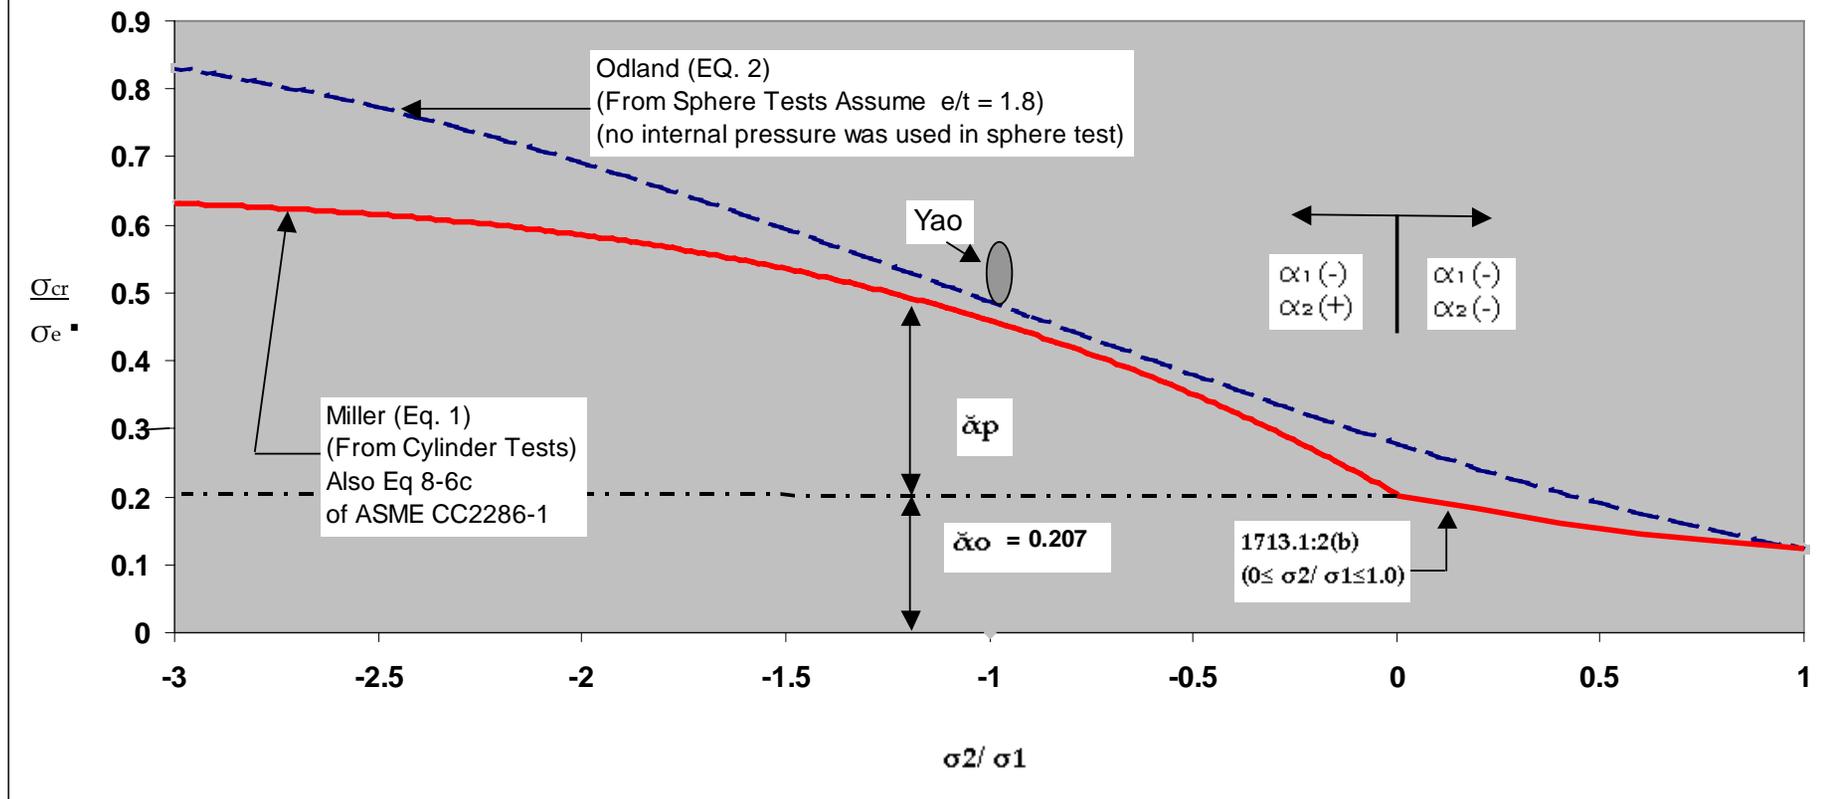
## Capacity Reduction Factor for Spheres

- ASME Code Case N-284 allows modifying the capacity reduction factor to account for the effect of orthogonal tensile stress on buckling strength.
  - The effect of orthogonal tensile stress due to internal pressure is well documented for cylinders.
- The N-284 capacity reduction factor is modified using formulas developed by C. D. Miller. The formulas are based on tests conducted on cylinders.
- Tests conducted on spheres, without internal pressure, show that the coexistence of orthogonal tensile stress reduces the effect of imperfections on the buckling strength of spheres
  - Orthogonal tensile stresses are a result of in-plane tension or compression loads.
- The modified capacity reduction factor is now used in ASME Code Case 2286-1 for spheres.
- The following figure shows that the modified formula is conservative for spheres.

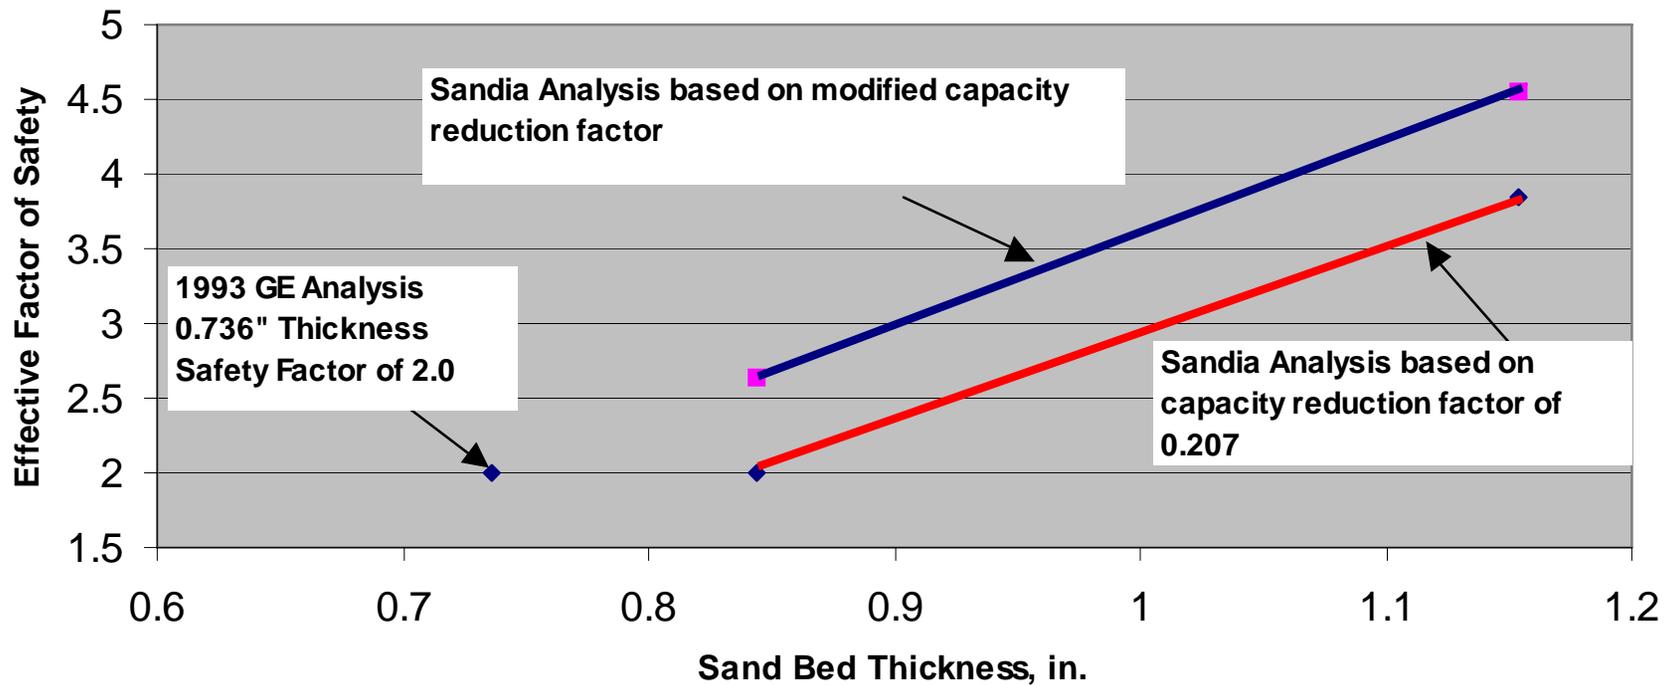
### Impact of Modified Capacity Reduction Factor on the Effective Factor of Safety with Uniform Sand Bed Thickness

Note: Re-drawn from Sandia Report SAND2007-0055 page 79  
(Red Curve)
