Enclosure - Table of Contents

This package of historical information and 2006 outage information is being provided to the ACRS Subcommittee reviewing the License Renewal Application for Oyster Creek. The purpose of the information is to respond to questions that were raised at the ACRS Subcommittee meeting on October 3, 2006 concerning the corrosion of the drywell shell and to update the Subcommittee on the results of recent inspection activities. This package is meant to help the ACRS members understand the information that the NRC staff has already reviewed over the course of weeks of audits and inspections. As such, the information set forth in this package consists of documents and responses to questions that were available to the NRC staff during the NRR AMR and AMP audits in January and February 2006, during the NRC Region 1 inspection in March 2006, in response to NRC RAls during the review of the Oyster Creek License Renewal Application, in docketed correspondence between GPUN or AmerGen and the NRC, and in documents reviewed by NRC Region 1 during the 2006 refueling outage. The information provided also includes some historical information that serves as the basis or supp

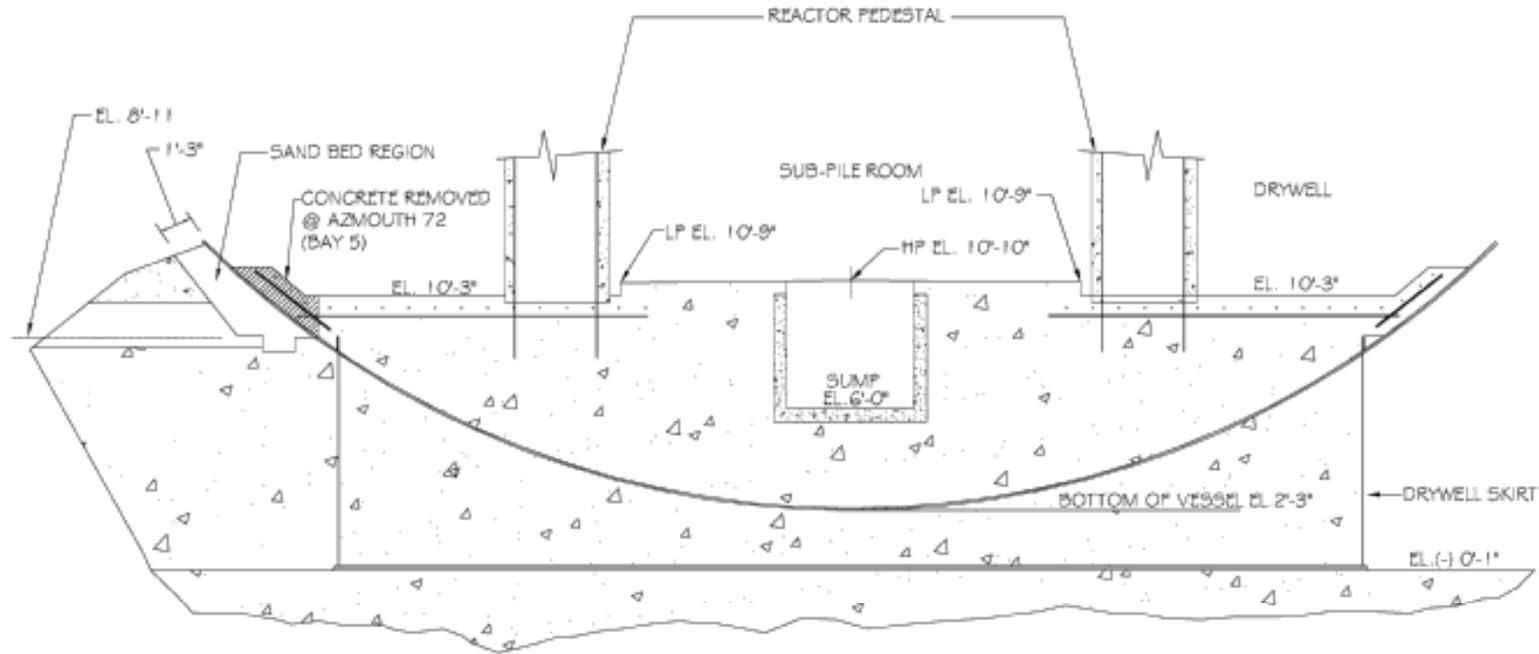
FIGURE 5

Outside the drywell support skirt and the spherical section, concrete was poured in contact with the sphere up to elevation 8' 11". At this point, the concrete was stepped back 15" radially up to elevation 12' 3" and later filled with sand (sandbed region), refer to Figures 5 & 7 for details. The purpose of the sandbed was to provide a cushion to smooth the transition of the shell plate from a condition of fully embedded between two concrete masses to a free standing condition. The sandbed region was provided with five drains designed to allow drainage of any water that may enter the region.

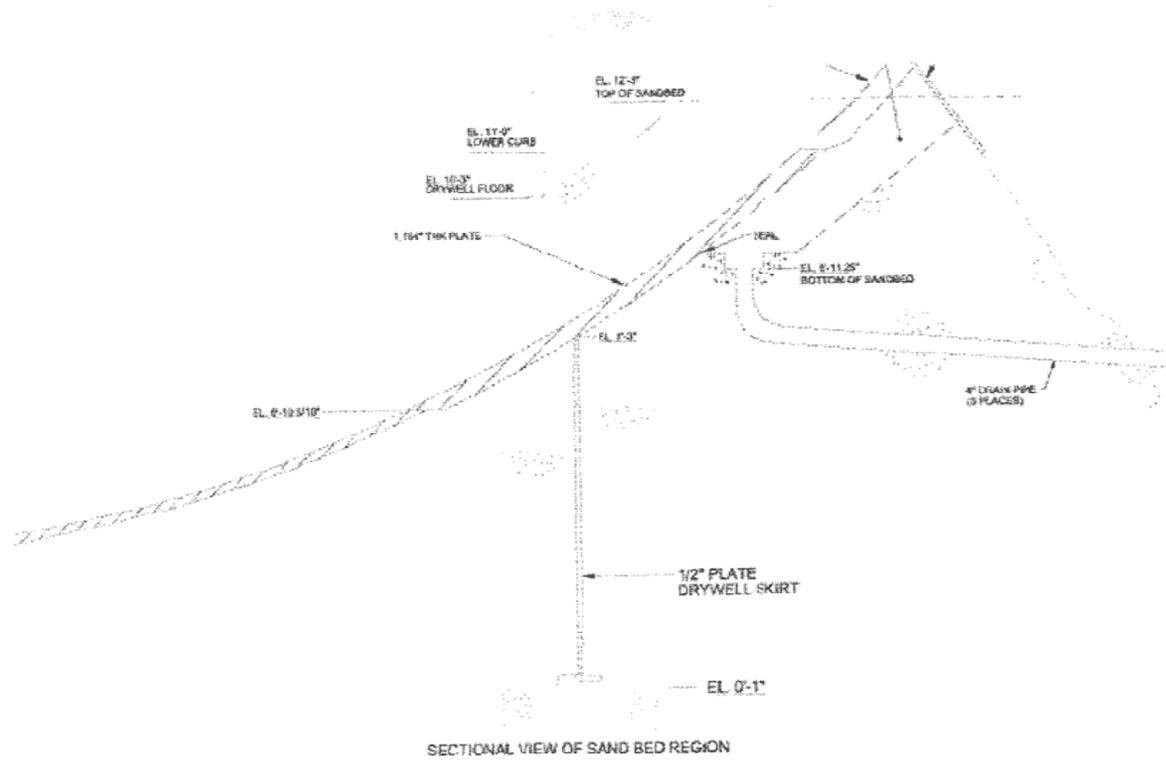
FIGURE 7

A review of the drywell construction and fabrication details shows that the drywell skirt is welded to the 1.154 inch thick plate below the sand bed floor before the end of the 1.154" thick plate. This thick plate is welded to the 0.676" plate at elevation 6 foot 10 1/4 inches. One of the purposes of the skirt, which is also now embedded in concrete, was to support the drywell during construction. The presence of the skirt prevents moisture intrusion into the 0.676" plate. Reference [Figure 7 in Section 3](#) of this Enclosure.
