Subject O.C. Drywell Ext. Ut Evaluation in Sandbed		Calc No. C-1202-187-5320-024	Rev. No. 0	Sheet No. 1 of 54
Originator MARK YEKTA	Date 01/12/93	Reviewed by S. C. Tammhelli		Date 04/16/93

The purpose of this calculation is to evaluate the UT thickness measurements taken in the sandbed region during the 14R outage in support of O.C drywell corrosion mitigation project. These measurements were taken from the outside of the shell. Access to the sandbed region was achieved by cutting ten holes completely through the shield wall from the torus room.

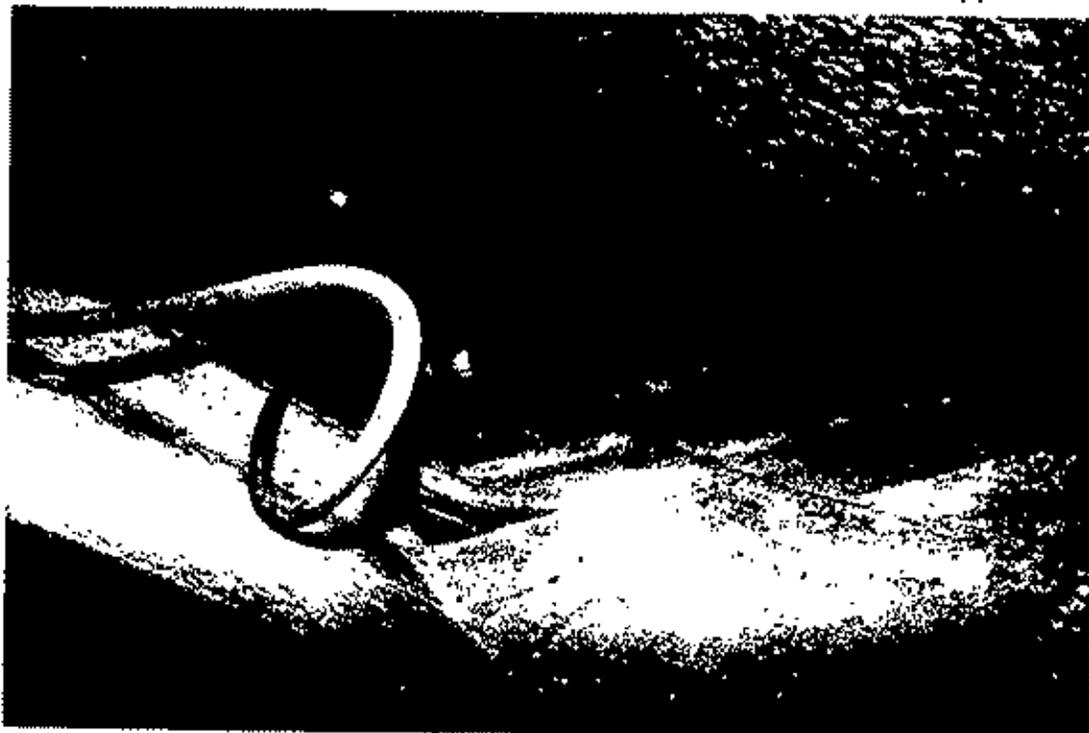
Bay #13 - Looking toward Bay #15 - This photo captures the concrete floor condition and a portion of lower shell corroded surface in very great detail. The floor in this area
